ENGINEERING INSPECTION & REPORT

ANZAC Community Centre,

Anzac Recreation and Social Society

December 2018

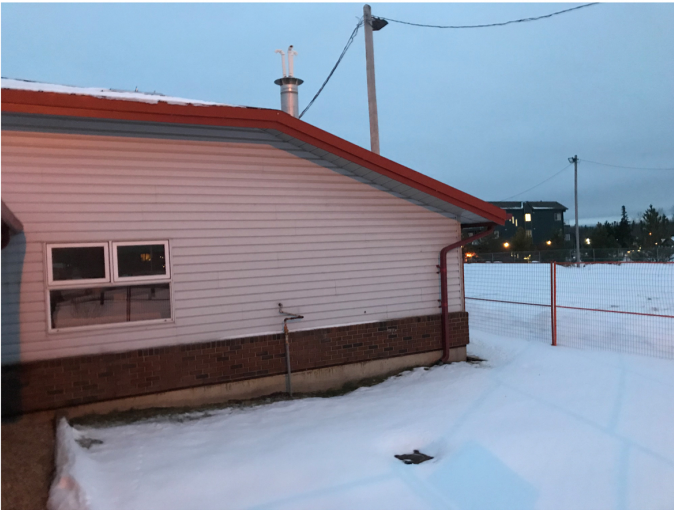
CMG did not review storm water drainage on the Subject Property and snow cover prevented any storm water patterns or topology for the Site. CMG did observe eavestroughs and downspouts for roof drainage. *The downspout extensions are set too close to the foundation, and should have extensions that route the water at least 1.2m away from the foundation walls.*

downspouts should have extensions that lead 1.2m away from foundation.JPG

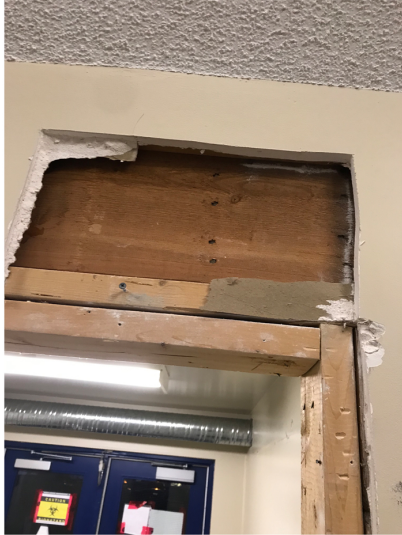
In spite of heavy ice loads on the roof at the time of the Site Visit, CMG did not see any defects in the lintels.

2x12 multi-ply lintel beam over main entrance.JPG

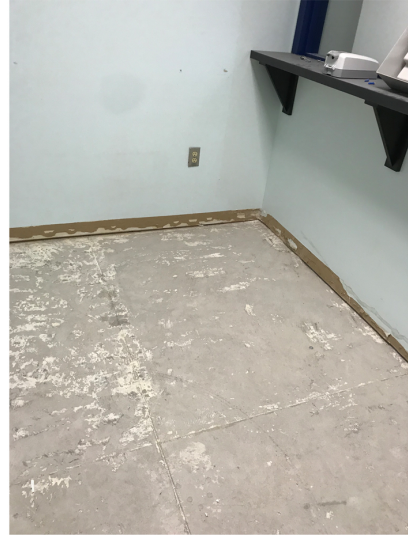
floor slab in satisfactory condition.JPG

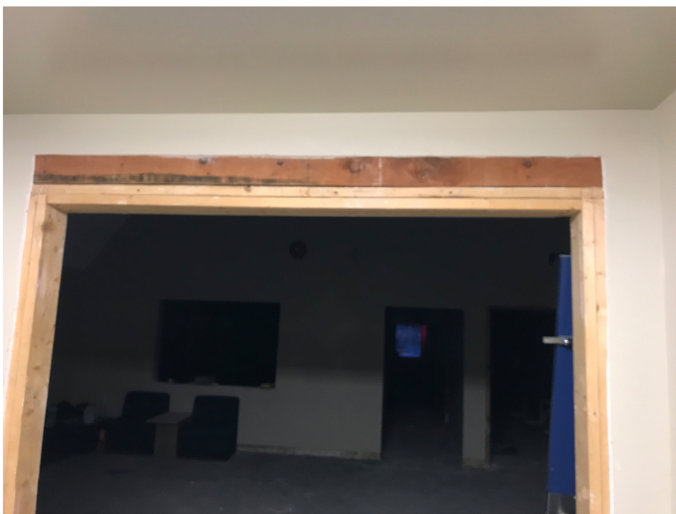
lintel support.JPG

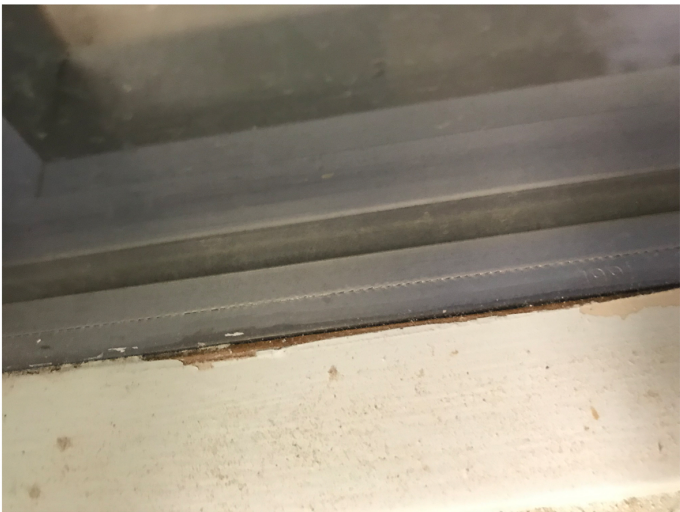
office window installed after 1991.JPG

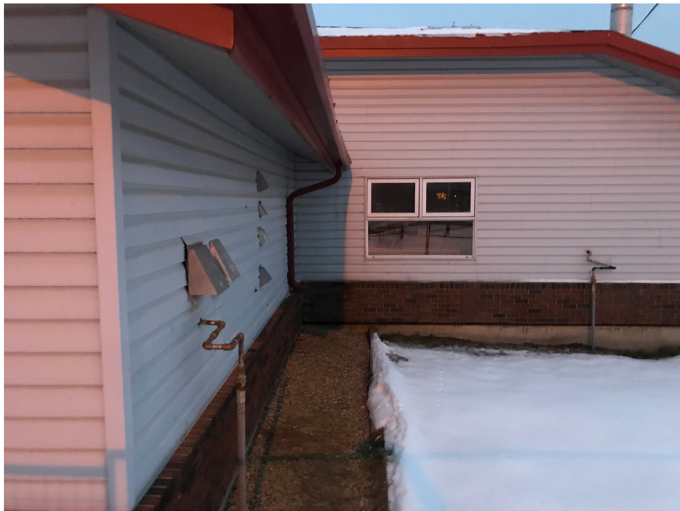
PVC siding with brick facade underneath.JPG

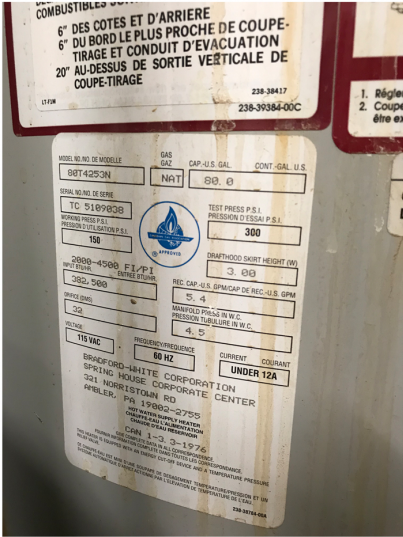
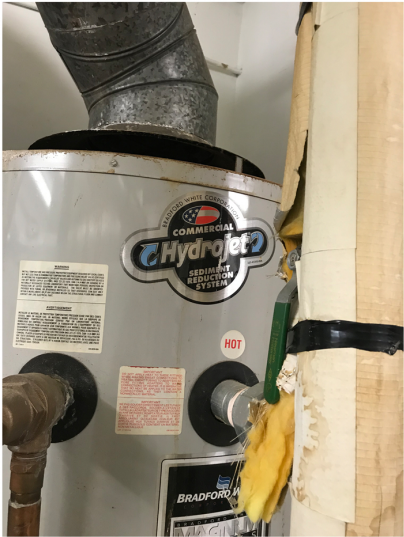
CMG observed a RMWB municipal water meter in the mechanical room of the Subject Building during the Site Visit. During the Site Visit CMG also observed 302 litre Bradford White brand hot water heater with s serial number TC5109038 indicating a manufacture date of March 1999. *This unit is likely near the end of its normal lifespan and new one should be*

80USG Nat Gas fired HW Heater Model 80T4253N SN TC 5109038.JPG

Bradford White HW heater.JPG

added to the system to reduce the risk of failure. The cost should be less than \$2 000 (2019) CAD. During the Site Visit CMG observed a circulation pump next to the hot water heater to provide faster hot water delivery to the Subject Building. CMG observed copper water supply piping and saw no evidence of any Polybutylene. The copper plumbing system should expect an effective lifespan of no less than 30 more years.

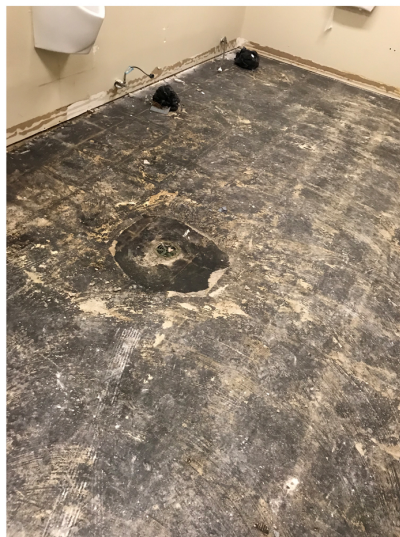
properly recessed drain in men's WC.JPG

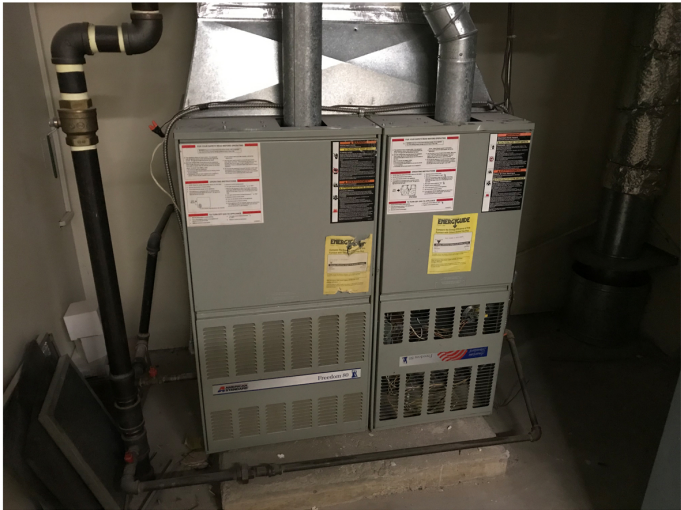
During the Site Visit CMG observed 5 furnaces. Two were older 1995 and 1998 vintage American Standard O/A Trane forced air furnaces with serial numbers K3811GC1G and N0413LK2G respectively in a room just west of the theatre room, and the other three were virtually new high efficiency forced air furnaces in the mechanical room. It is CMG's understanding that the older vintage furnaces were no longer being used. No evidence of HVAC equipment pre-dated the estimated 1992 construction year.

older mid efficiency furnaces.JPG

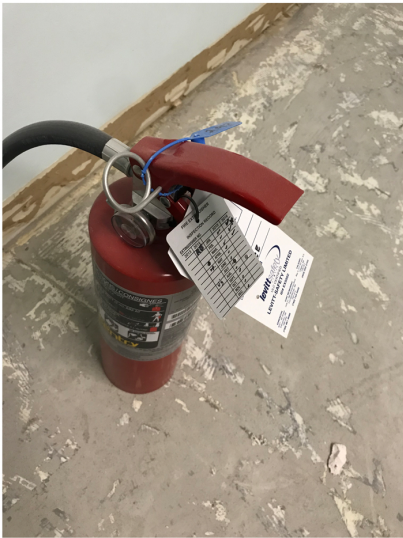
fire extinguisher check regularly until Subject Building closed.JPG

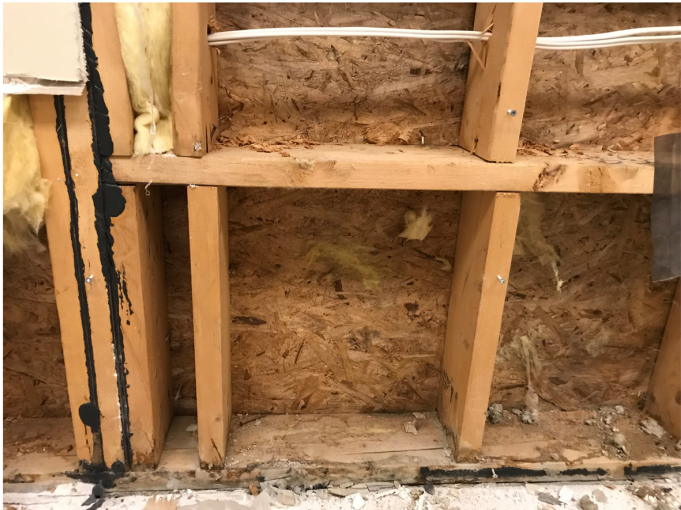
Some drywall had been removed in some of the walls, and a black coloured substance could be seen on the revealed insulation in some areas of the external walls. Some small sections of the sill plate (the supporting wood under the stud walls) was damaged, and this can be cleaned and sections replaced if necessary.

deteriorating sill plate on internal wall.JPG

in a separate document, On-Point has chosen to clean the sill plates rather than replace them since they likely determined them to not be rotten.

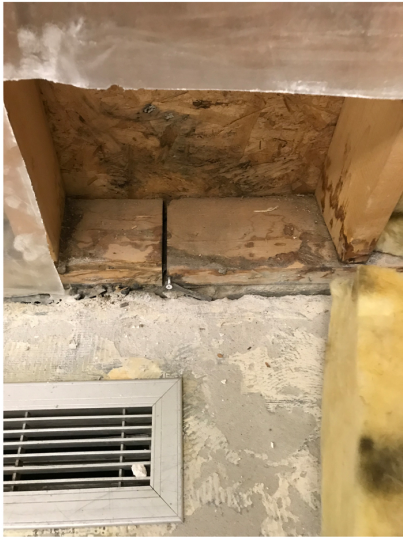
deteriorating sill plate under window next to heat register in office area.JPG

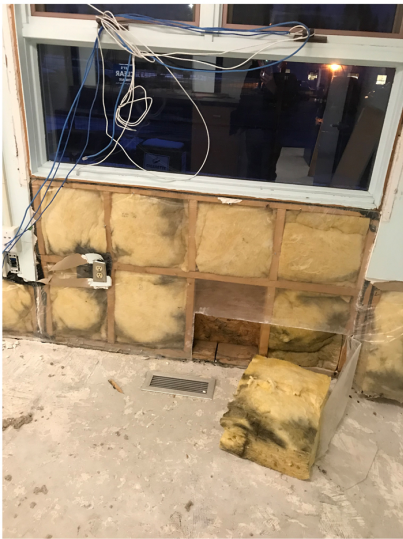
The Flood is likely to be the main reason for the mould in the Subject Building. When a flood like this occurs, it is normally the best practice to remove the lowest 4 feet of drywall, and put dehumidifiers into the building to reduce the chance of mould forming.

During the Site Visit CMG observed much of the flooring was removed for the remediation. The walls were mostly a finished painted drywall, and the ceilings were the same. Some drywall had been removed in some of the walls, and a black coloured substance could be seen on the revealed insulation in some areas of the external walls.

evidence of mould in insulation.JPG

At this point much of the remediation has taken place, and the remaining remediation appears to be removing mouldy insulation, and cleaning or repairing any affected structural wood elements. The Client commissioned On-Point Restore to come to the hall and assess the remediation. In an estimate that the Client obtained from On-Point Restore that can be found

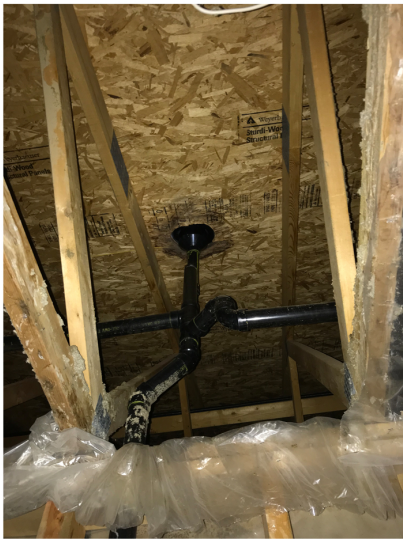
evidence of water ingress by sanitation drain vent.JPG

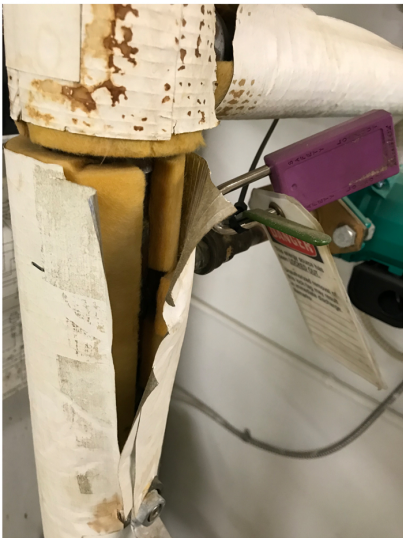
no asbestos found in insulation in STANTEC report.JPG

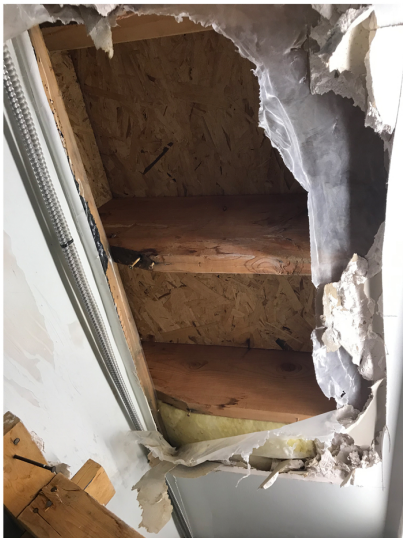
no visual evidence of mould above mechanical room.JPG
