## **Anzac Community Centre**

Building Envelope & Mould Remediation  
Report; Addendum 1

May 17, 2018

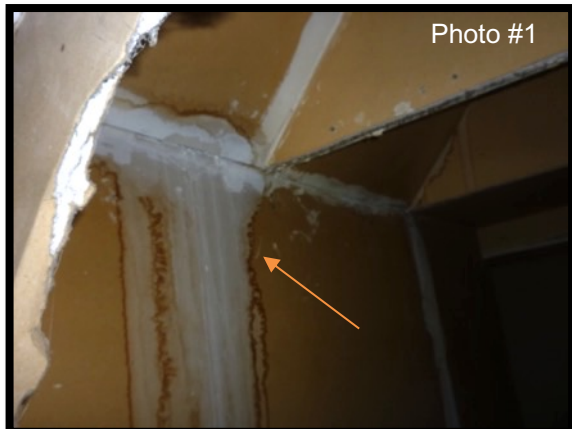
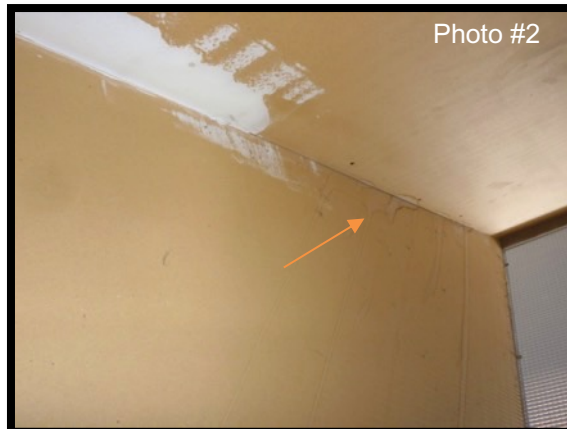
Water damage was observed on the drywall within the access area for the tower/skylight situated in the attic

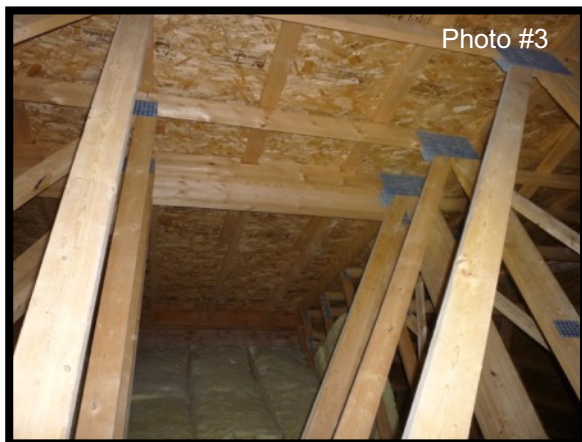
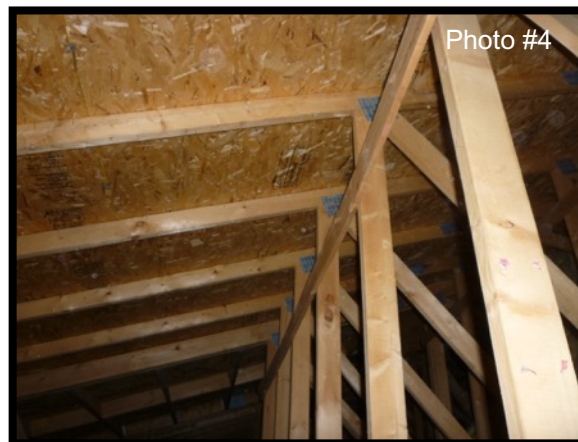
In most areas the trusses and underside of the roof sheathing appear to be in generally good structural condition

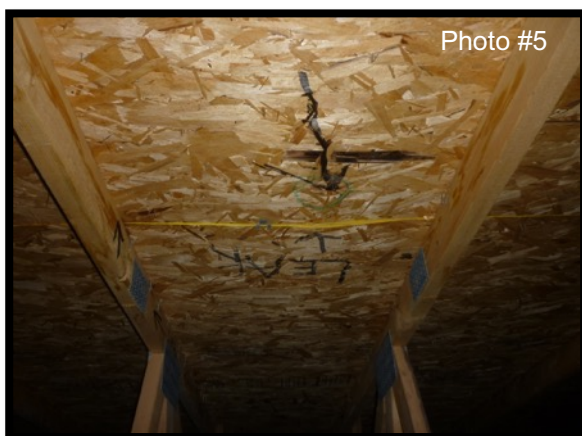
Areas where water infiltration had caused damage to the attic sheathing had been previously labeled

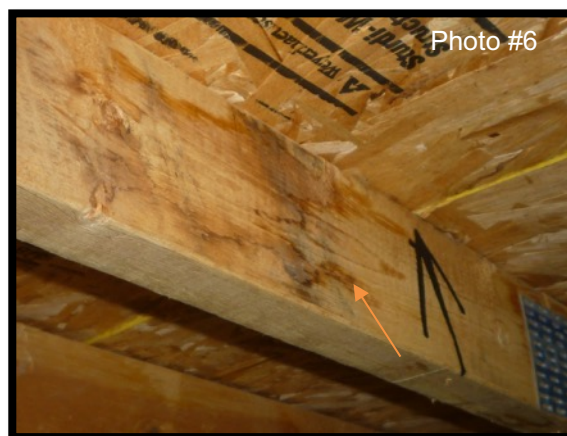
Localized areas of water staining and suspected fungal amplification are present where leakage was labeled

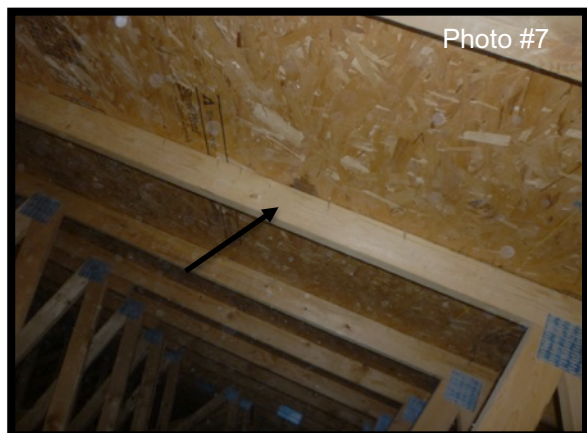
Additional photo showing a localized water stain on the underside of the roof sheathing

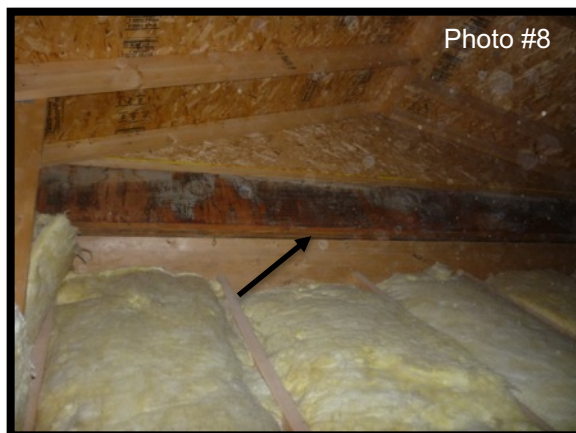
Mould growth was observed on a glulam beam adjacent to the skylight/tower

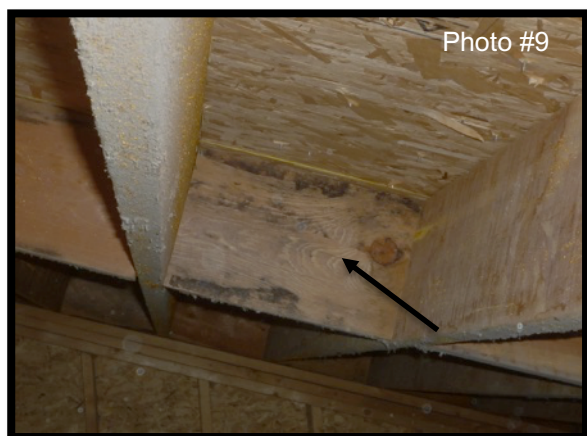
Mould growth was noted on several cross members above the hall area

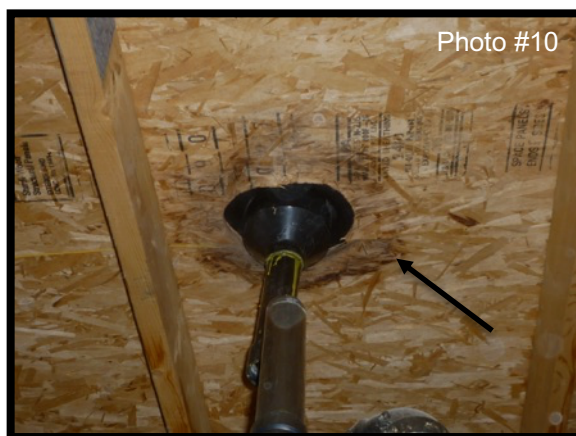
Water damage on the roof sheathing around a plumbing stack situated above the hall area bathrooms

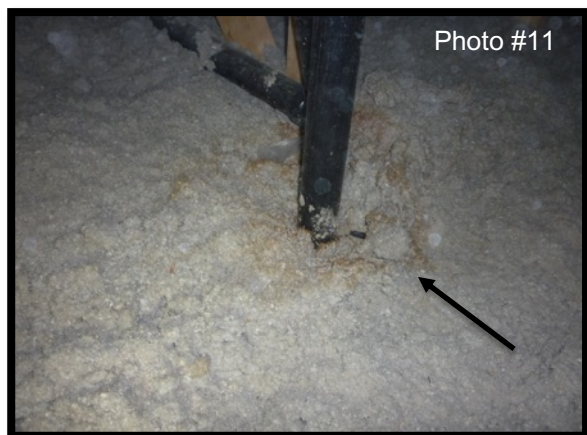
Leakage from around the plumbing stacks had caused water damage and compaction of the attic insulation

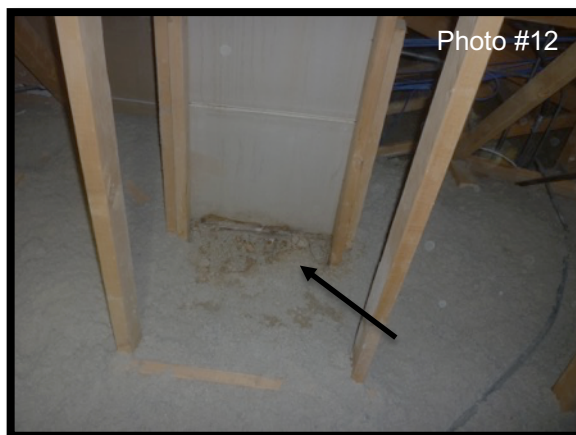
Water stained insulation and drywall within the attic adjacent to the access hatch in Janitor's Room 118

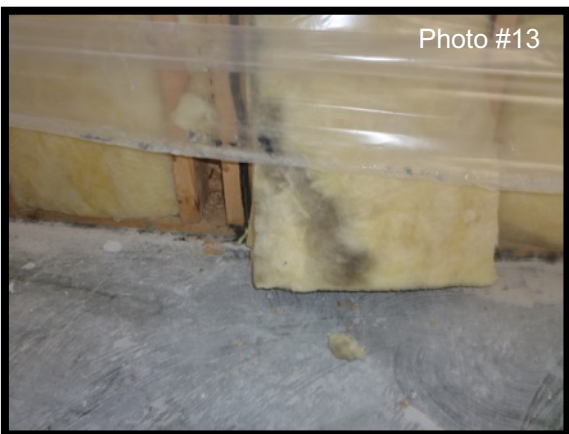
Staining was noted on the exterior wall insulation throughout the facility

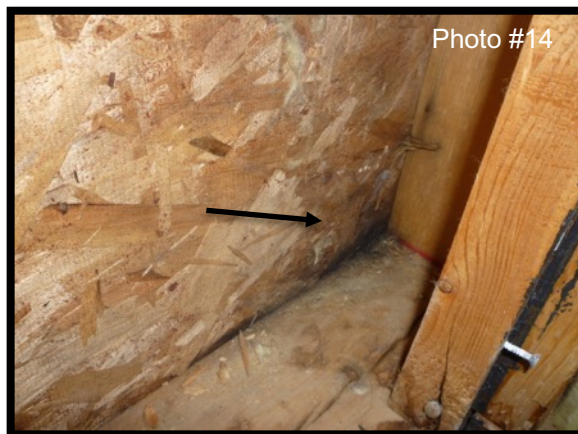
Mould growth was confirmed on the exterior OSB sheathing throughout the perimeter of the facility

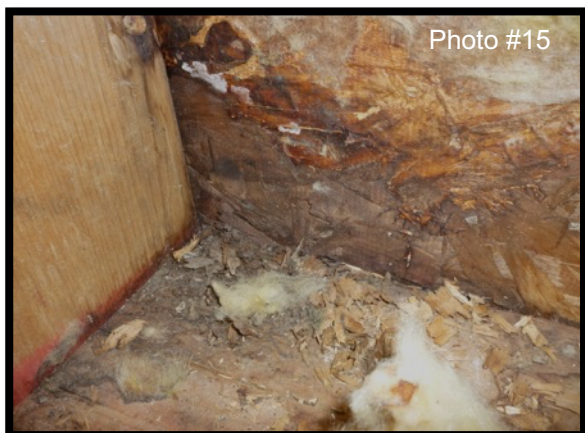
In several areas, the exterior OSB sheathing was heavily damaged

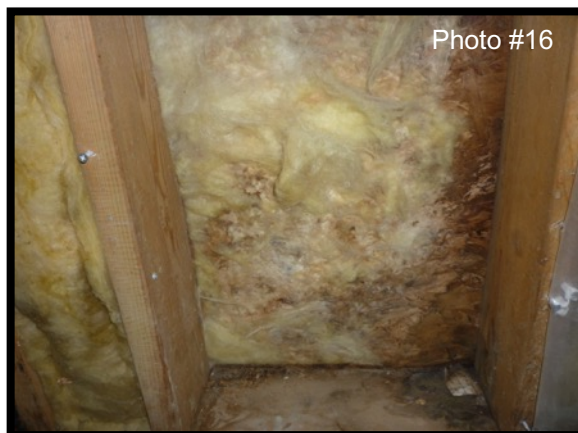
Additional photo showing mould growth and damage on the exterior OSB sheathing

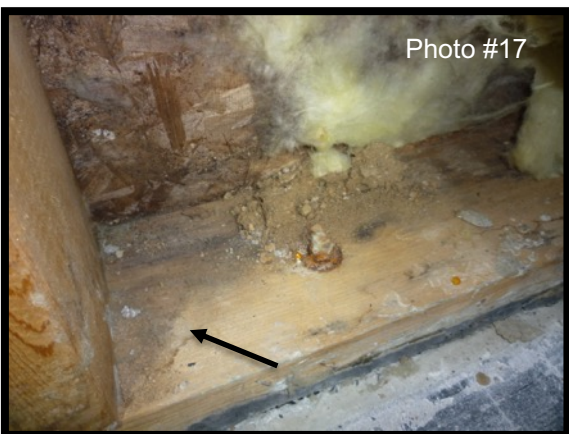
The exterior baseplates had visible water staining and mould growth in several areas

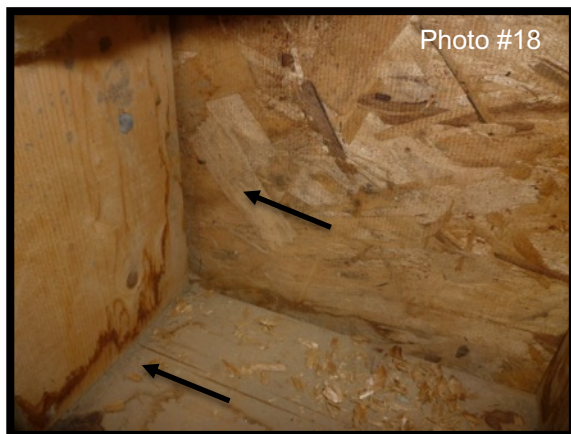
Additional photo showing water stains on a vertical wall stud and fungal amplification on the OSB sheathing

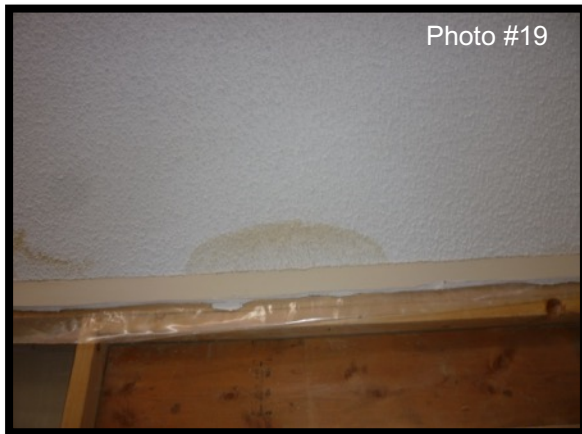
Photo #19

Water staining was observed on the ceiling in the lobby area. Trace amounts of mould growth were confirmed

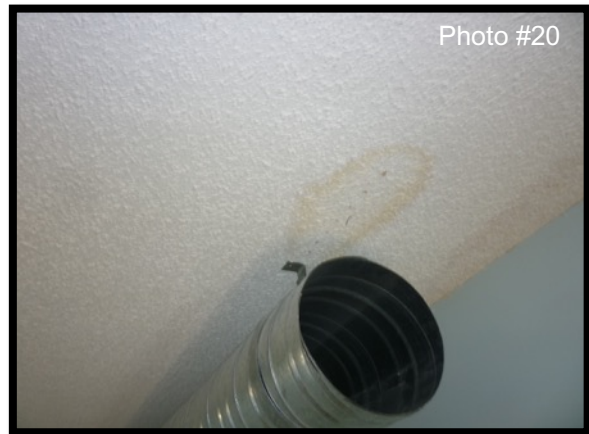
Photo #20

Water staining was also noted on the ceiling in Office RM 124

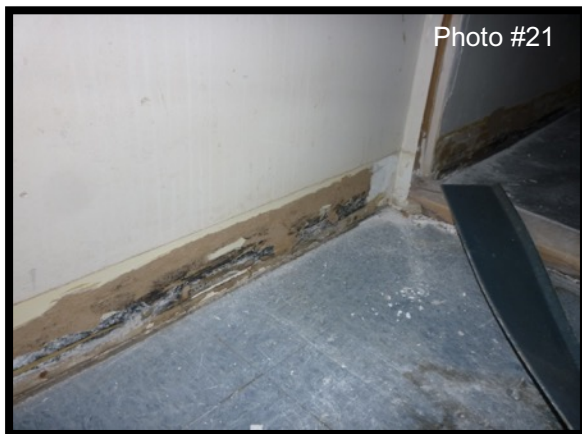
Photo #21

Mould growth was noted on the bottom of the walls in the janitors room (RM 115)

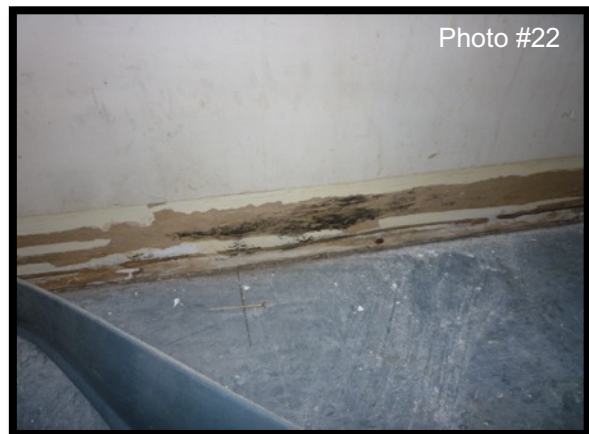
Photo #22

Mould growth was also evident on the bottom of interior walls within the health room, the office bathrooms, and the boardroom

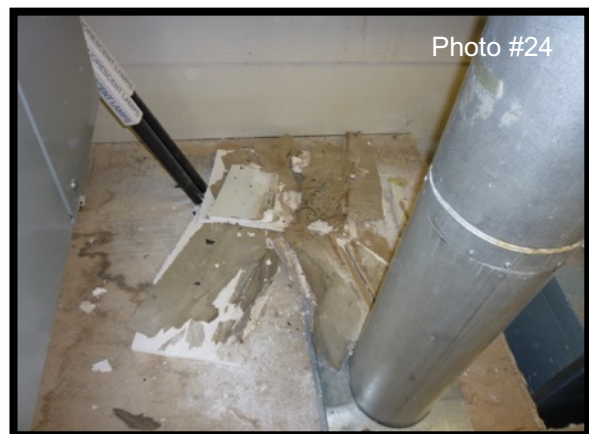
Photo #24

Mould growth and water damage were evident on the ceiling in the mezzanine of Mechanical Room 122

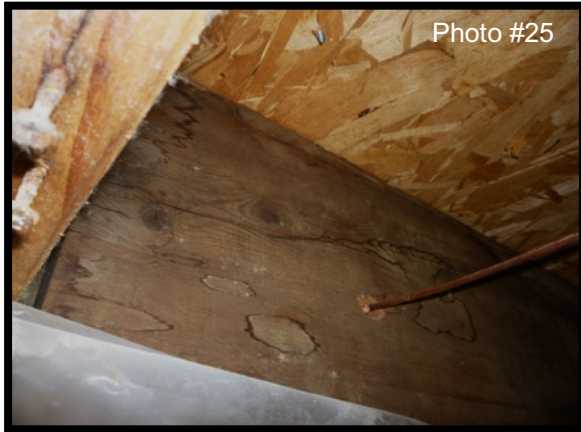
Water staining was observed on a beam in the ceiling cavity above the mezzanine of Mechanical Room 122

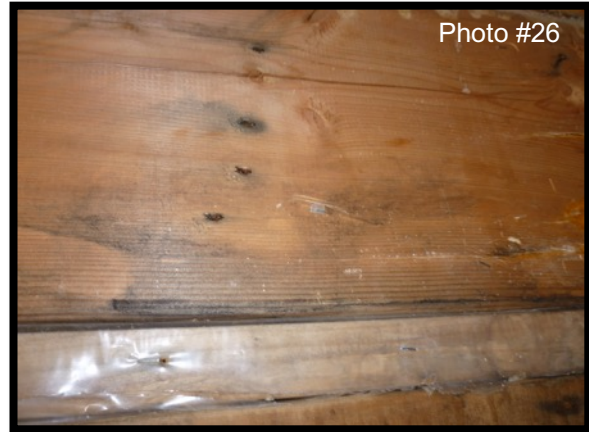
Mould growth on a door header outside Rink Hall Mechanical Room 114

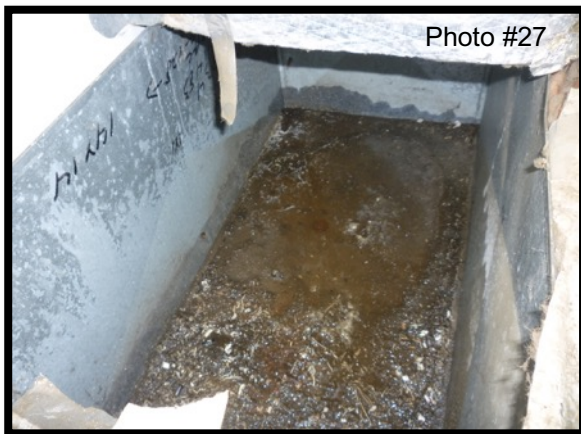
Water pooling and debris were noted in the basin underneath the combustion air duct in Mech. Rm. 114

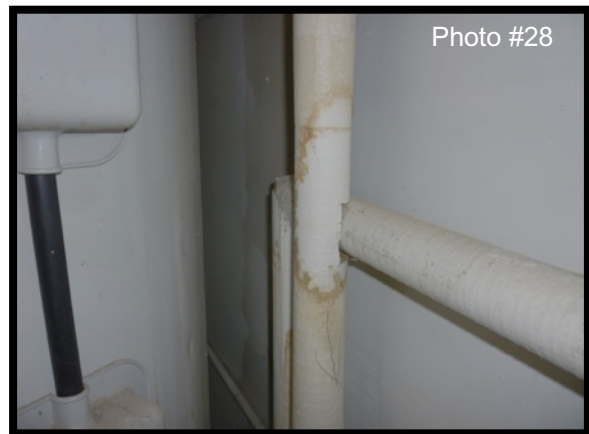
Water staining was noted on the pipe insulation covering in several areas

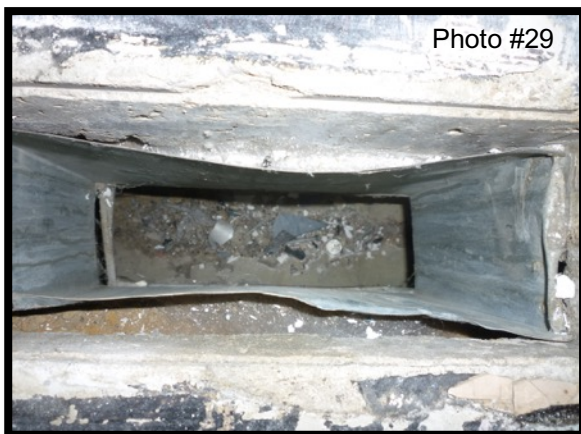
Debris was observed in the in ground supply air ducts. Water pooling inside the ducts is a known concern

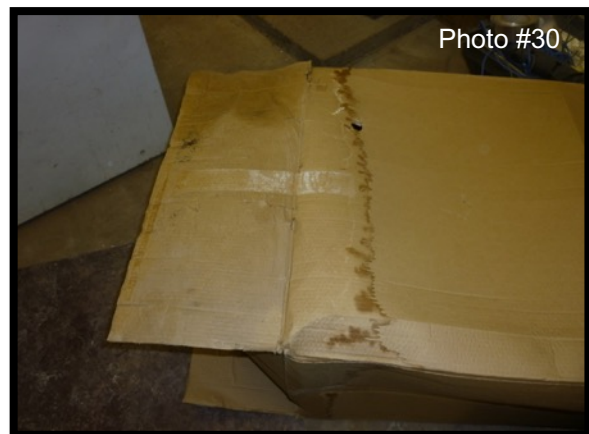
Water staining was noted on stored items within Mech. Rm. 114

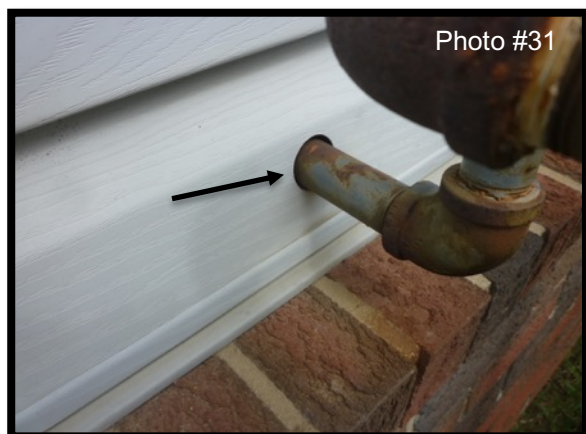
Multiple unsealed penetrations in the exterior siding were noted

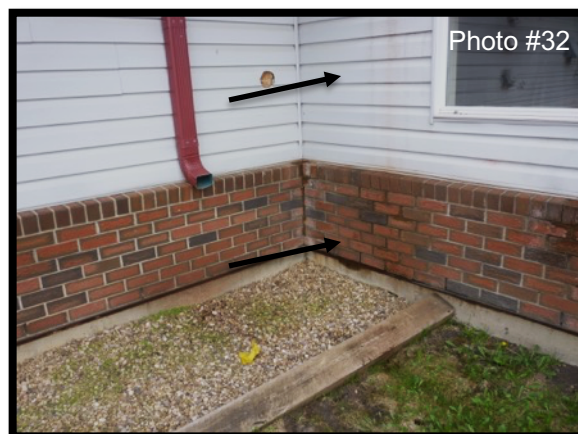
Heavy water staining was noted on the exterior siding and brick cladding in several areas.

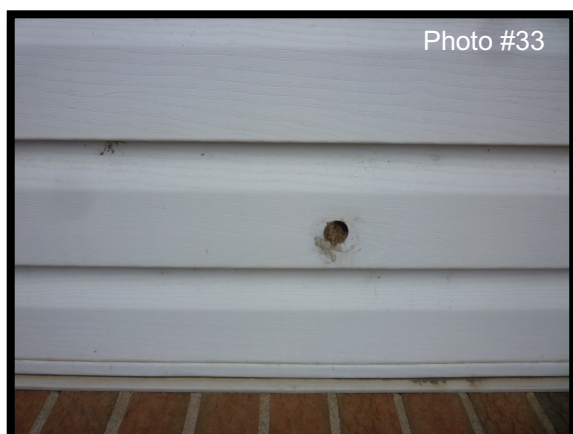
Additional photo showing an unsealed penetration in the exterior siding

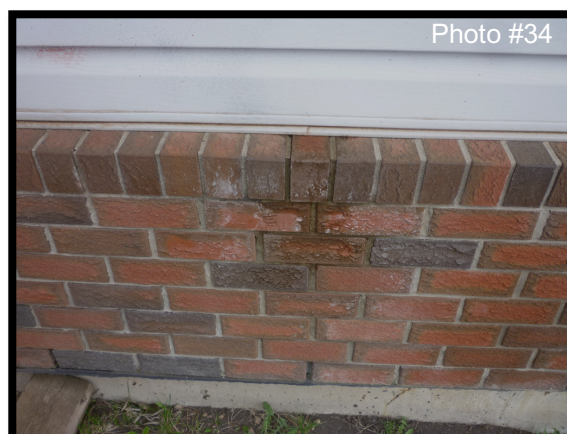
Additional photo showing water staining on the exterior brick cladding

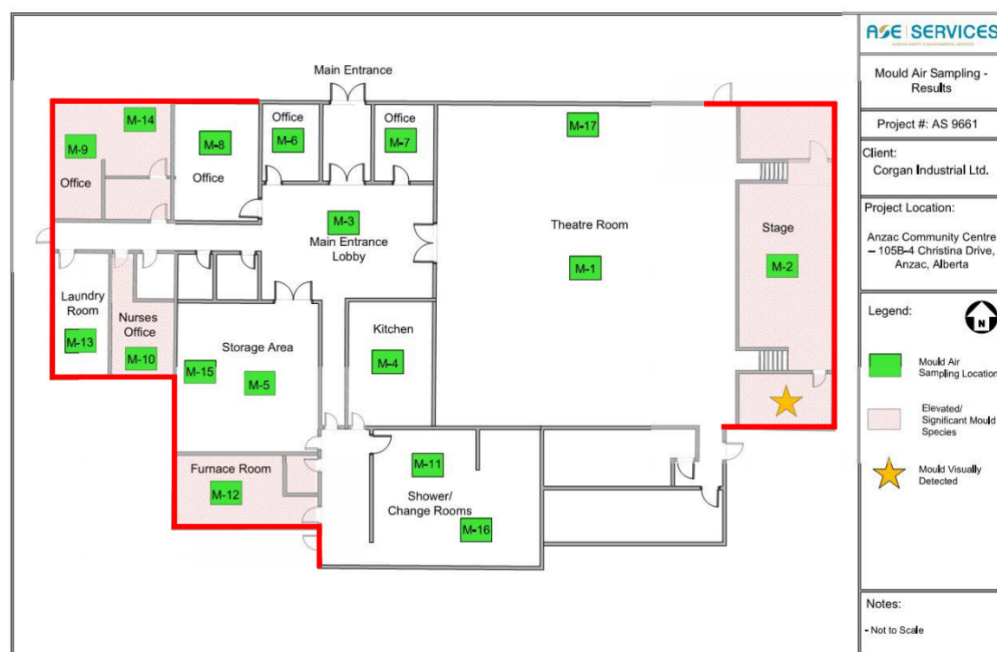
Image 1: Alberta Safety and Environmental Services Mould Locations

- Stage
- Storage Room to the north of the Stage
- Mechanical & Janitor Room to the south of the Stage
- Office in the north-west corner
- Nurses Office
- Mechanical Room in the south-west corner

Stantec agrees with Alberta Safety and Environmental Services recommendation that these areas will need to be inspected and properly remediated. For proper identification of hazardous materials, it is recommended a qualified testing agency is hired to do destructive analysis and testing. Once the scope of the hazardous materials is determined a professional abatement contractor should be engaged to remove all the hazards. All potential and confirmed mould and water damaged materials should be properly remediated following the appropriate high, moderate, or low risk procedures as outlined in Government of Alberta – Best Practices Mould at the Work Site. Following the removal of all hazardous materials, final air sampling should be conducted to ensure the building is safe for re-occupancy.

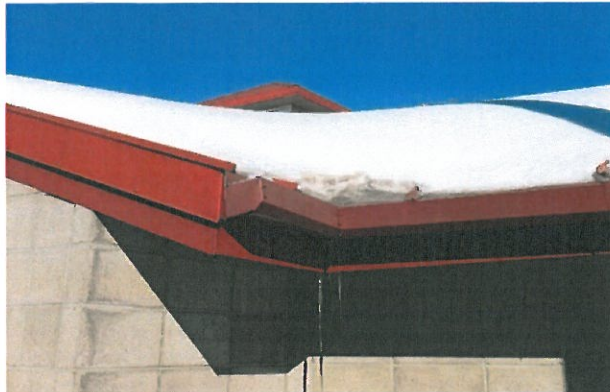
- Significant ice damming was observed on roof areas above the main washrooms (Photo 3), the rink hall entrance (Photo 4), and the nurse's office (Photo 5). Ice damming occurs when the underside of the snow cover melts as a result of exposure to a heat source. Heat sources can be from heat loss in the attic space or the surface of the metal roof due solar heat gain. When the melted water flows over colder sections of the roof and eavestrough, ice formations occur. Ice damming can be minimized by keeping the attic space cold, but this can be impeded by leakage of warm air into the attic, heat loss from uninsulated ducts and pipes, heat loss through the attic insulation and insufficient ventilation in the attic. Comments and observations from our review of the attic are included in Section 3.3 of this report. Attic ventilation is achieved through vented soffits and roof vents; however, no roof vents were visible on the roof at the time of our review. We also could not confirm if there were any ridge vents at the peaks of the metal roof. We recommend further review to assess how the roof is vented.

**Photo 3: Ice damming above southwest washrooms**

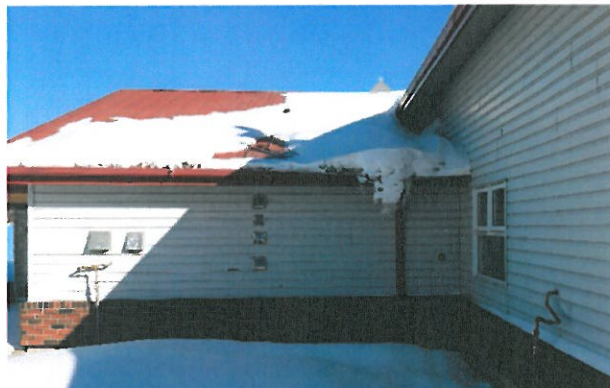
**Photo 5: Ice damming above nurse's office**

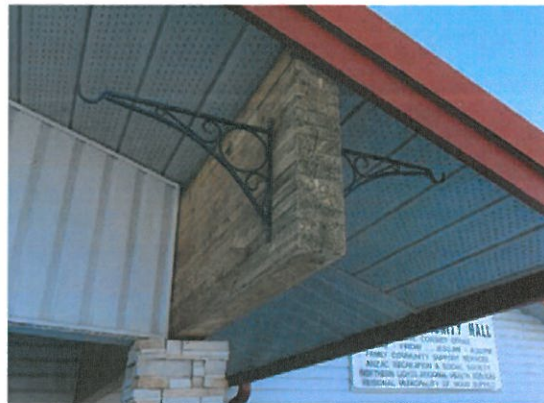
- Roof canopies above the main building entrances are supported by exposed glulam beams, which are supported by exterior columns and the exterior wall (Photo 6). Thermal scans of the exterior walls at the beam connections found noticeable heat loss due to thermal bridging through the wood framing (Image 1, Photo 7). Air leakage was also detected at some of these locations (Image 2, Photo 8). In addition to air vapour barrier repairs, we recommend adding insulation to either the beams or exterior walls to reduce the amount of heat loss at the beam connections.

Photo 6: Exposed end of typical glulam beam

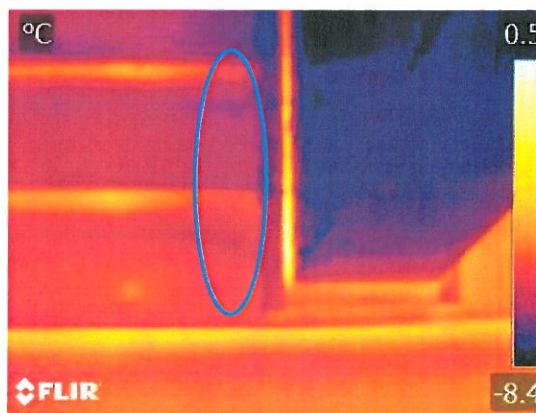
Image 2: Air leakage at typical beam connection

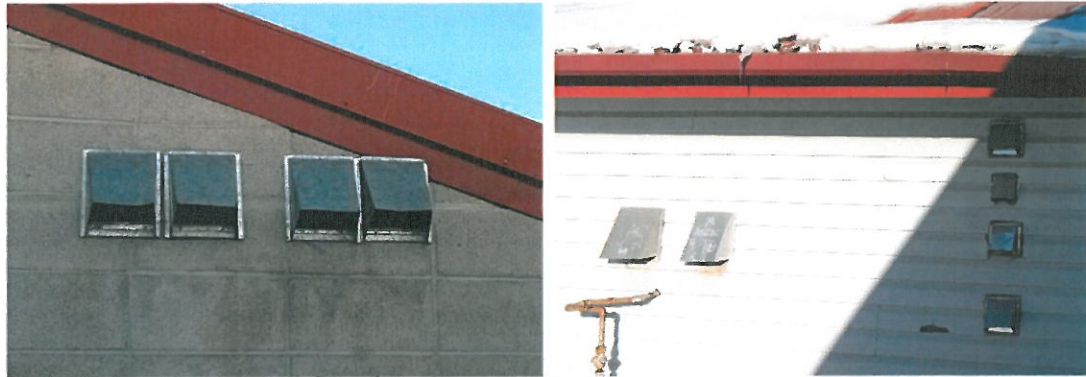
- Wall-mounted exhaust vents appear to be poorly detailed, with top flanges reverse lapped over cladding and fascia (Photos 9 and 10). It is our understanding the exterior walls will be re-clad as part of the renovation project, at which time we anticipate the vents will be re-detailed.

**Photos 9 and 10: Reverse lapped vent covers**

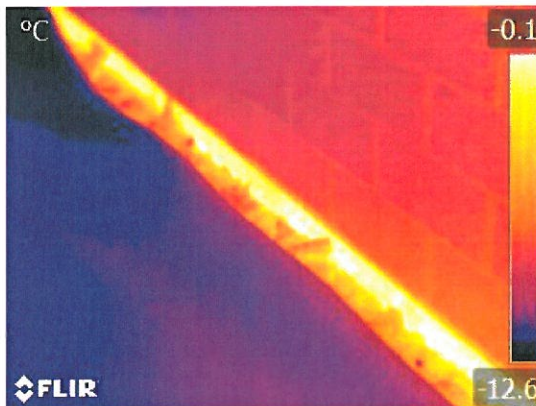
- Thermal scans of the exterior walls found noticeable heat loss through the exposed concrete foundation (Image 3, Photo 11). This appears to be due to thermal bridging through the uninsulated concrete. We recommend adding exterior insulation to reduce the thermal bridging at these locations.

**Image 3: Heat loss through exposed concrete**

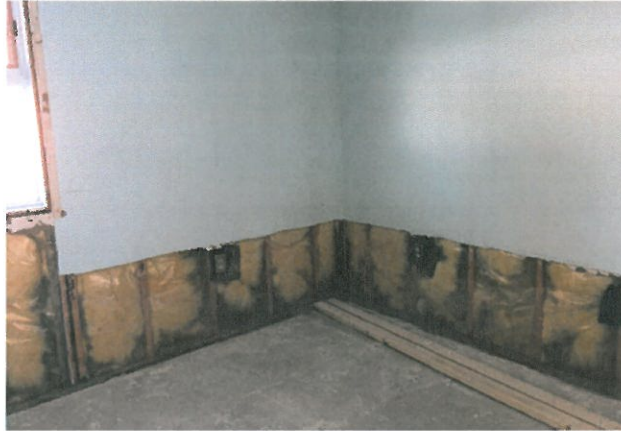
**Photo 12: Stained insulation in north office**

We recommend testing of interior finishes for mould growth and subsequent remedial work as required including, but not limited to replacement of interior gypsum board and stained batt insulation, and resealing of the polyethylene sheet vapour barrier at penetrations and wall-to-floor junctions with acoustical sealant. Alternatively, the polyethylene sheet vapour barrier and batt insulation could be replaced with closed cell spray-applied air barrier/vapour retarder insulating urethane foam, or it could be completely removed if an exterior air vapour barrier and insulation is provided when the building is re-clad.

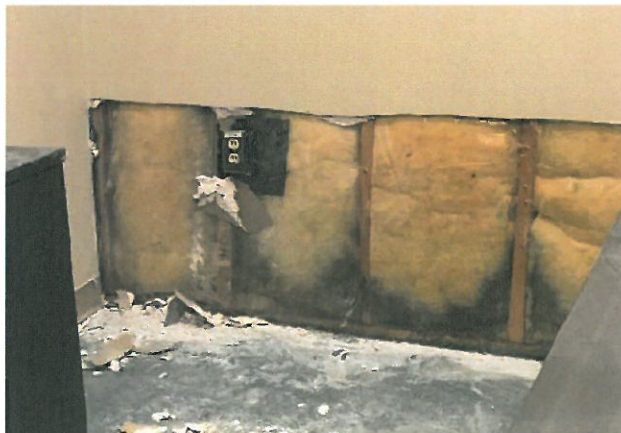
**Photo 13: Stained insulation in nurse's office**

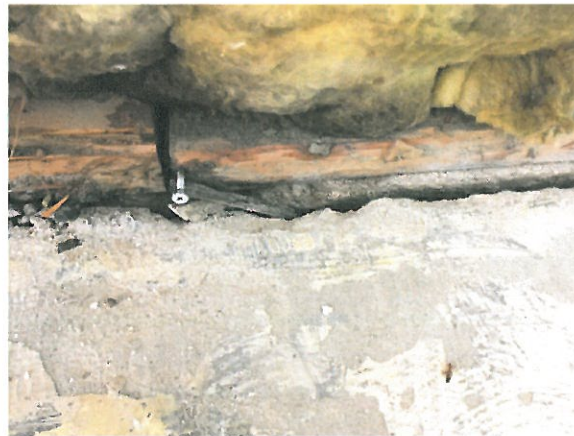
- A joint was observed between the interior floor slab and concrete grade beam (Photo 14 by Stantec). This appears to be a construction joint and it is likely separated due to movement of the slab. It is our understanding the site experiences periodic flooding, which can cause underlying soils to swell and push up on the slab. We anticipate that there is no reinforcement between the slab and grade beam, likely to allow for movement of the slab caused by movement of the soil. The joint could be filled with a sealant or grout to fill the void, however, on-going movement may still occur, which could lead to further separation of the joint.

**Photo 14: Joint between interior slab and grade beam under typical exterior wall**

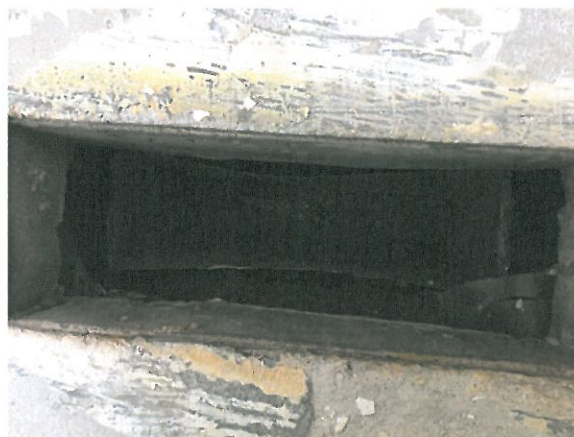
**Photo 15: Separated duct at slab penetration**

- The cause of the flooding is not known at this time; however, during the renovations, the perimeter grade on the exterior of the building should be sloped to provide drainage of surface water away from the building. Geotechnical review would be required to determine if there is a groundwater issue.
- The interior slab is also penetrated by heating ducts, which are located below the slab. It is our understanding these ducts are being abandoned. The abandoned ducts can be filled with concrete to provide a continuous concrete slab surface.

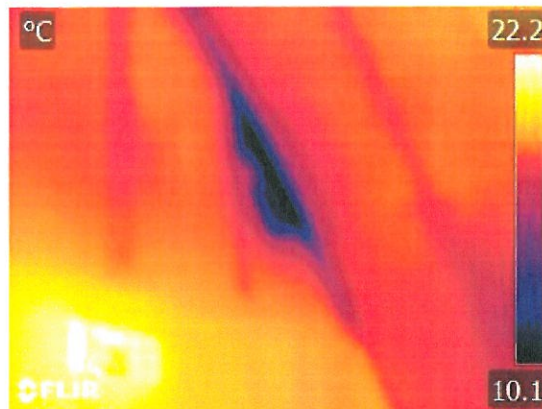
- Thermal scans of the interior found numerous cold spots in wall areas adjacent to unconditioned attic spaces (Images 4 to 9). At most locations, the cold spots were found to be locations of missing or fallen batt insulation. At one location between the kitchen and rink hall, a draft was also detected (Image 9, Photo 20). This was found to be due to a discontinuity in the vapour barrier between the kitchen ceiling and rink hall ceiling, which are located at different elevations (Photo 22). This air leakage may have also contributed to the previously noted moisture damage, which had occurred near Grid D11 (Photo 23).

Image 4: Cold spot in foyer/boardroom wall

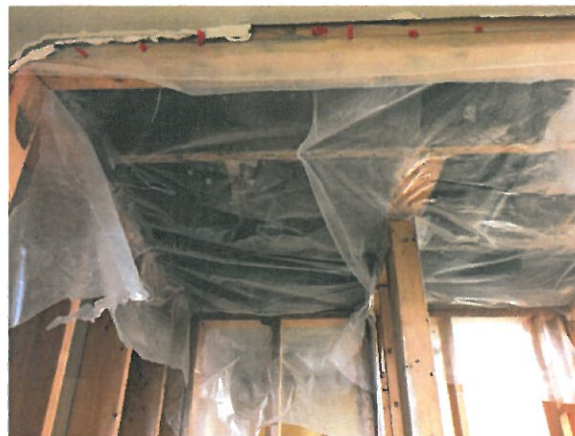
Photo 23: Location of moisture damaged ceiling near Grid D11 per A201

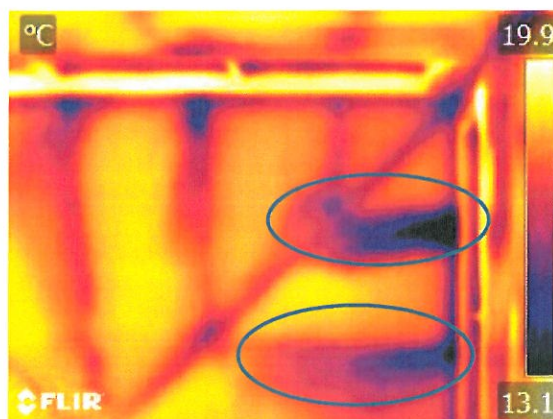
- Thermal scans of the upper walls and ceiling in the foyer identified several locations of increased heat loss (Images 10 and 11). There was no access to this ceiling space to confirm the cause of these thermal anomalies; however, we suspect it is similar to the thermal anomalies observed near the lower ceilings.

Image 10: Thermal anomalies in foyer ceiling

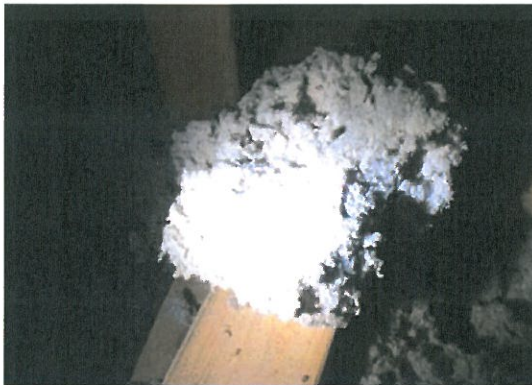
- The attic space above the lower ceiling levels is accessed by two access hatches located in the janitor's room and bar area (Figure 2). The attic hatches consist of an opening framed between the bottom chords of the roof trusses with an insulated wood box serving as the hatch cover. No access hatches are provided to access the ceiling spaces above the main hall and mezzanine (Area 2 in Figure 2); however, a previously made opening the hall ceiling (circled in Figure 2) indicated that this attic space was filled with approximately 6" of loose cellulose insulation with a large air space between the top of the insulate the roof. With the exception of the rink hall and the foyer ceiling/walls in Area 1, which are insulated with batt, all ceiling spaces appeared to be insulated with loose blown-in cellulose insulation. The thickness of this insulation was found to be between 6" and 8". It is difficult to determine what the original thickness would have been since it has been disturbed and has compressed over time from moisture accumulation in the attic (Photos 26 and 27).

**Photo 27: Compressed attic insulation**

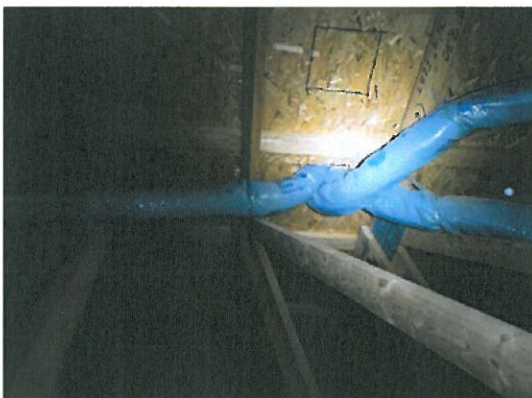
- Flexible insulated exhaust ducts are routed through the attic space to rooftop and wall-mounted vents (Photos 9 and 28). It is not good practice to route multiple ducts to one roof vent. It is also not good practice to run exhaust ducts horizontally through the attic space, as noted above the main washrooms (Photo 29). There is a risk of condensation and ice forming along these ducts where they sag, have excessive runs, or have bends or kinks that result in a reduction in the duct diameter. Ideally, these ducts should be routed directly up from the ceiling penetration to a roof vent.

**Photo 28: Exhaust ducts terminating at roof vent**

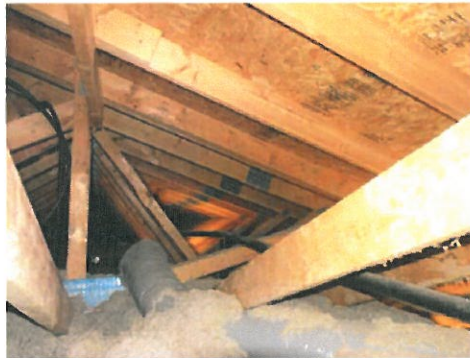
**Photo 29: Duct running under insulation across attic floor**

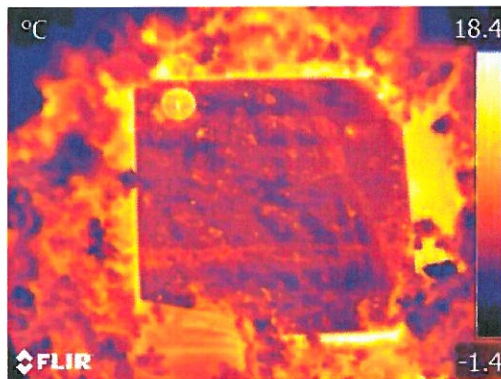
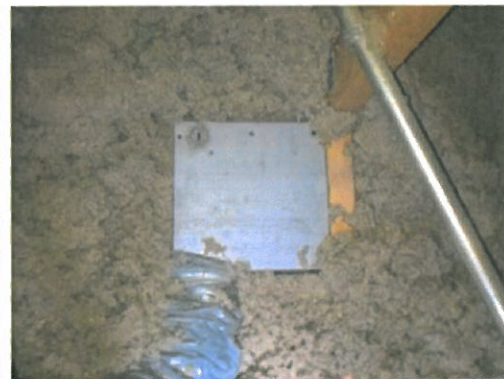
- The fans attached to these ducts were found to be uninsulated and unsealed (Image 12, Photo 30). Air leakage around the main washroom fans likely contributed to the moisture damage previously found in the in the ceiling near Grid D11. Heat loss through the uninsulated fan enclosures can also contribute to ice damming by increasing the air temperature in the attic. We therefore recommend that all exhaust fans be sealed and insulated. This usually involves installing a poly boot over the fan, and sealing it to the polyethylene vapour barrier and duct wrap.

**Image 12: Thermal image of typical exhaust fan**

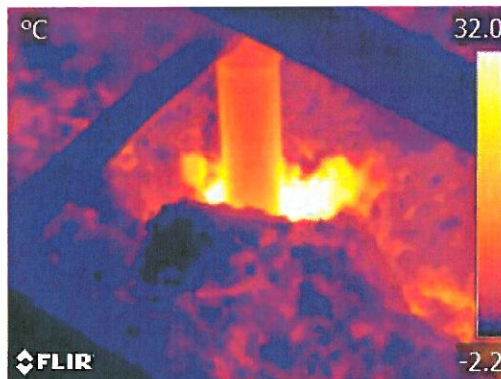
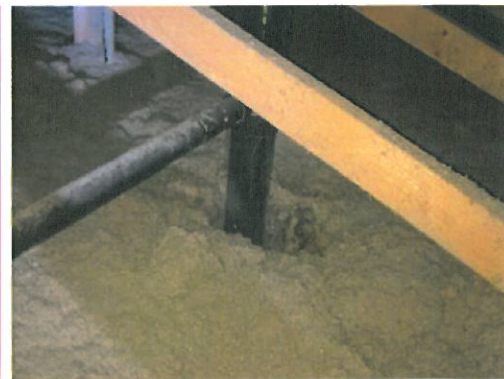
- Pipe vents are not insulated (Image 13, Photo 31). Heat loss from these pipes can also contribute to ice damming. We therefore recommend insulating them.

**Image 13: Thermal image of an exhaust pipe**

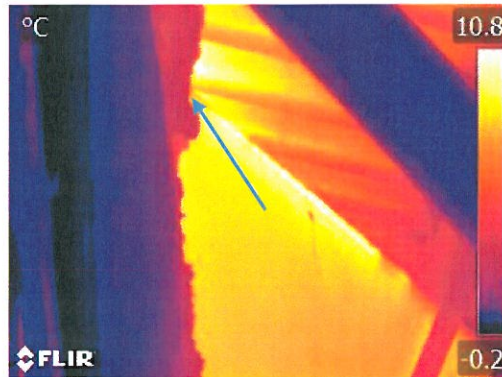
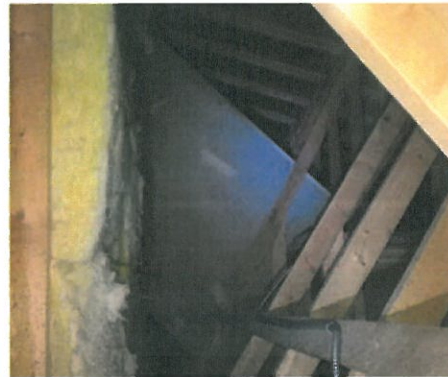
- Return air ducts from the foyer do not appear to be insulated (Image 14, Photo 32). Air leakage also appears to be occurring through the top of the duct penetration (see arrow on Image 14). Further review is recommended to determine if these ducts could be removed, or insulated and sealed.

Image 14: Thermal image of return air duct

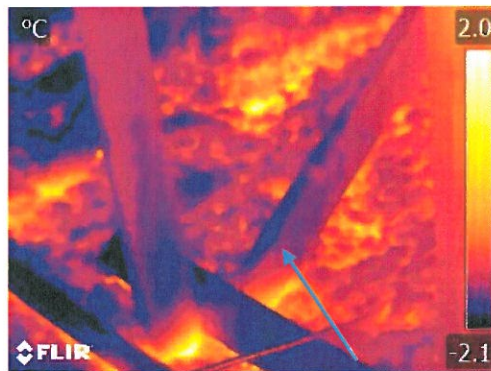
- Thermal scans also found numerous hot spots in the attic at low spots in the insulation, at transitions between interior walls and ceilings, and at electrical penetrations (Images 15 to 17). Most of the heat loss at these locations is due to insufficient insulation or thermal bridging; however, there may also be discontinuities in the vapour barrier, such as between the kitchen and rink hall. Further review would be required to confirm.

Image 15: Heat loss at lows spots in insulation
