ENGINEERING INSPECTION & REPORT

on
ANZAC Community Centre,
for
Anzac Recreation and Social Society

April 2019

ENGINEERING PROPERTY / BUILDING CONDITION ASSESSMENT

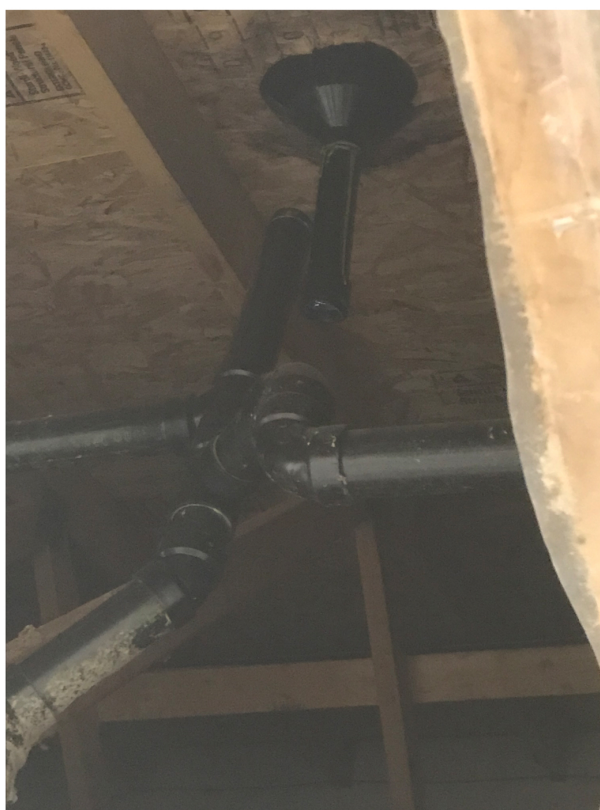
reconnect water vent and replace OSB around top.JPG

All rooftop protuberances including the flashing around them should be properly sealed so that no moisture can get in. The roof top sewer gas vent in the change room 1 (CR1) should be replaced, and reconnected as soon as possible. Any rotten OSB around it should be carefully cut out from underneath and a new piece sistered in place with PL9000 or equivalent. Cutting should be completed so that the roof itself is not penetrated, and no screws or nails should be used from below.

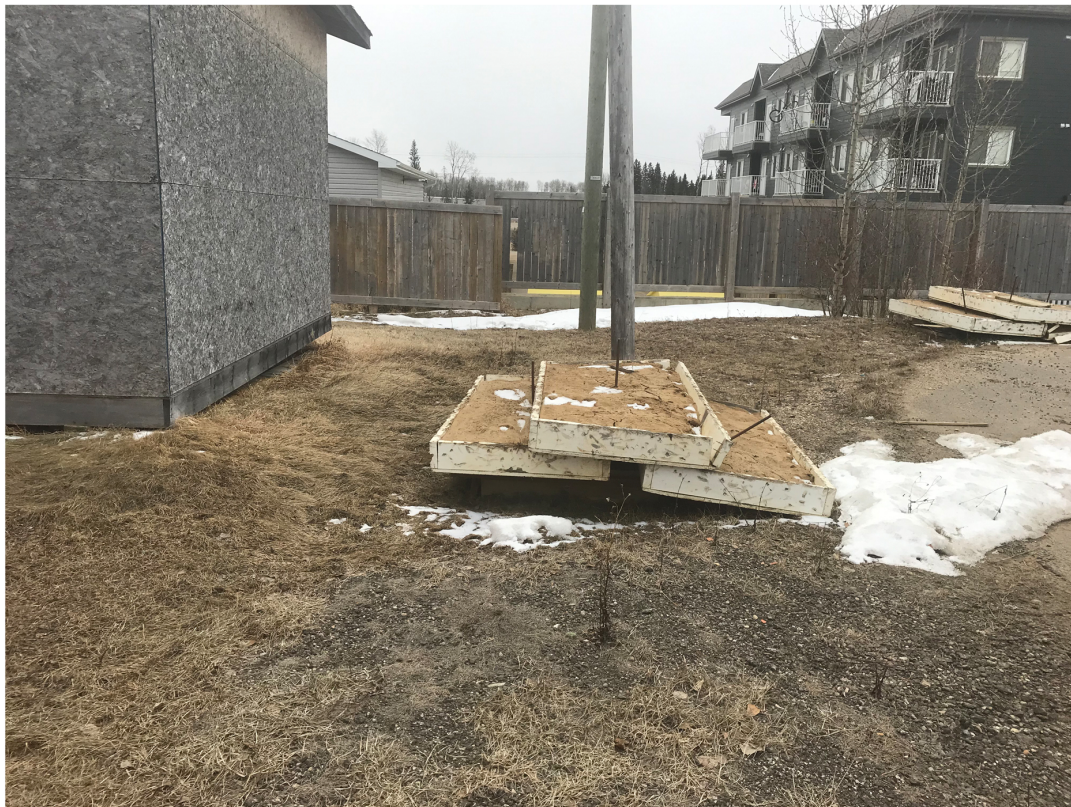
downgrade drainage on south east corner of rink.JPG

The surficial drainage around the Subject Building was adequate, with some potential issues with the rink. The rink itself should have a 8cm (3") high asphalt curb or equivalent installed on its east side so that any melting water would travel to the south end of the rink away from the foundation.

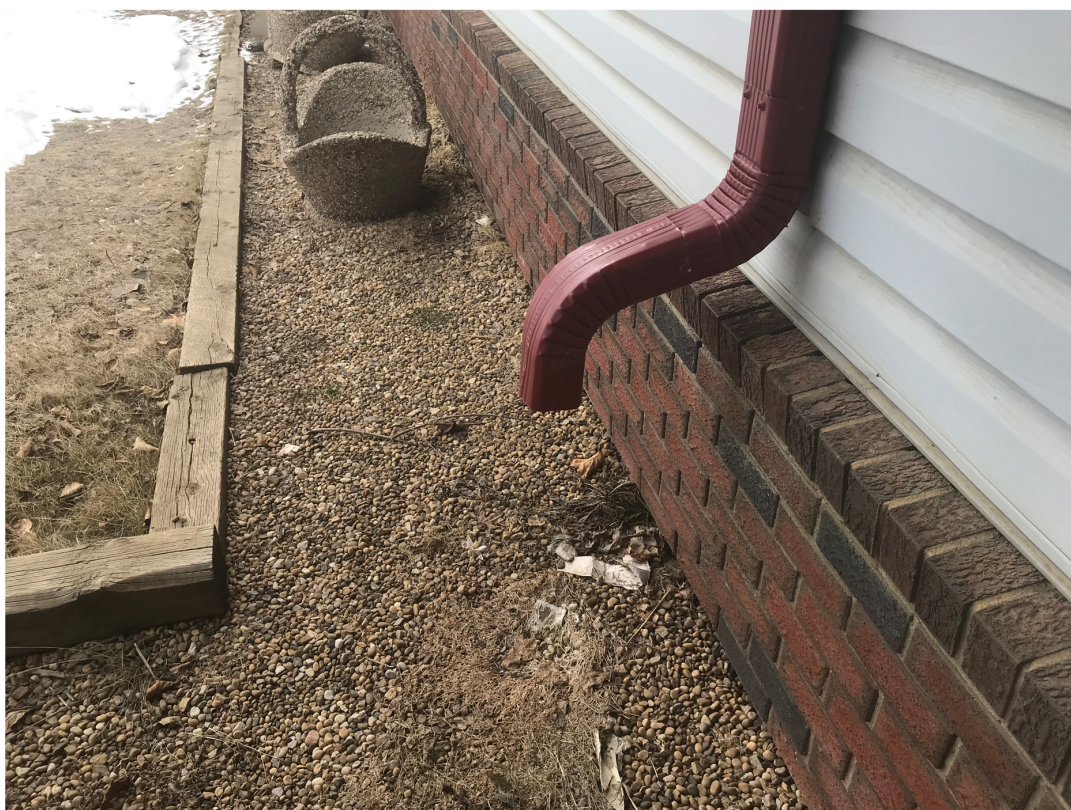
no downspouts extend more than 0.3m from foundation wall.JPG

The roof drains were all draining next too the foundation with some concrete water diversion pads diverting water away, and some with no means of re-routing the water. 1.2m long Downspout extensions or new concrete water diversion pads should be installed under or to any downspouts with small extensions.

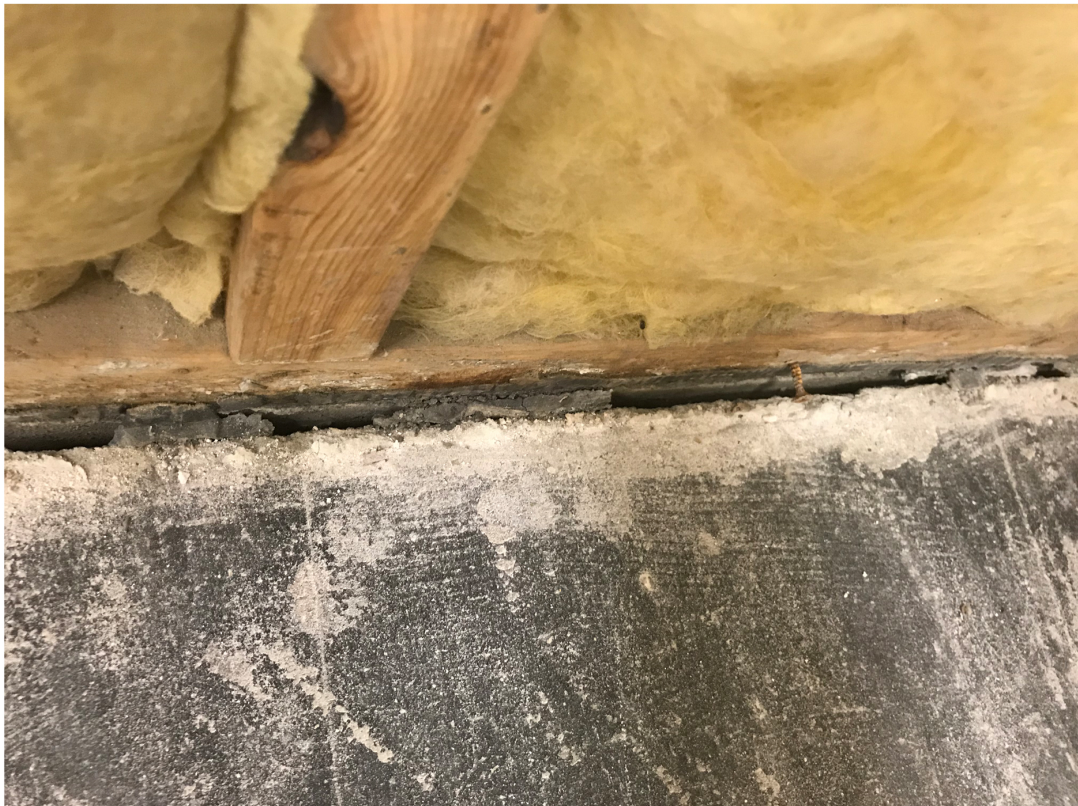
space between floor slab and foundation wall should be filled with epoxy.JPG

The metal door sill plate on the south-east corner of the hall should be sealed on the inside with epoxy and the space between the floor slab and the foundation wall in the dressing room should also be sealed with an appropriate epoxy.

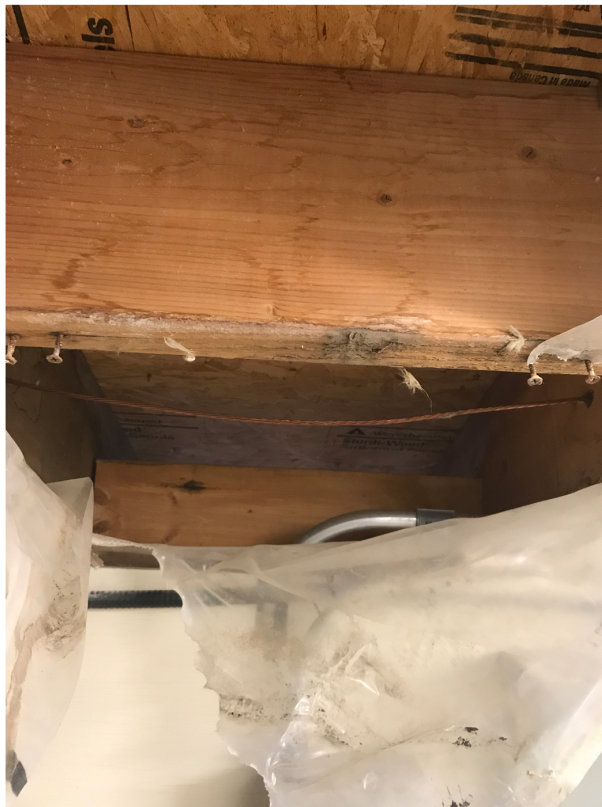
surficial damage in joists below old furnace stack in electrical room..JPG

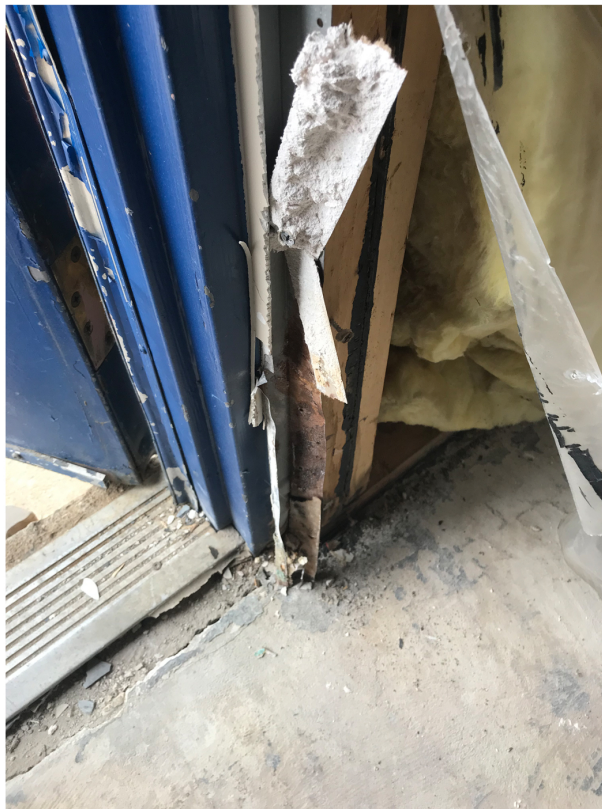
sill under doorway should be sealed with silicone.JPG

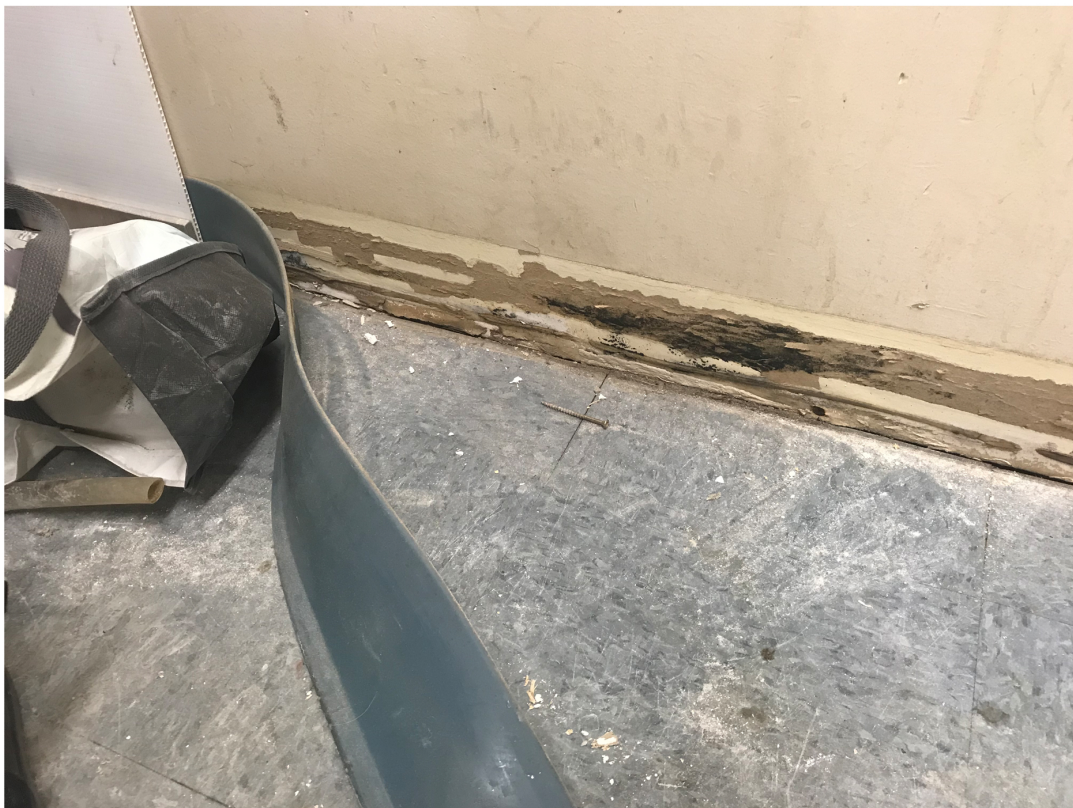
Janitor room and adjoining WC (WC4): The drywall behind the baseboard in both rooms was measured as **level 4 Stachybotrys**. This is the highest level of contamination in the Subject Building and is likely due to water on the floor of the janitor room next to the walls. Water from, for example spilled water next to the wall, could become trapped between the rubber baseboard and the wall. Warm wet drywall is prime feeding material for this type of mould. CMG removed some of the drywall material to look at the structural wall elements, and no evidence of mould was observed on the sill plate or studs in the wall there. The drywall should be removed to a height of 4'1" so that new sheets of drywall easily replace the existing drywall. Some fungicide should be sprayed on the floor after removal so that this mould does not spread. If possible the drywall should be placed so that it does not touch the floor slab or flooring and no baseboards should be replaced in these two rooms.

rubberized baseboard in Janitor Room harboured mould growth.JPG

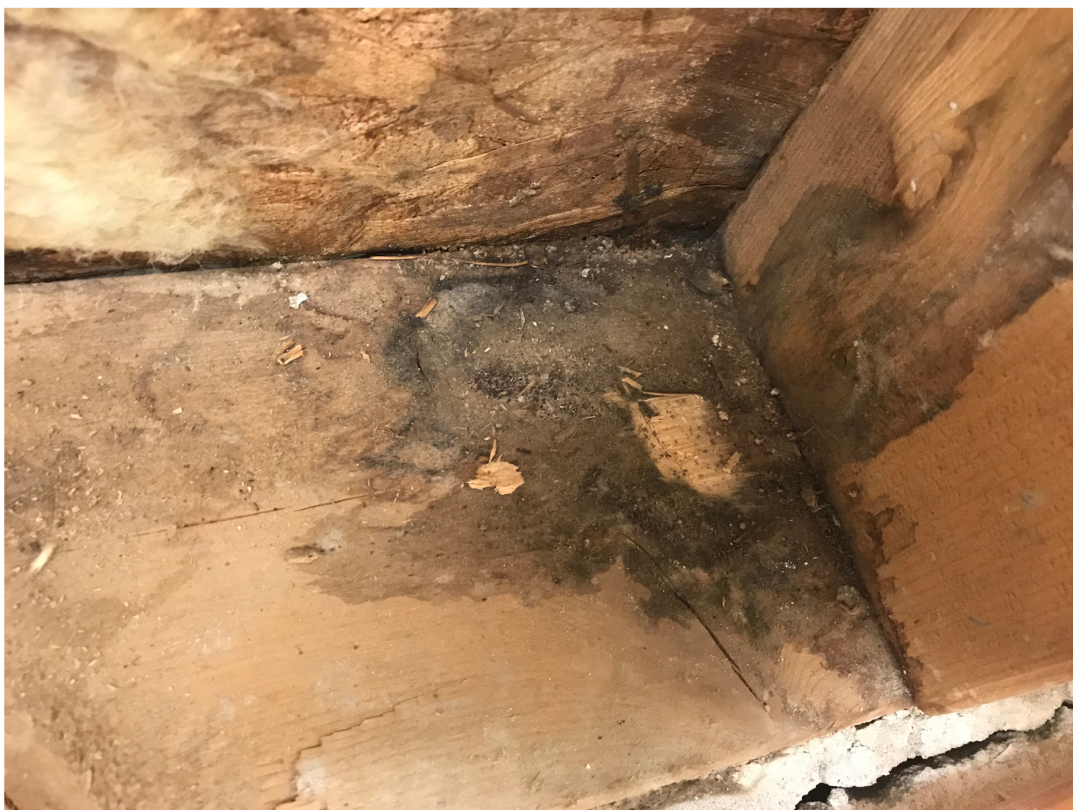
Multicultural Room (MC): Surficial damage to the sill plates and OSB was observed here and they can be sanded and sprayed with a fungicide.

evidence staining on 2x6 sill plate is surficial.JPG

No structural elements had their function affected by rot and can all remain in place. Some fungicide can be sprayed on the affected stained sill plates and studs, and then sanded after 24 hours.

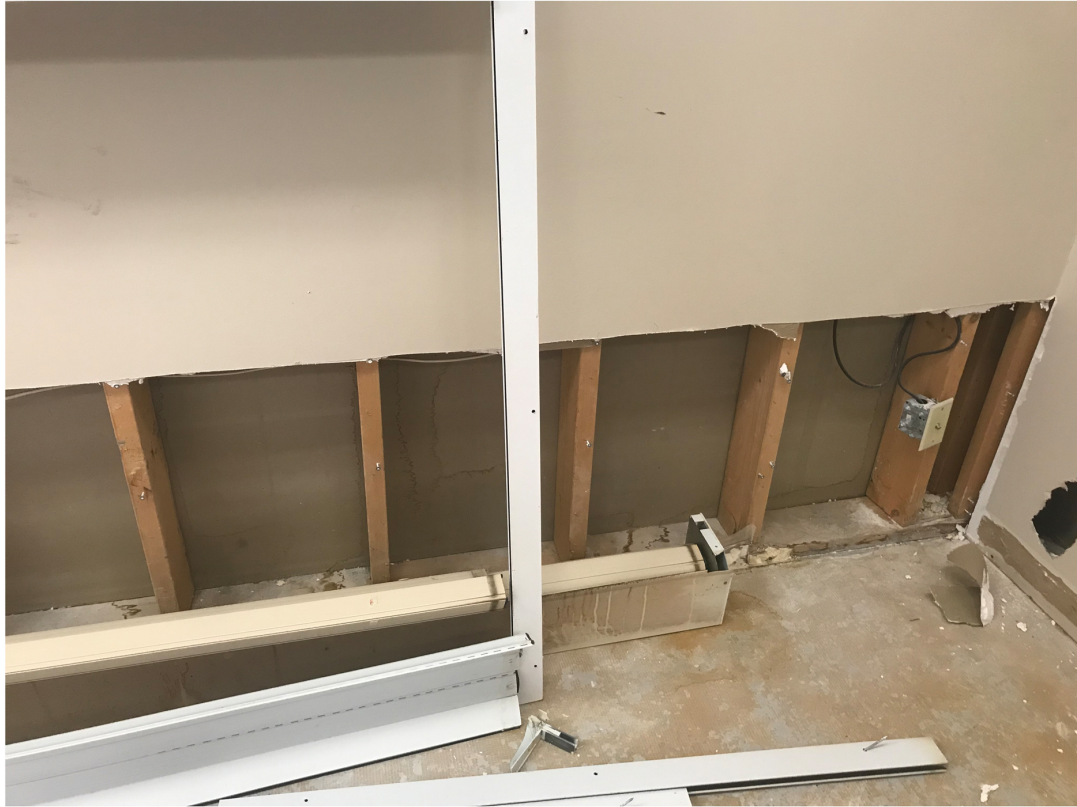
more surficial staining in multicultural room outer wall.JPG

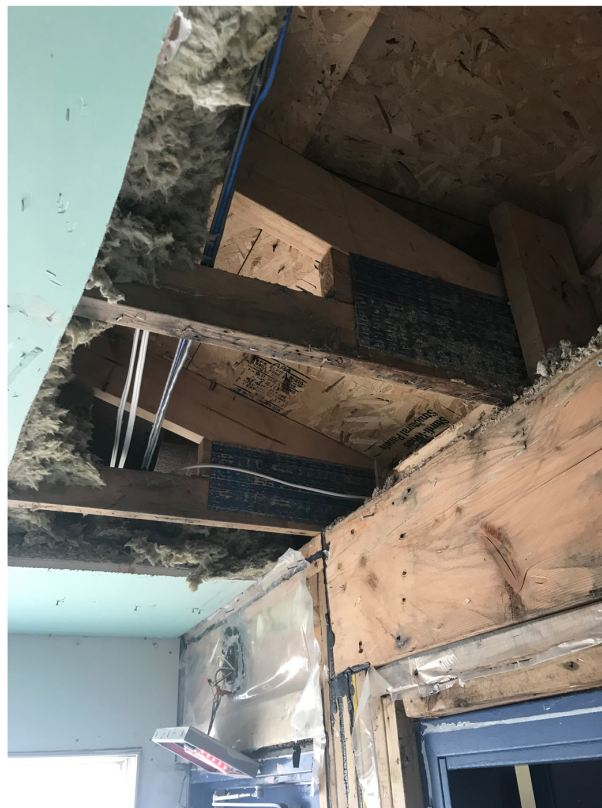
Rink Hall (RH): The Attic was was measured at 10800 spores / m³. The sample was taken near the stained valley roof joists although bulk samples of the wood revealed no mould, other areas such as drywall around the wood may have had some contamination. 4800 spores / m³ (**medium**) were identified as the Cladosporium spores that will cause allergic reactions and should be handled with care, *but are not classified as toxic*. Another 1067 spores / m³ (**light**) were Basidiospores that are also a concern in breathable air in large numbers (over 5000 spores / m³). The medium levels of the non-toxic Cladosporium spores indicates that there may be some insulation that should be replaced in this area. CMG recommends only removing insulation that is along the bottom 3m of the roof valley here. Since we want the attic to remain cool, some spray foam could be added to the bottom of the attic below the valley here or alternatively less insulation could be added here so that the air can flow under the valley.

rink hall rafters below a valley in roof.JPG
