REGIONAL MUNICIPALITY OF WOOD BUFFALO

Anzac Community Centre
Update to Anzac Recreation and Social Society

Current Building Review

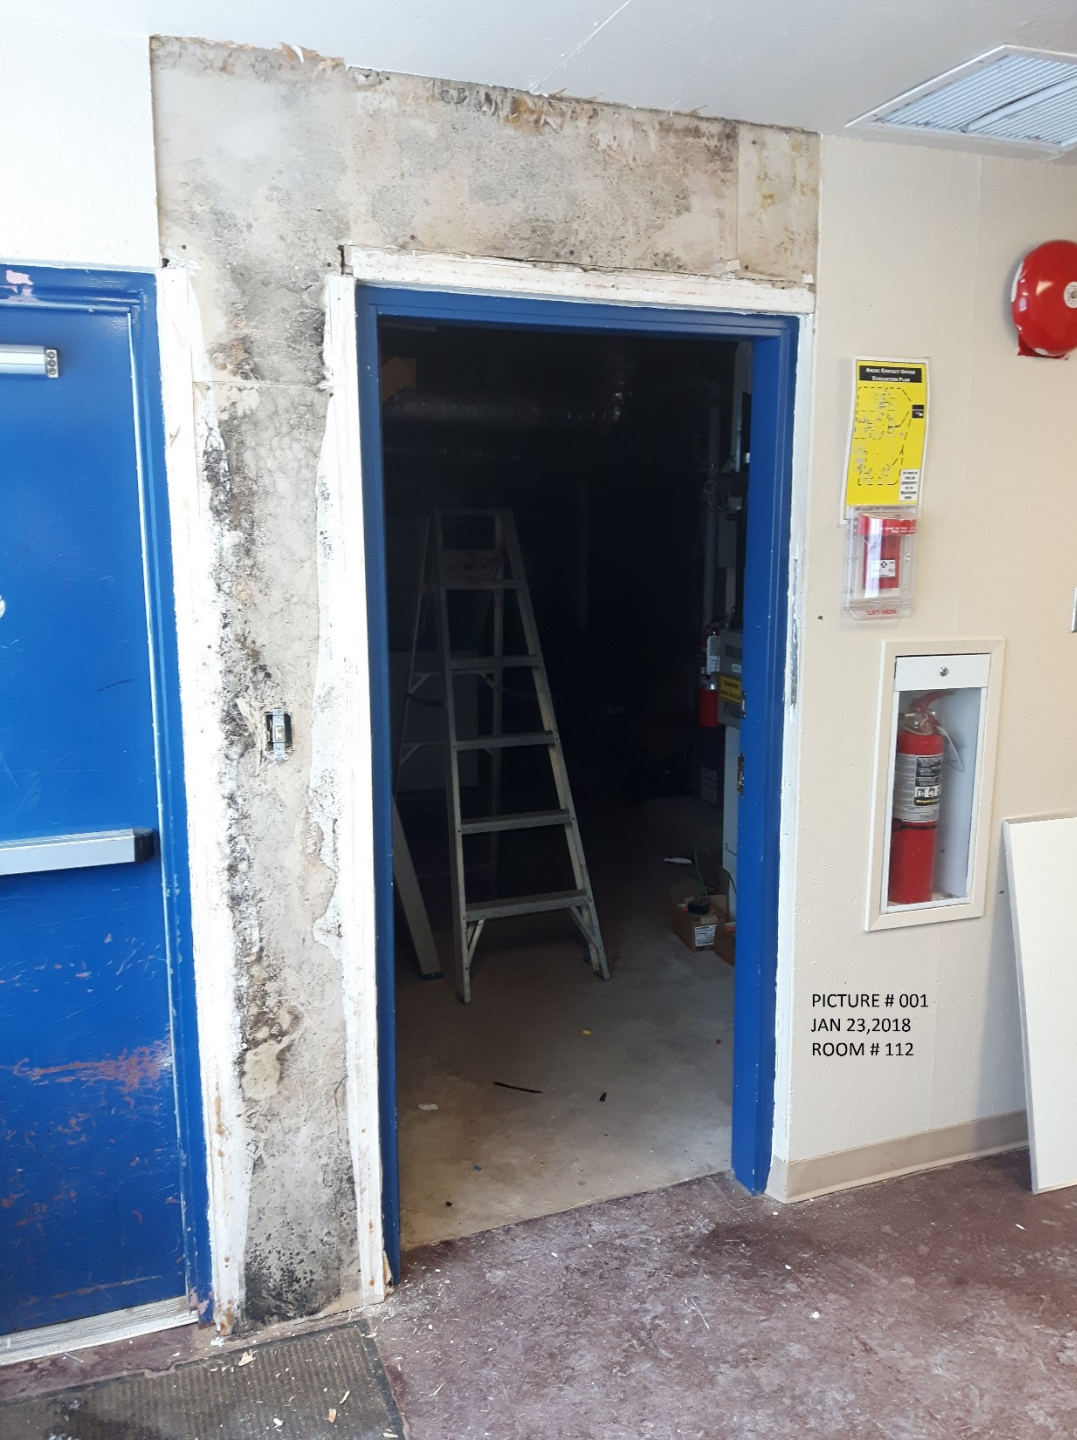
PICTURE # 001
JAN 23, 2018
ROOM # 112

**Rink Hall
Moisture trapped between
Oriented Strand Board and
Gypsum board**

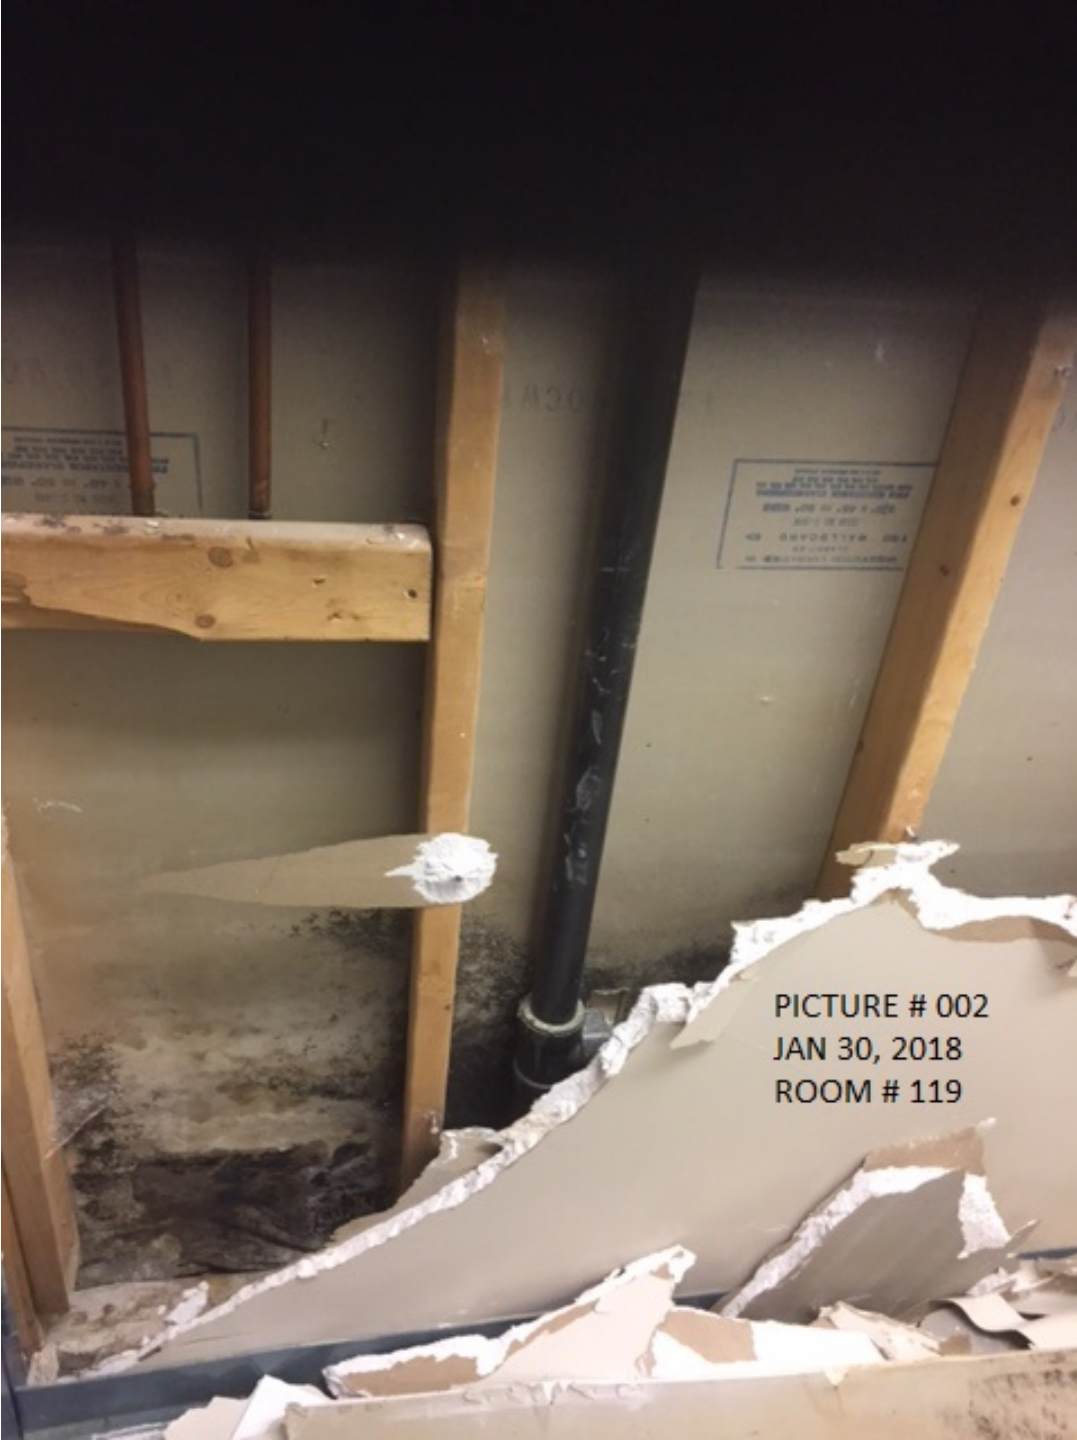
PICTURE # 002
JAN 30, 2018
ROOM # 119

**Washroom 119 to
Janitor 118.
Mould due to piping leaks.**

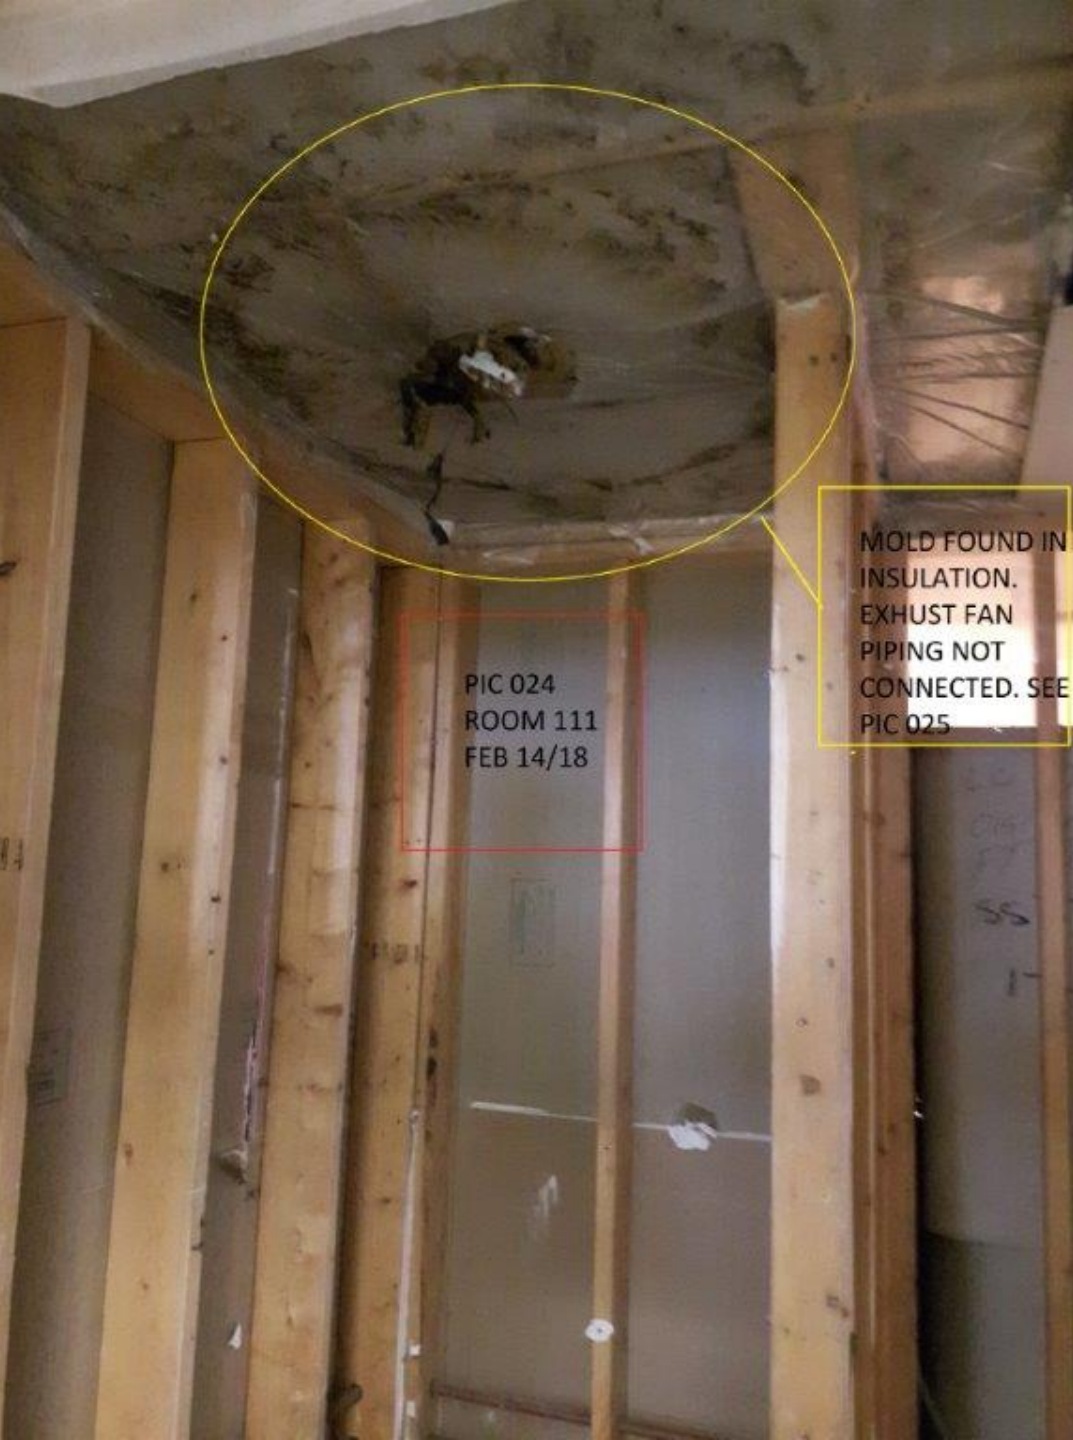
**Shower in change room 111
Water leak through shower
light.**

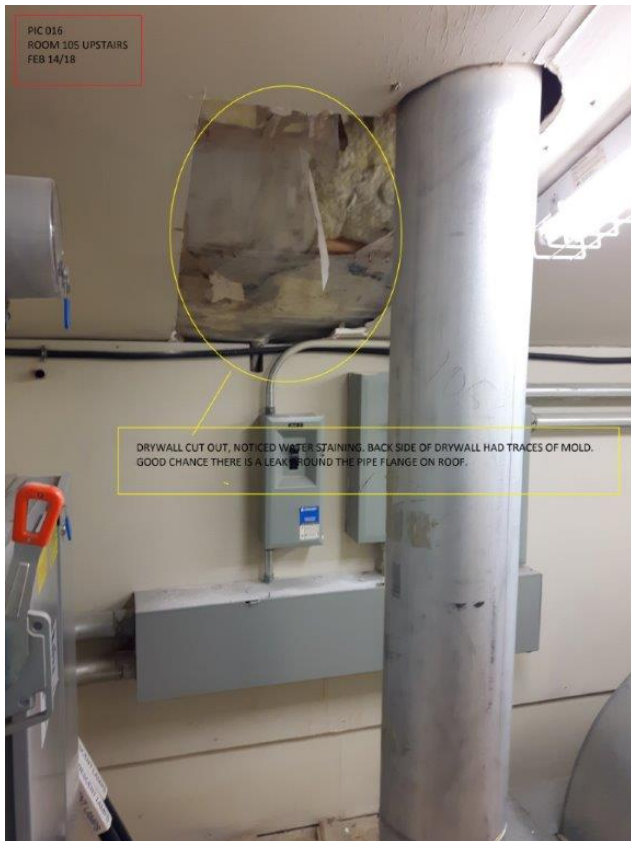
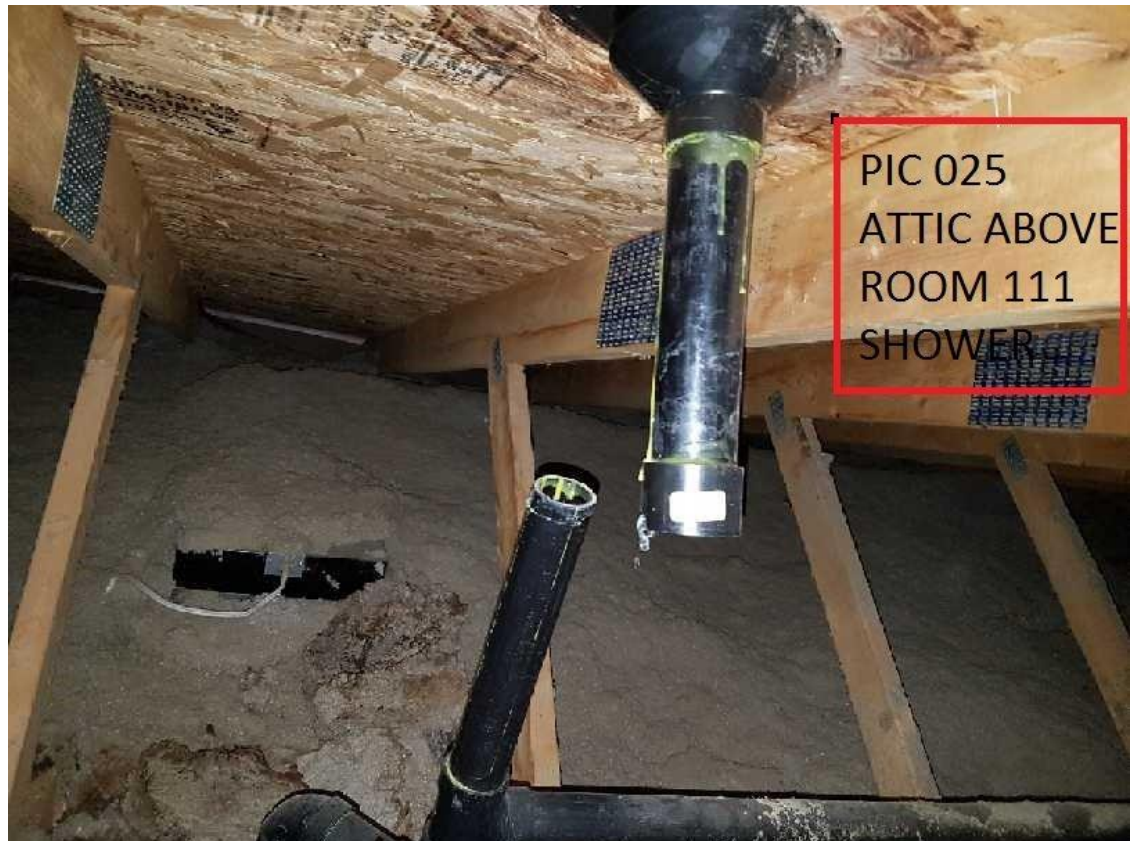
Other areas were further investigated and isolated locations of mould were discovered. Pictures below show findings in Mechanical Room and the Attic.

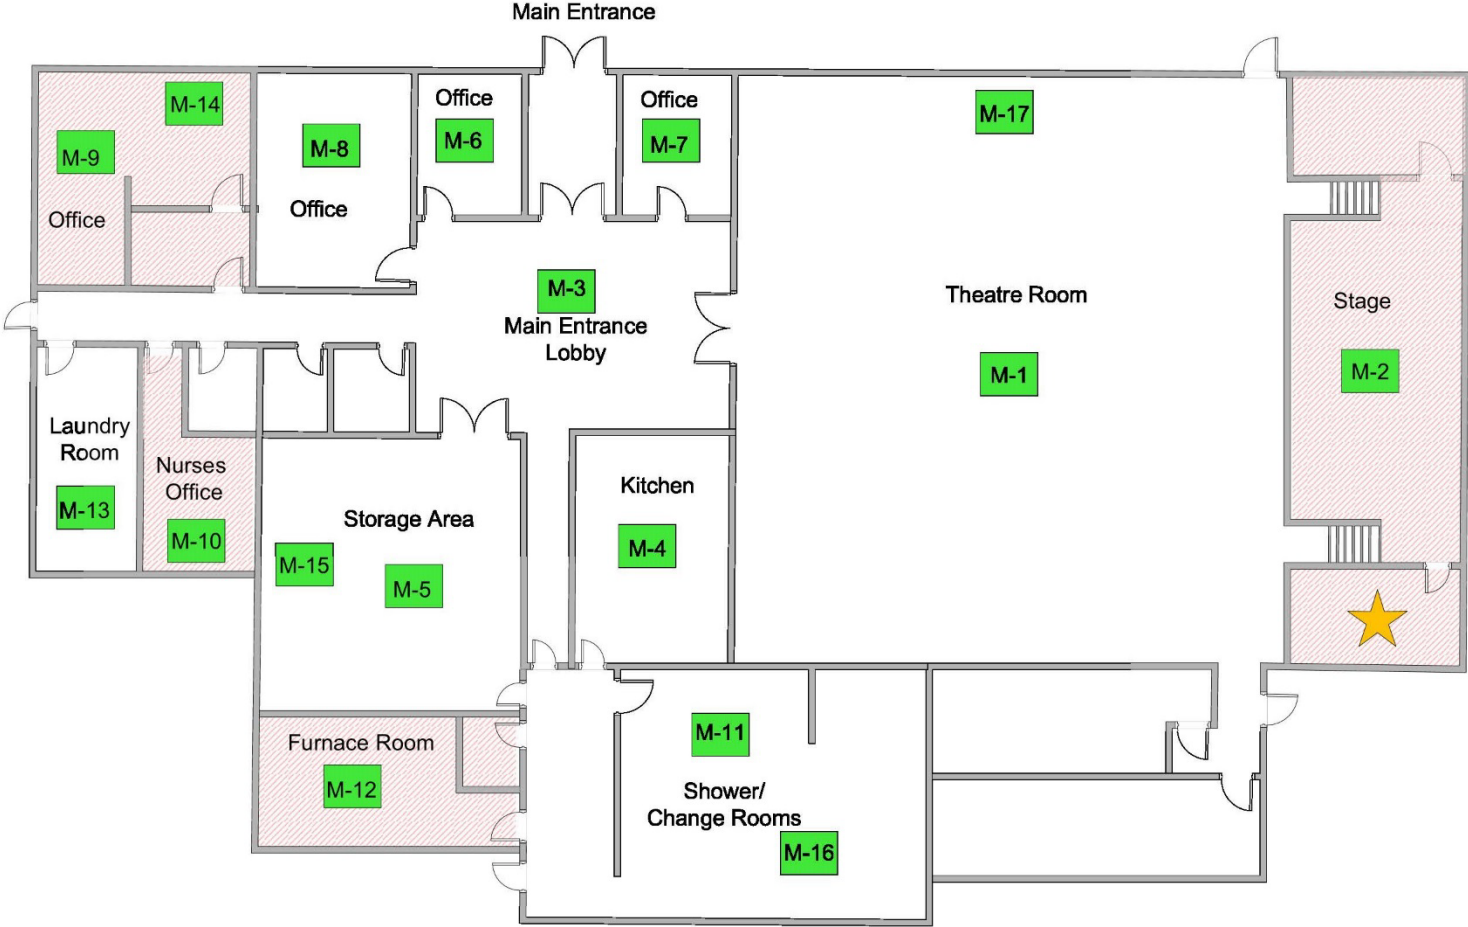
**Mould Air Sampling -
Results**

- Significant Mould was found in Office (124), Nurses Office (121), Mechanical Room (114 and 105) and the Hall Stage.
- Visual Mould was detected in Mechanical Room (105).

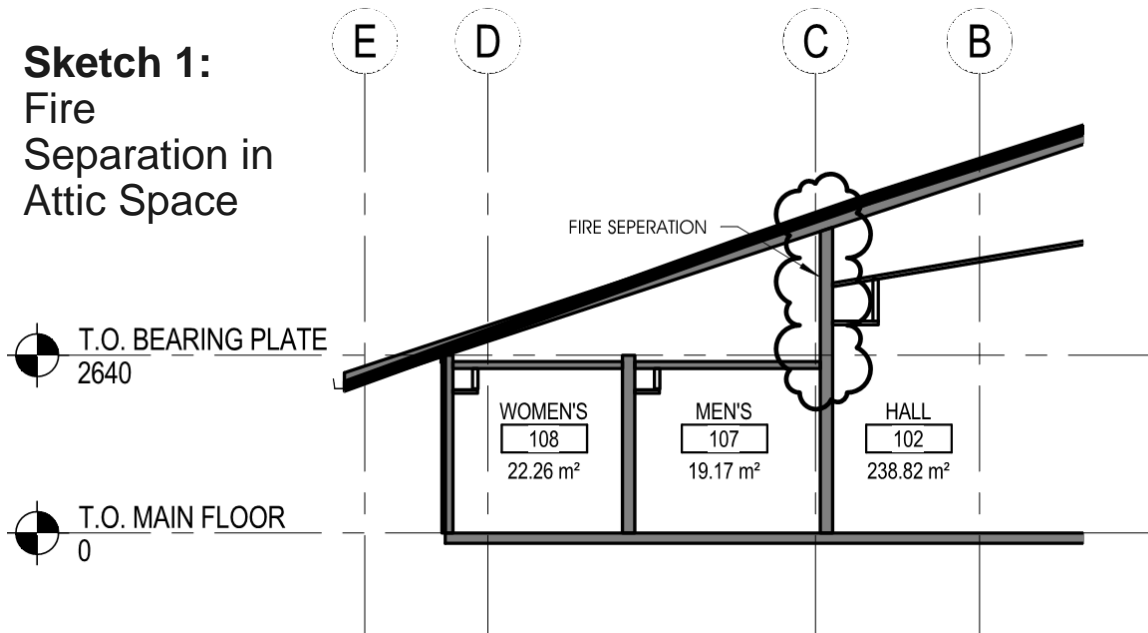
Sketch 1: Fire Separation in Attic Space

Due to the fire separation required for this building.

The attic space is separated into compartments and creates concealed spaced without ventilation.

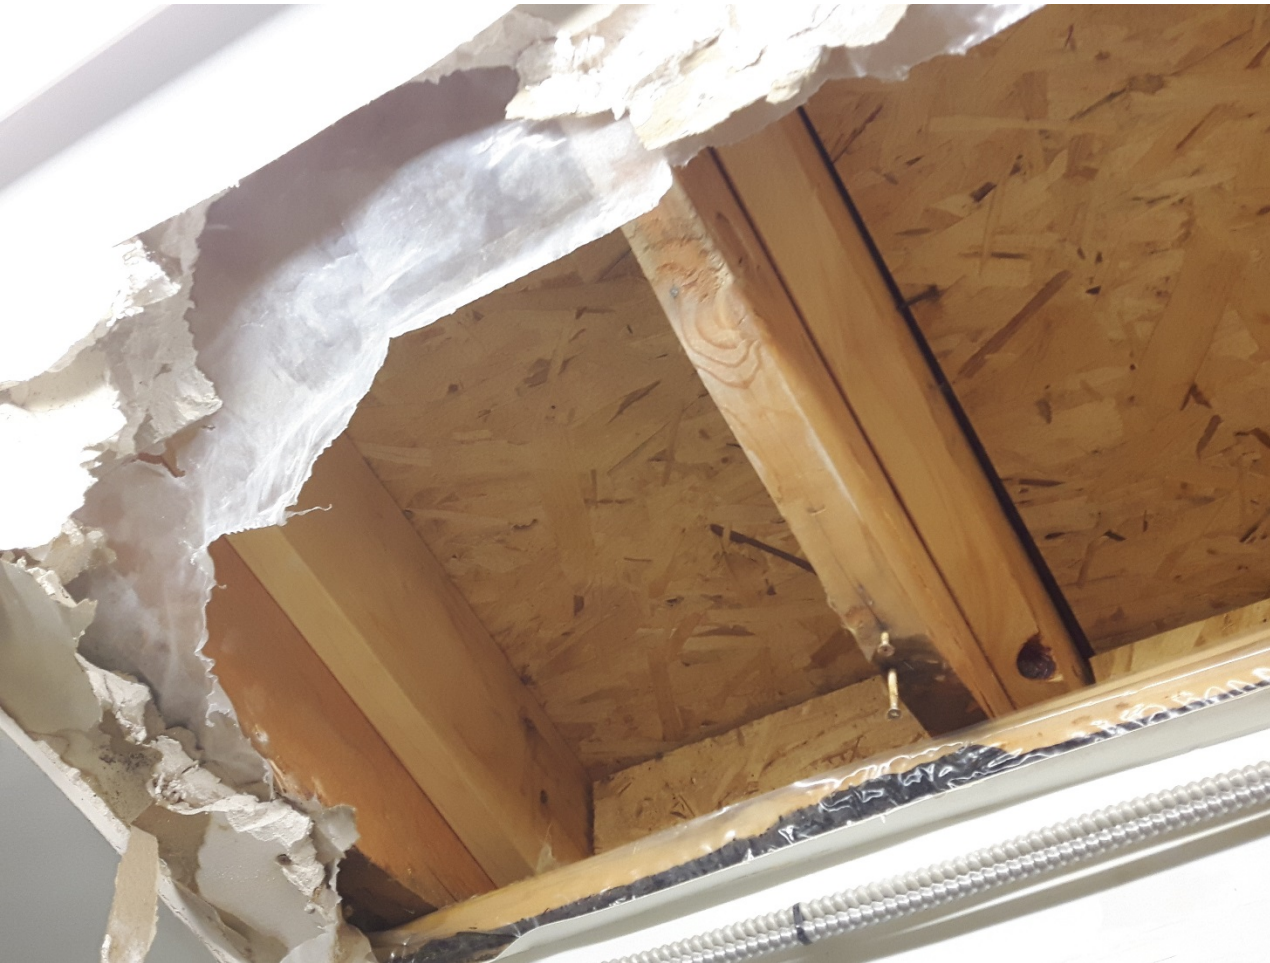
This promotes moisture build-up.

Typical eave is 4.5" deep and does not allow for adequate insulation or venting and the heel of the truss is completely blocked.

Cold Attic required to be vented at the eave and throughout the attic volume.

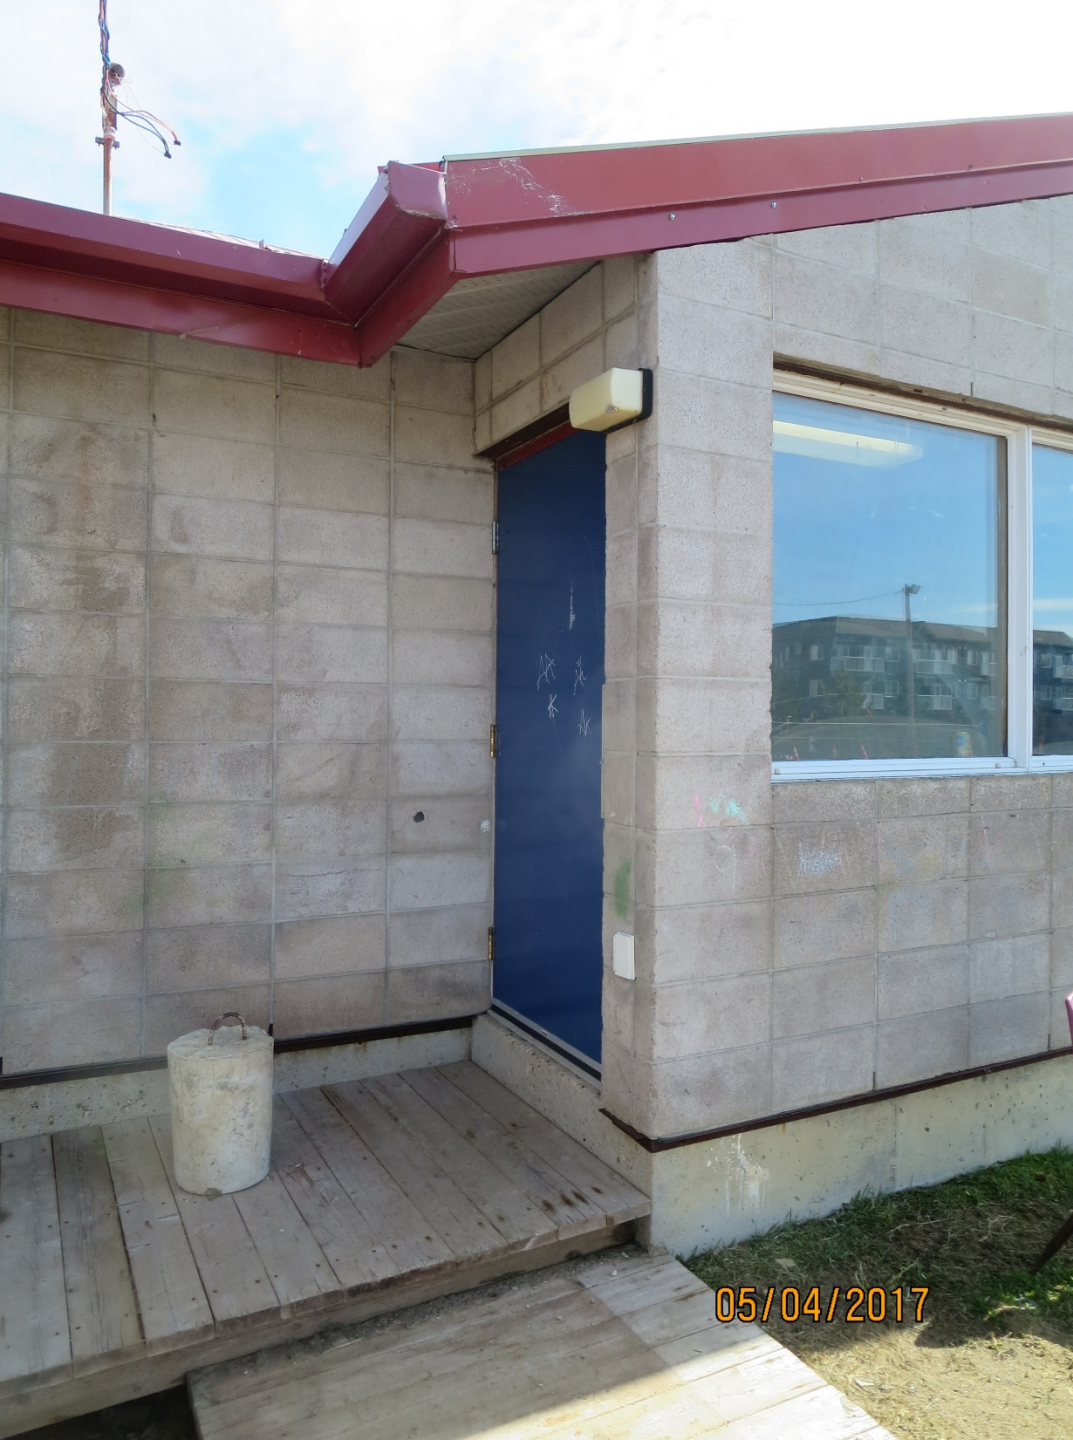
South West Elevation

Moisture trapped between
Concrete Block veneer.

- Weep Holes are not provided.
- Sill and head flashings are not provided.
- Roof eave is not protecting the wall. Moisture is entering the wall cavity and can not escape. Promoting Mould.

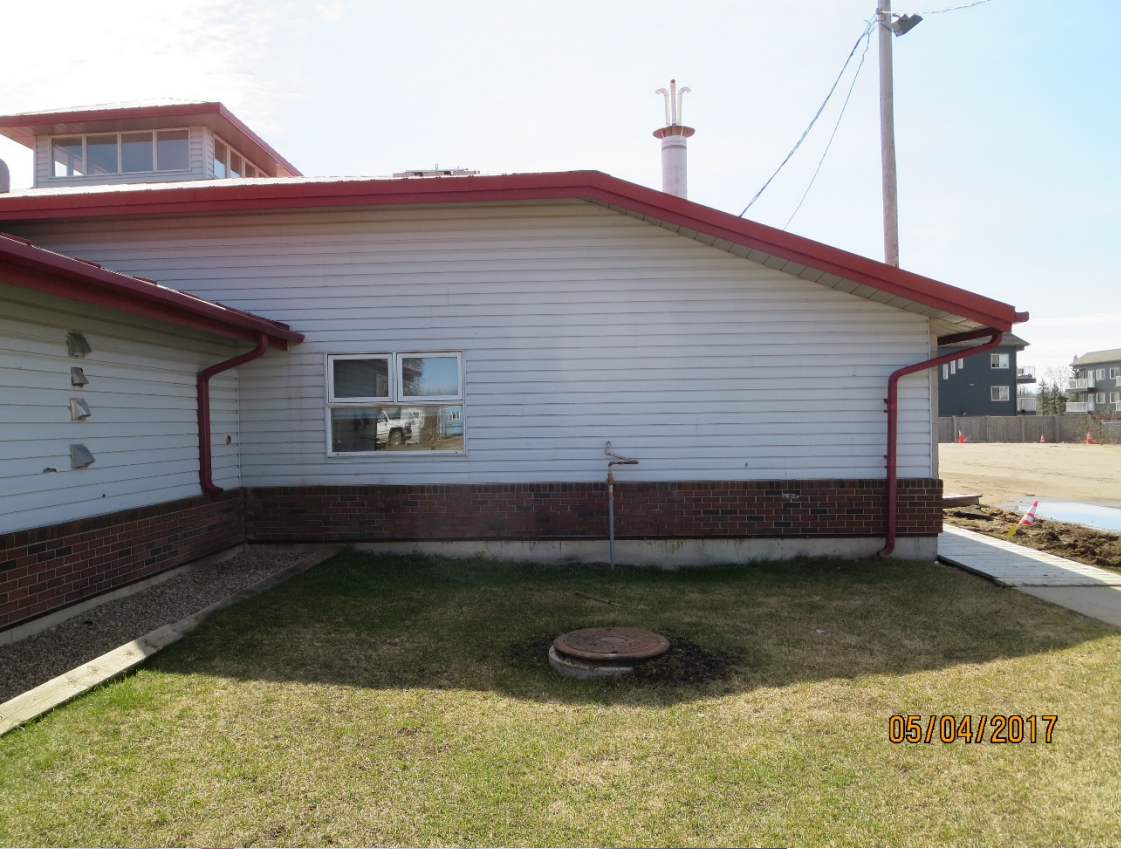
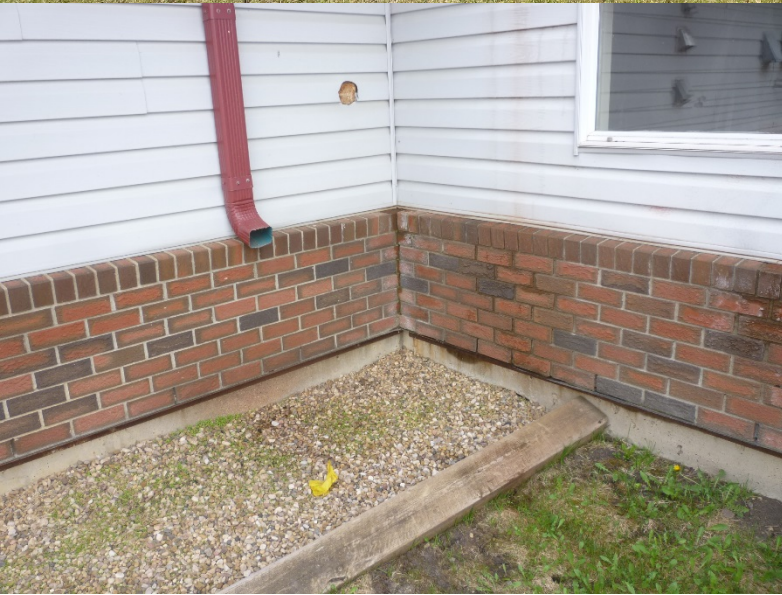
North West Elevation

Envelope deficiencies.

- No window flashing
- Brick sill cap is not flashed or sloped to drain water. Moisture penetrates the wall cavity.
- Water from the roof is not draining away from the building. Staining is apparent on the siding from the eavestrough leaking.
- Downspouts are not taking water away from the building.
- Site is not graded properly.

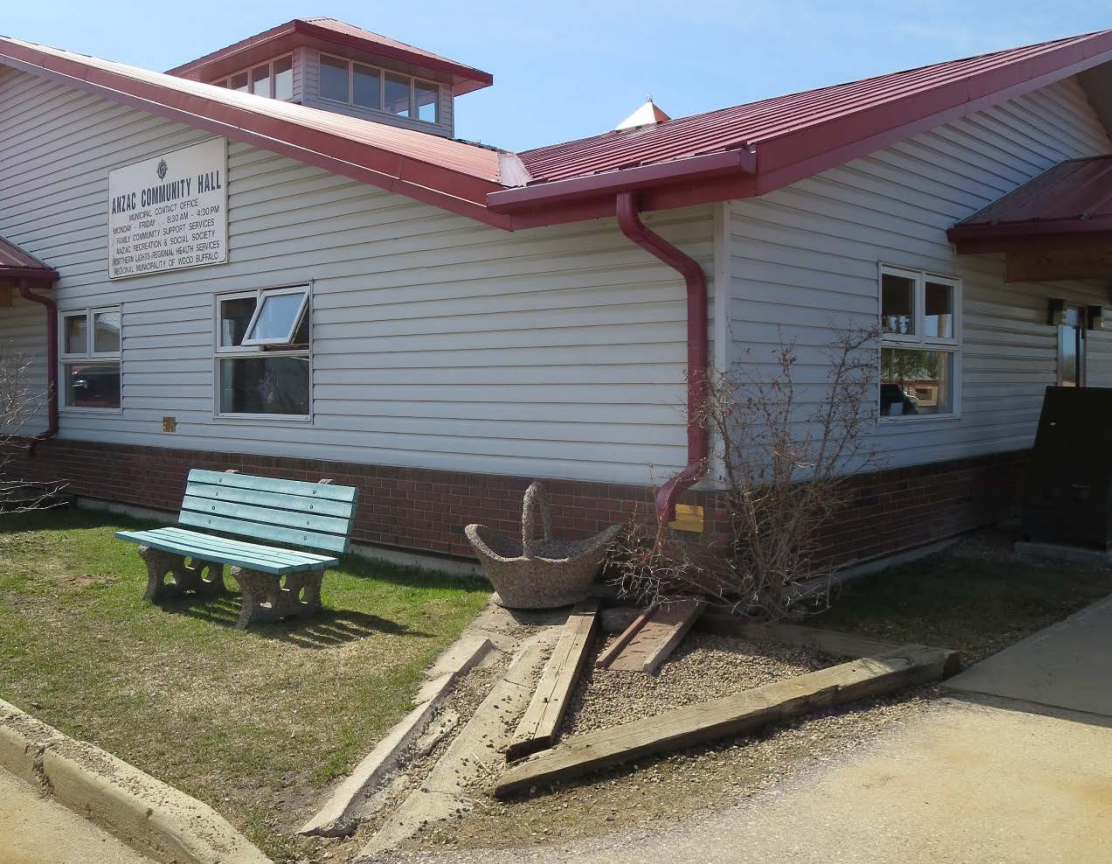
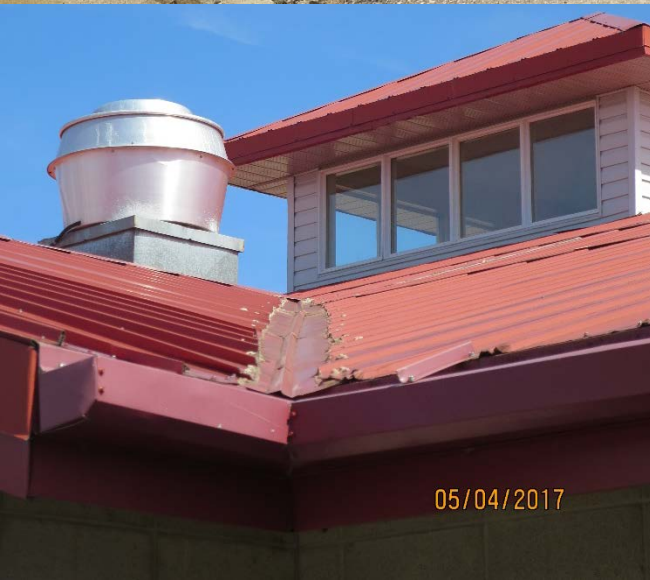
North West Elevation

Roof deficiencies.

- Roof valley does not built to shed water.
- Water from the downspouts is trapped in the gravel perimeter base and is likely migrating to the foundation.

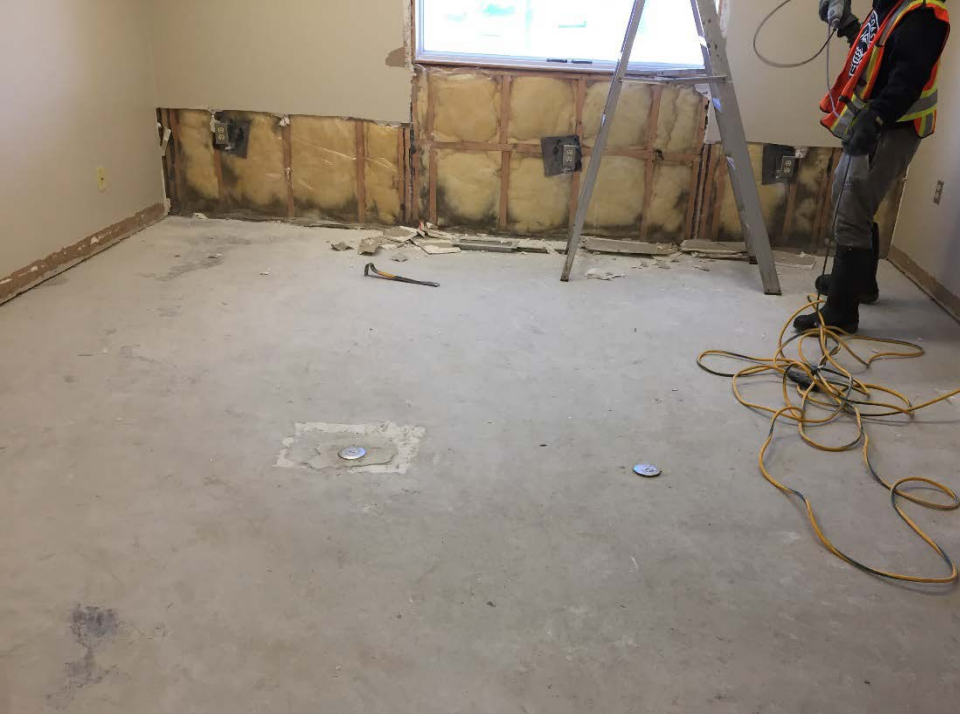
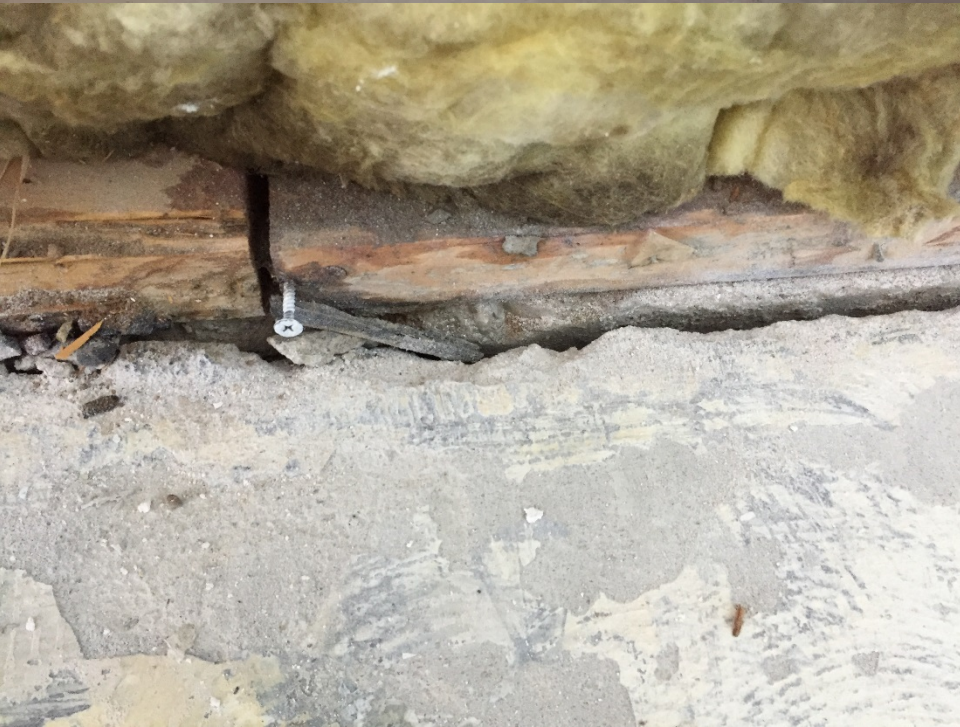
Interior Elevation

Moisture trapped in wood framing.

- Exterior wall base plates and framing have been deteriorated by moisture trapped in cavity.

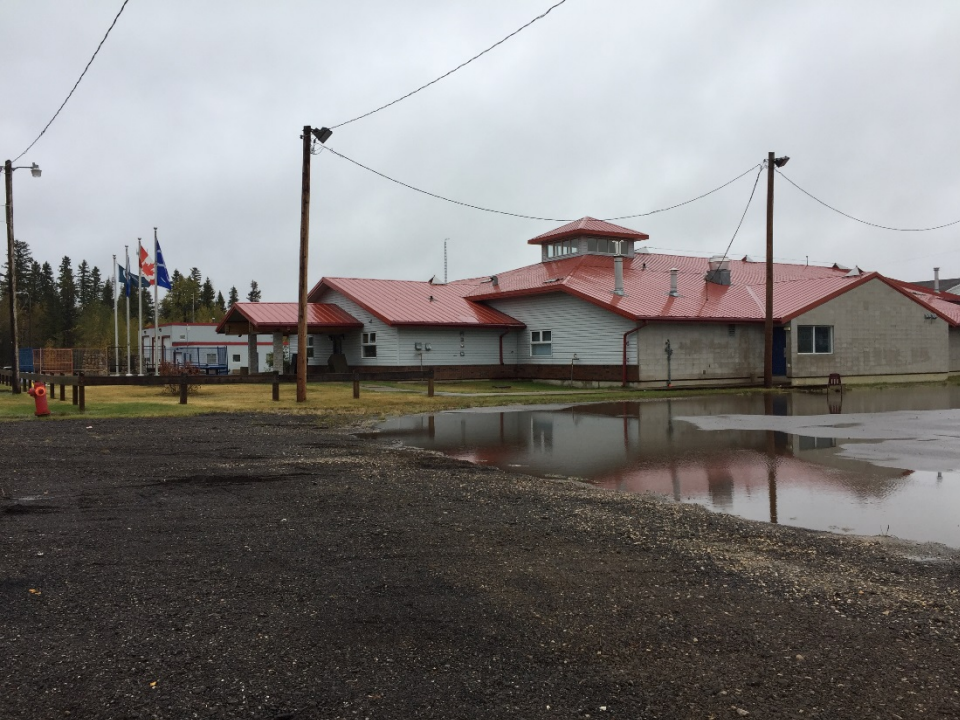
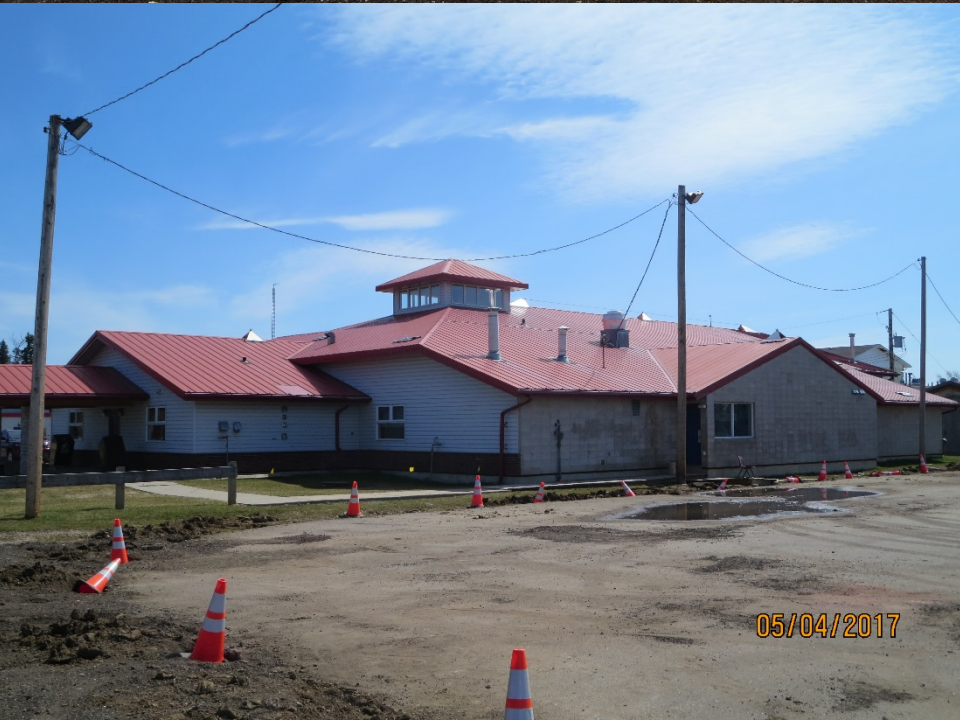
North West Elevation Site drainage.

- Ice slab paving causes water to drain towards the building. The water appears to be infiltrating under the foundation. This requires further investigation and mitigation.

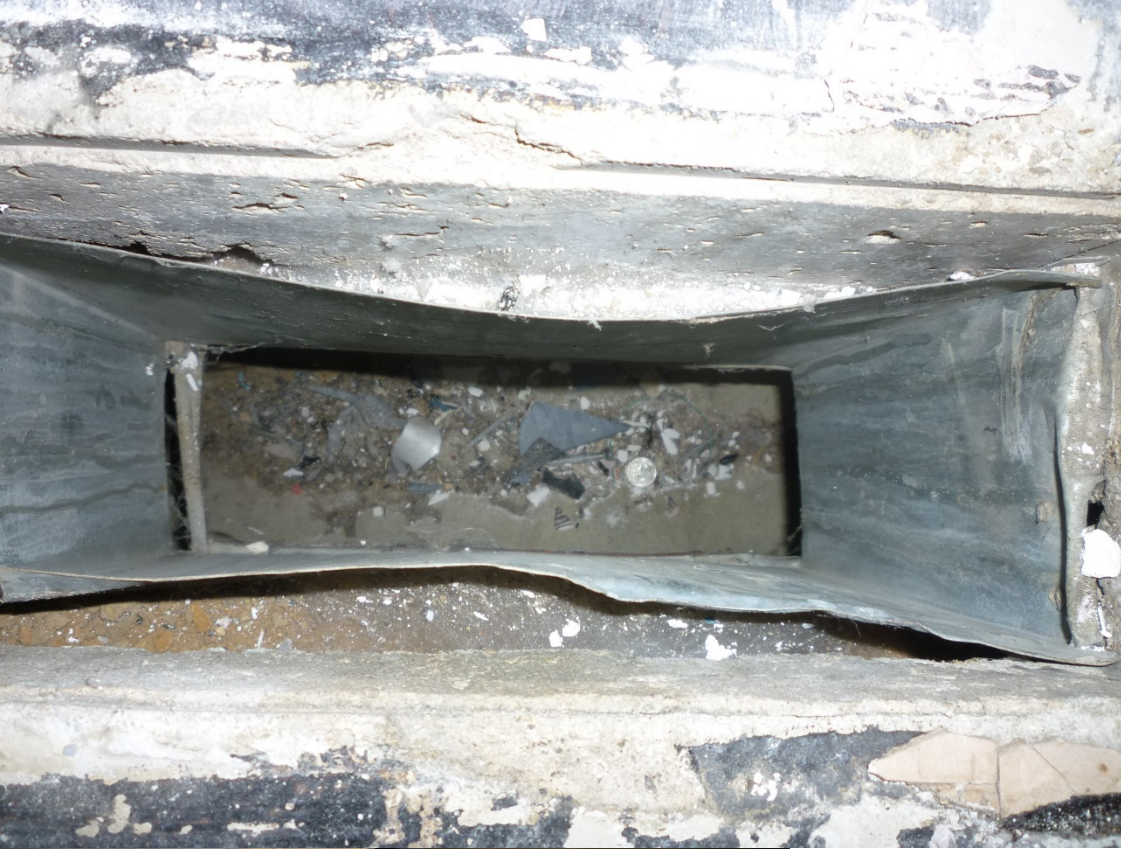
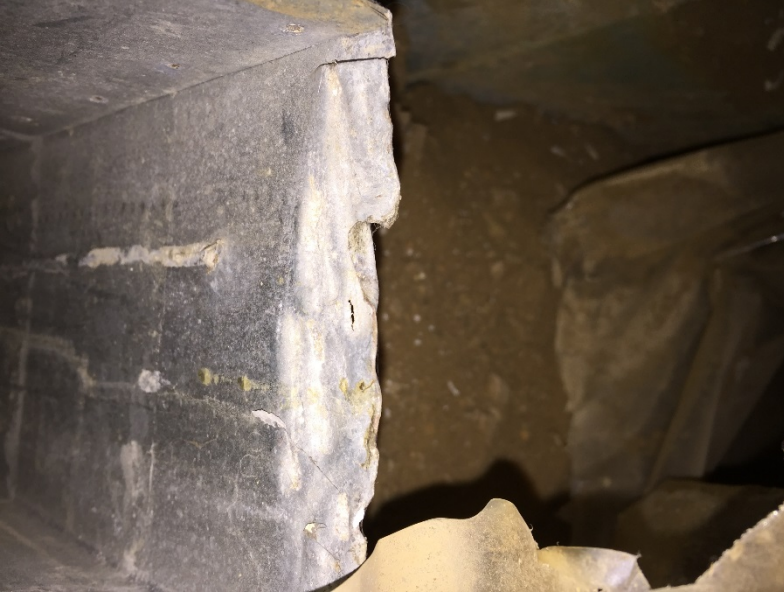
Building Structure

Floor slab deficiencies.

- Floor vents have pulled away from the concrete slab. The sub base supporting the concrete floor slab has fallen away. This could be due to site water infiltration below the grade beam which has causes structural movement. Investigation is required by a geotechnical engineer.

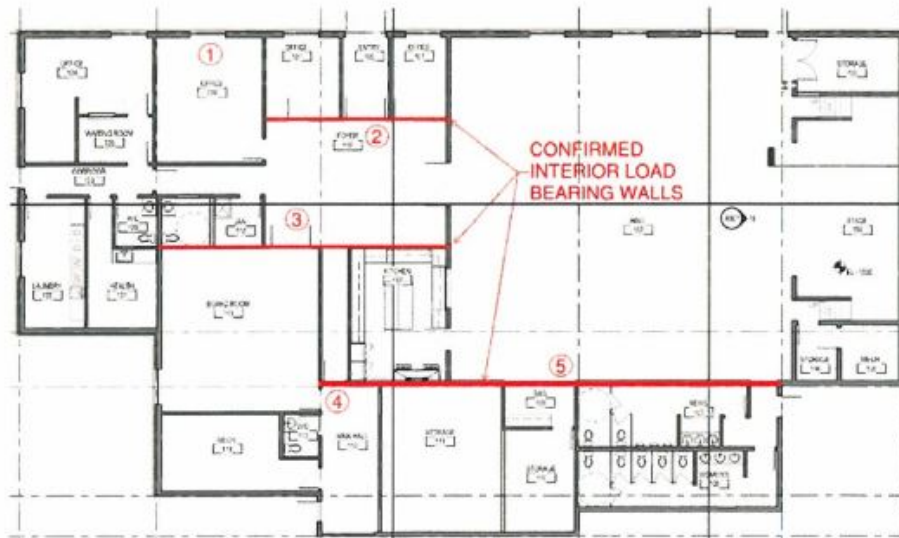
Figure 3: Reviewed lintels and noted load bearing walls

- Roof supporting lintels were reviewed by the structural engineer. The lintels are required to be upgraded to support the building properly. They are under capacity in bending.

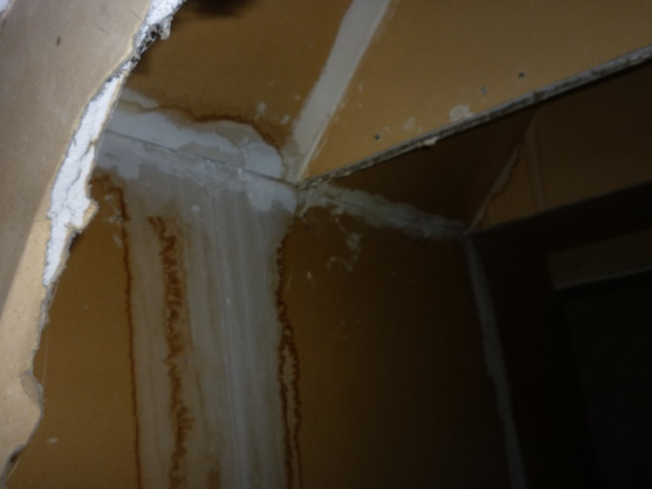
Foyer 116 Tower - Water damaged gypsum board

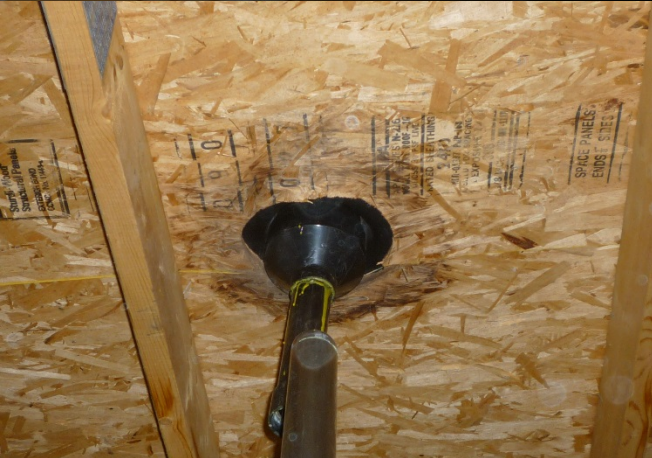
Water damage on the roof sheathing at the plumbing stack.

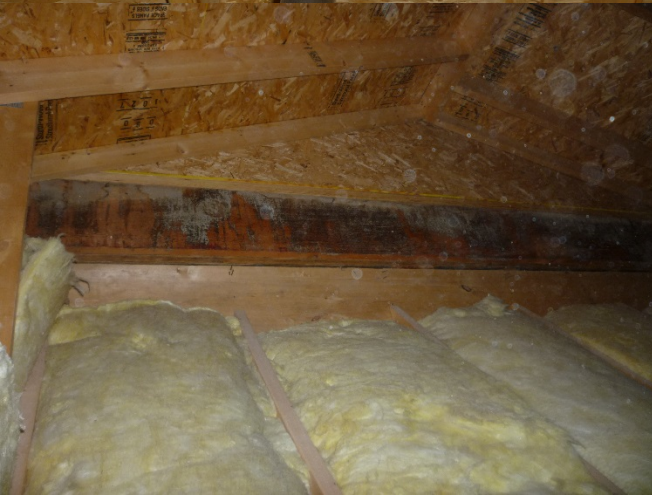
Mould growth observed on a glulam beam.

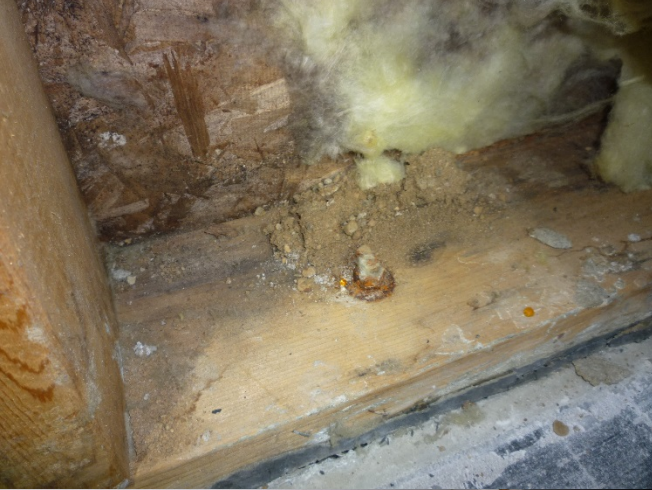
Exterior base plates have visible water staining and mould growth.

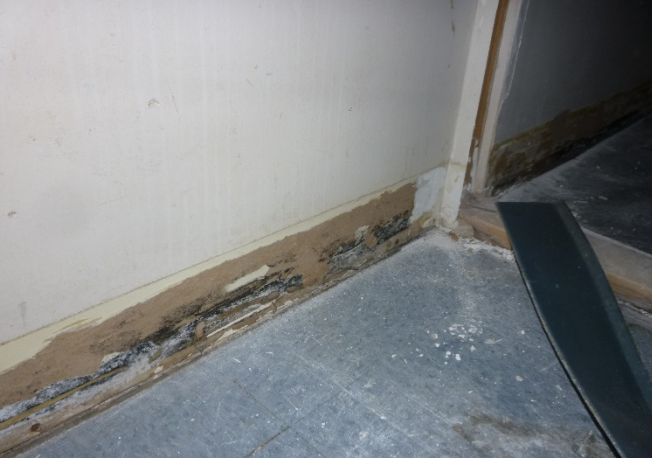
Mould growth noted on bottom of walls.

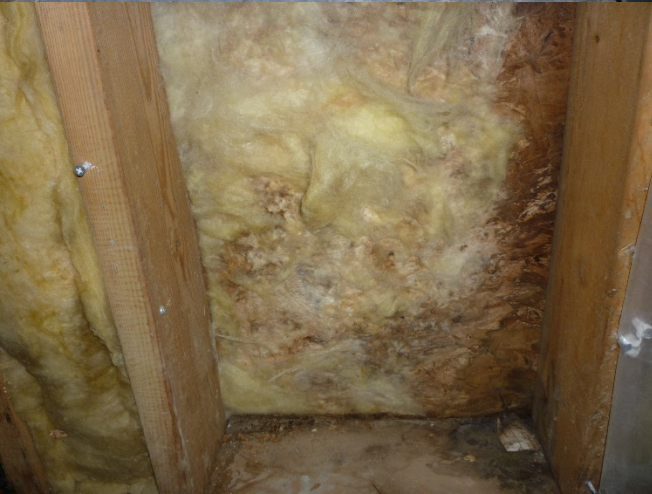
Mould growth and damage on exterior sheathing.
