# **ENGINEERING INSPECTION & REPORT**

**on**  
**ANZAC Community Centre,**  
**for**  
**Anzac Recreation and Social Society**

April 2019

## **ENGINEERING PROPERTY / BUILDING CONDITION ASSESSMENT**

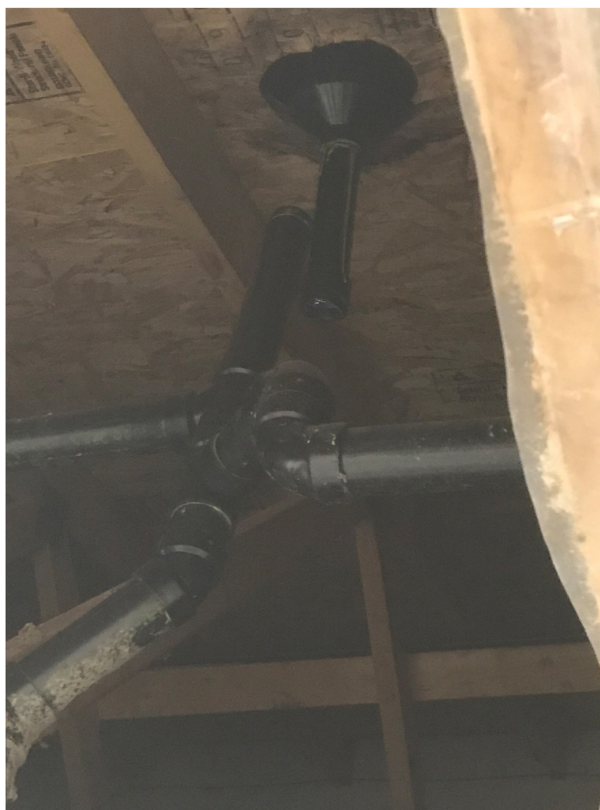
reconnect water vent and replace OSB around top.JPG

All rooftop protuberances including the flashing around them should be properly sealed so that no moisture can get in. The roof top sewer gas vent in the change room 1 (CR1) should be replaced, and reconnected as soon as possible. Any rotten OSB around it should be carefully cut out from underneath and a new piece sistered in place with PL9000 or equivalent. Cutting should be completed so that the roof itself is not penetrated, and no screws or nails should be used from below.

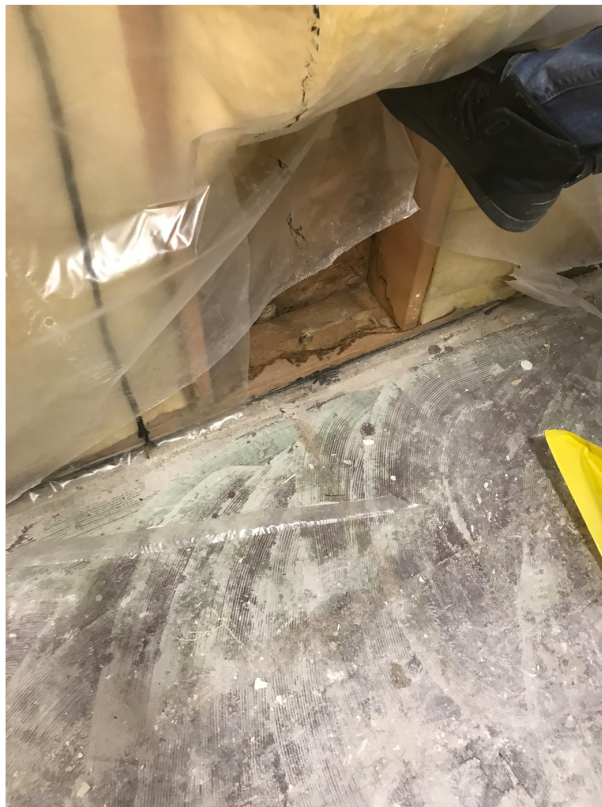
Change Room 1 (CR1): Surficial damage to the OSB was observed here and they can be sanded and sprayed with a fungicide.

surficial damage to sill plate in change room 1.JPG

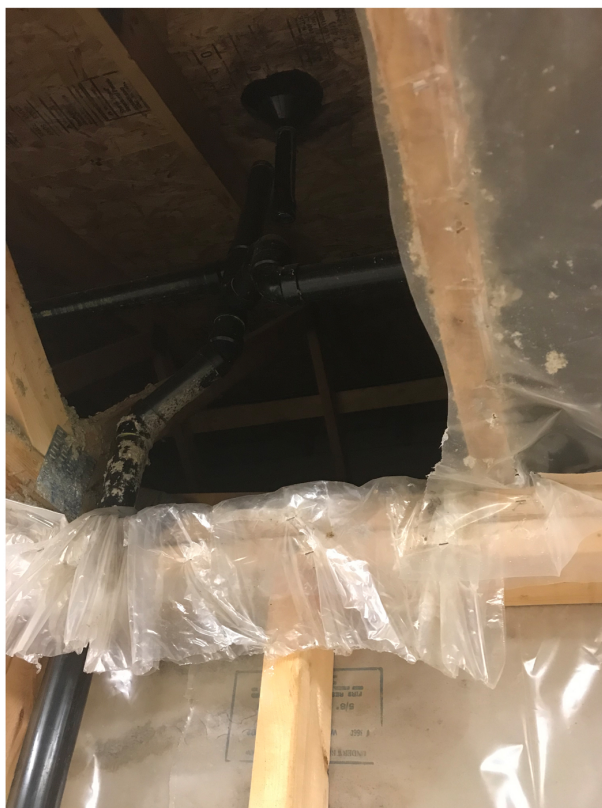
vent in change room 1.JPG

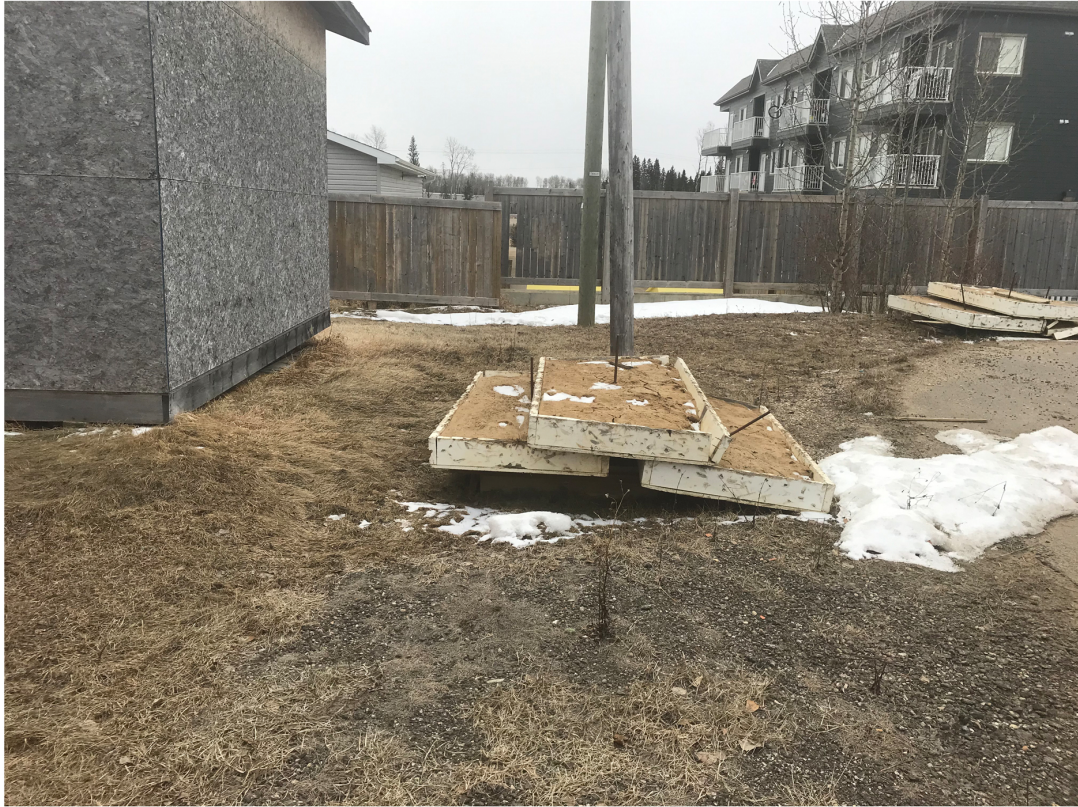
The surficial drainage around the Subject Building was adequate, with some potential issues with the rink. The rink itself should have a 8cm (3") high asphalt curb or equivalent installed on its east side so that any melting water would travel to the south end of the rink away from the foundation.

downgrade drainage on south east corner of rink.JPG

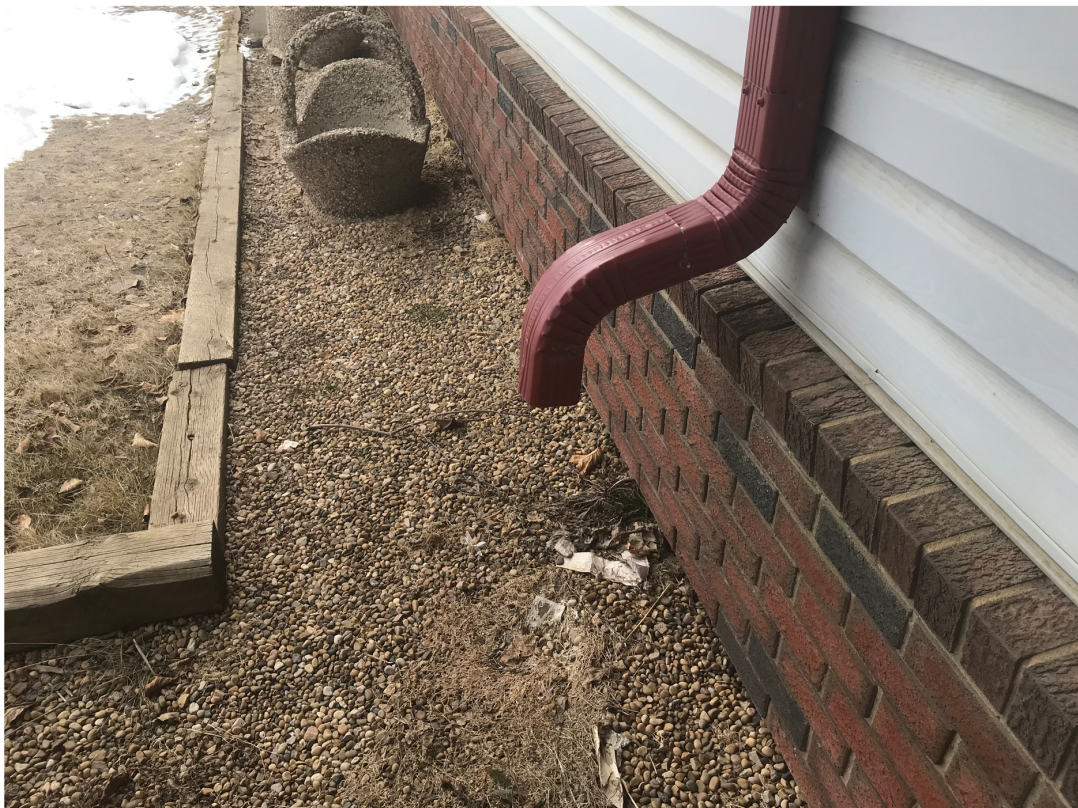
The roof drains were all draining next too the foundation with some concrete water diversion pads diverting water away, and some with no means of re-routing the water. 1.2m long Downspout extensions or new concrete water diversion pads should be installed under or to any downspouts with small extensions.

no downspouts extend more than 0.3m from foundation wall.JPG

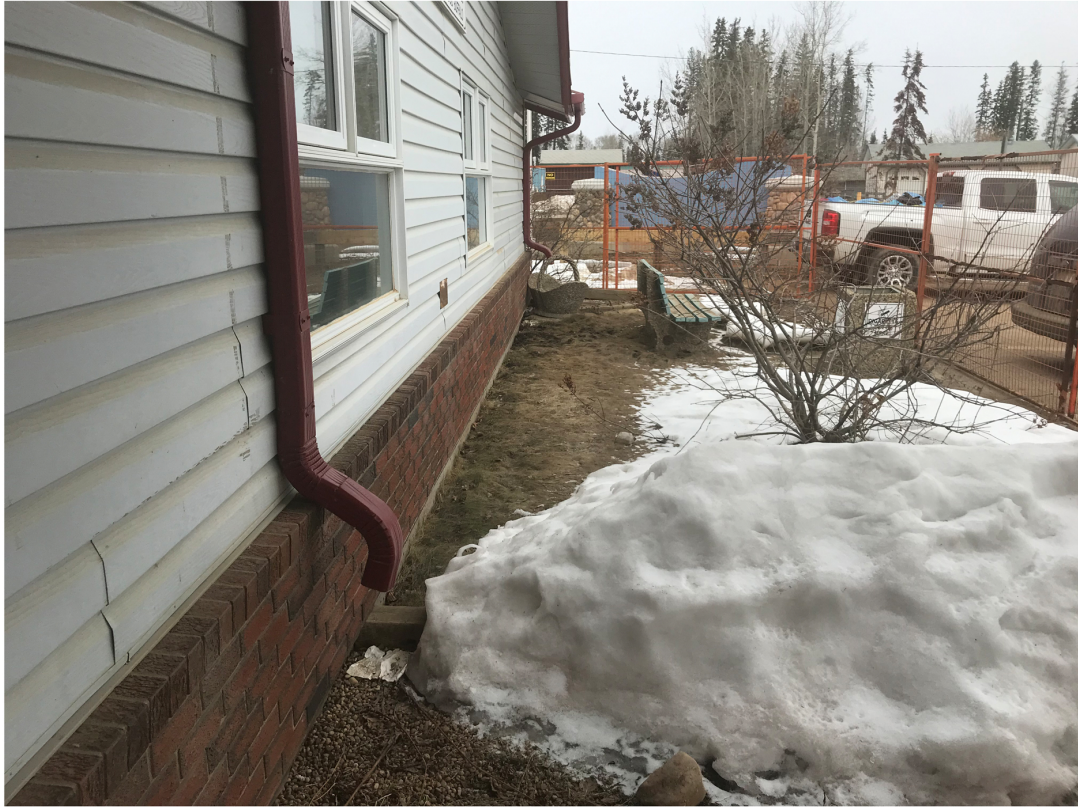
roof downspouts should extend 1.2m away from foundation.JPG

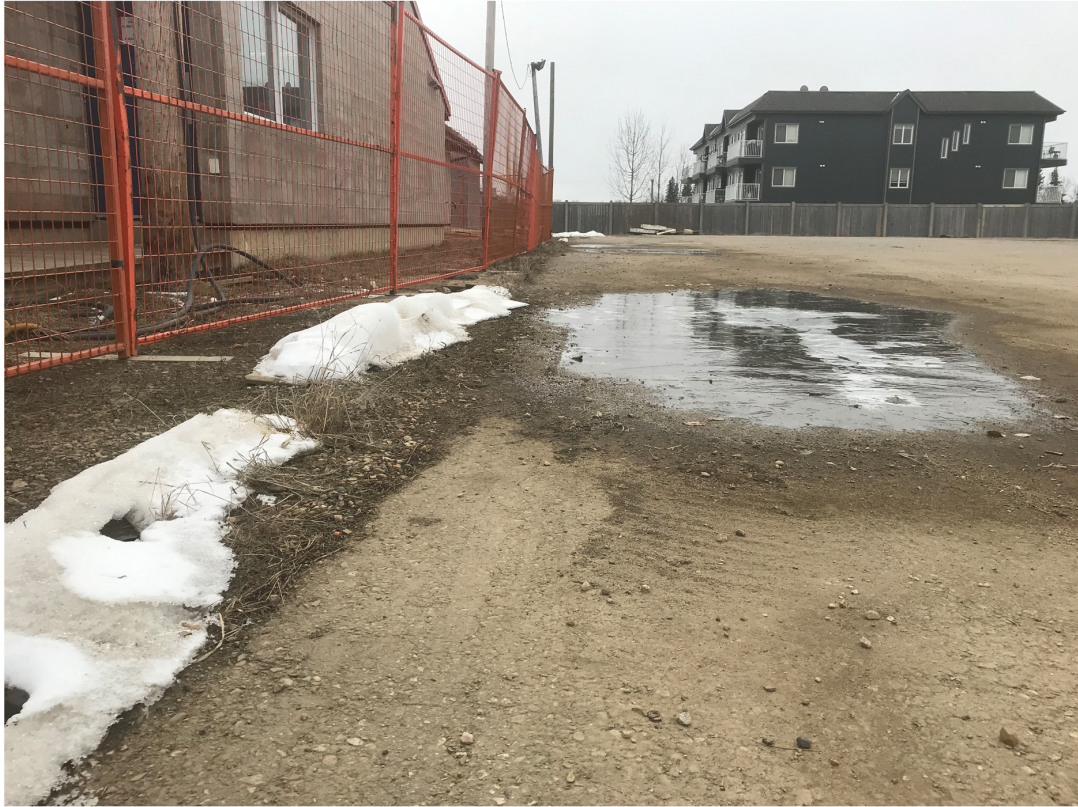
water pooling in rink area far from rink entrance.JPG

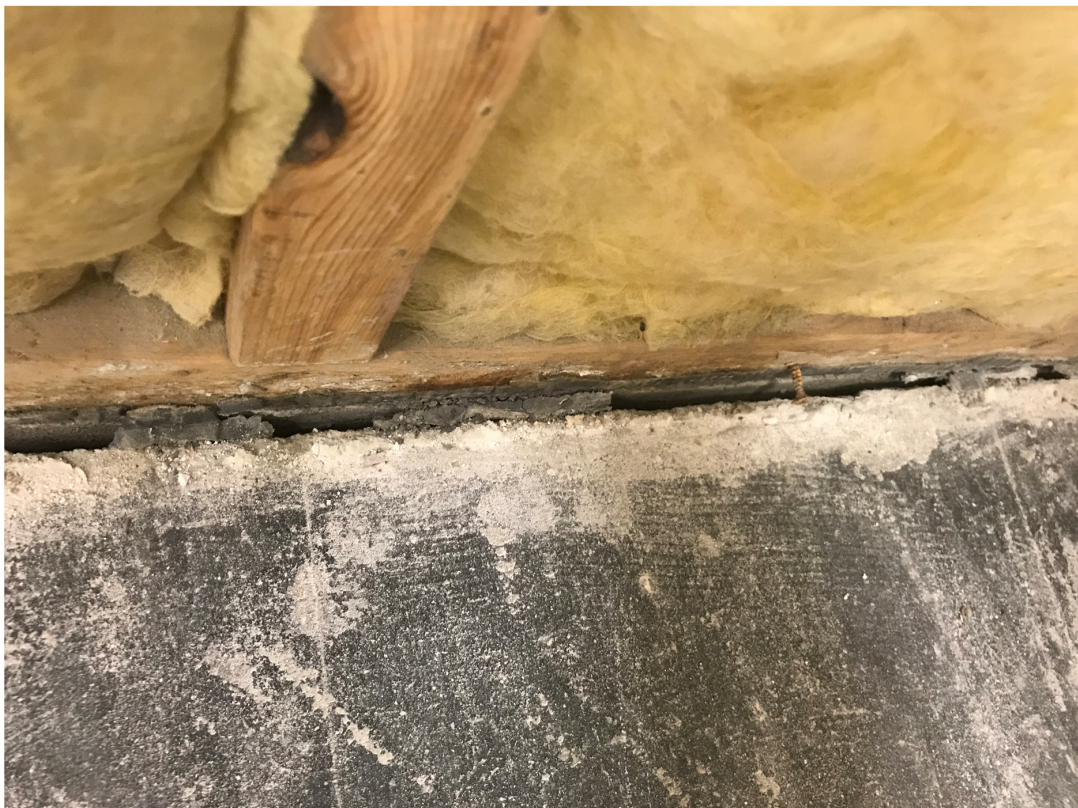
space between floor slab and foundation wall should be filled with epoxy.JPG

The metal door sill plate on the south-east corner of the hall should be sealed on the inside with epoxy and the space between the floor slab and the foundation wall in the dressing room should also be sealed with an appropriate epoxy.

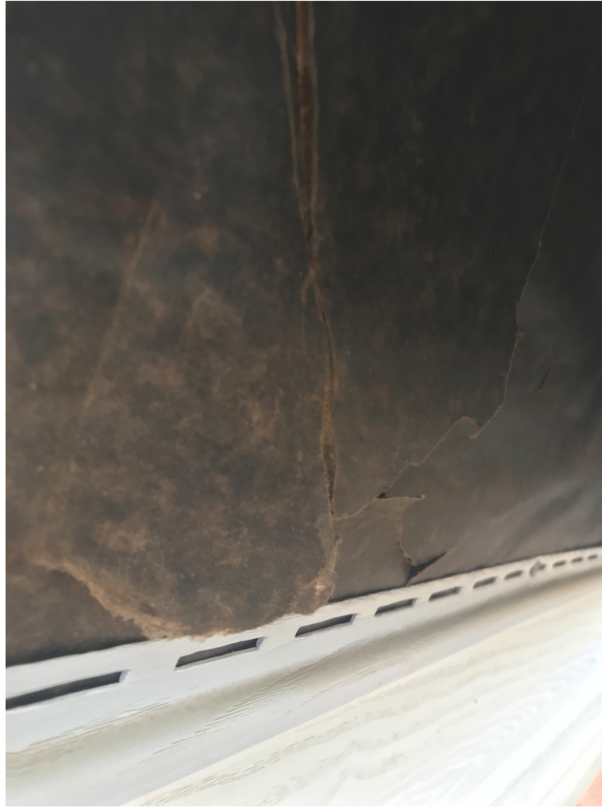
tar or felt paper under vinyl PVC siding showing some wear in a couple spots.JPG

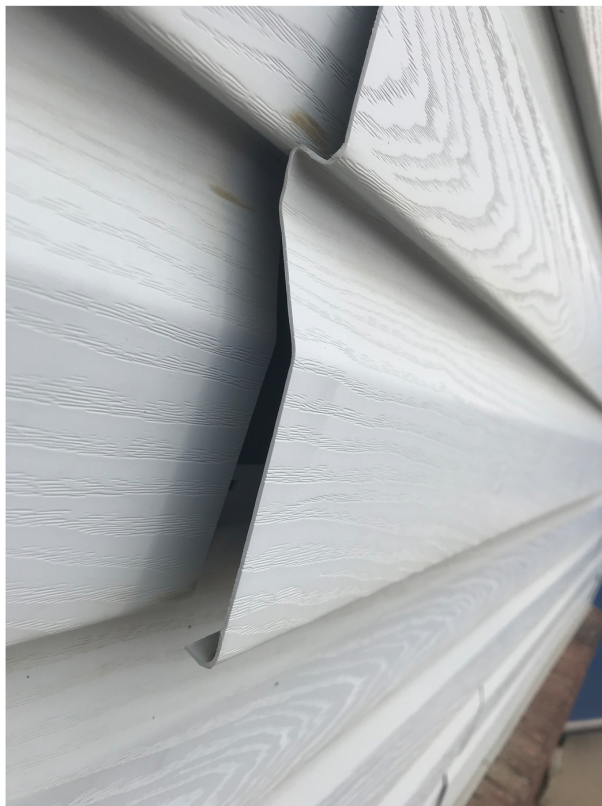
vinyl siding showing some signs of wear in two places on east wall.JPG

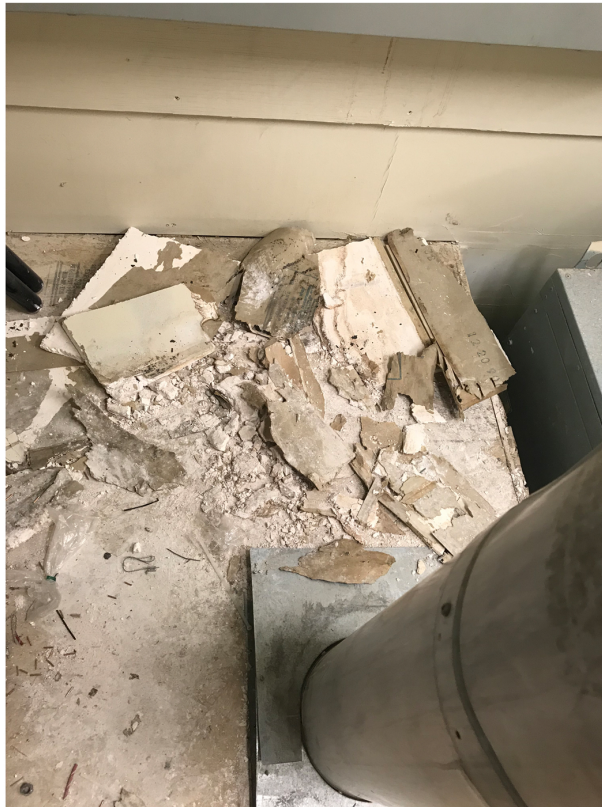
The Electrical Room (ER): The electrical room is located in the upper level to the west of the stage. The Attic (the upper west side of the stage on the south side of the hall) was measured at 5600 spores / m<sup>3</sup> of airborne spores. This was in the same room as the stack for the legacy furnaces that CMG identified as being poorly insulated. The mouldy drywall that was removed off the ceiling is likely the cause of the higher level airborne spores here. Aspergillus/Penicillium-like spores were in much higher numbers here at 2800 spores / m<sup>3</sup> (medium). Please minimize disturbance in removal of drywall in this area. The **ceiling drywall was sampled by CMG and measured at a level 3 Chaetomium**. Remediation for this area was reviewed in previous sections and direct skin contact with this type of mould should be avoided. A light airbourne amount was detected in this room likely from the disturbance of the drywall there. The **fir roof joist was sampled, and no mould was detected** and we do not expect the insulation to be affected either. All stained, and cracked drywall in this room should be removed and replaced, and the stack should be better insulated so that the attic area here stays cool and dry.

evidence of potential mould in drywall below old furnace stack.JPG

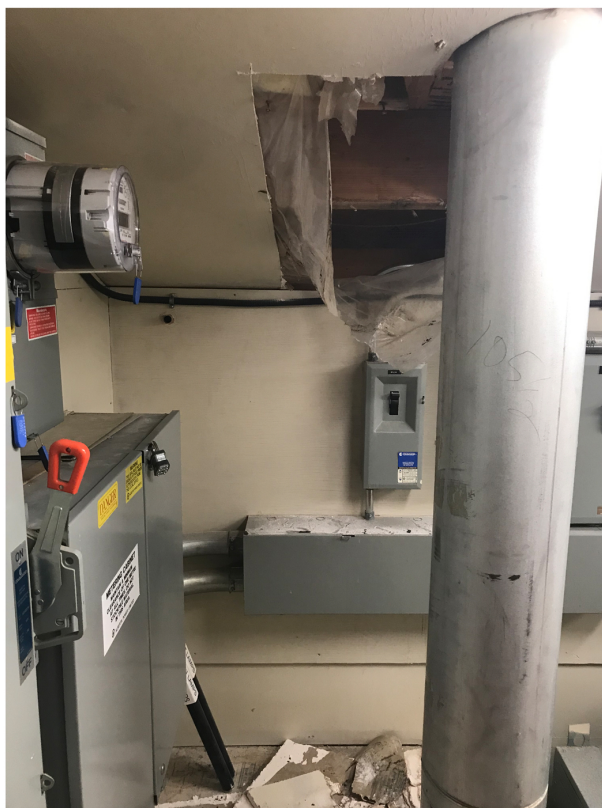
old furnace stack not insulated.JPG

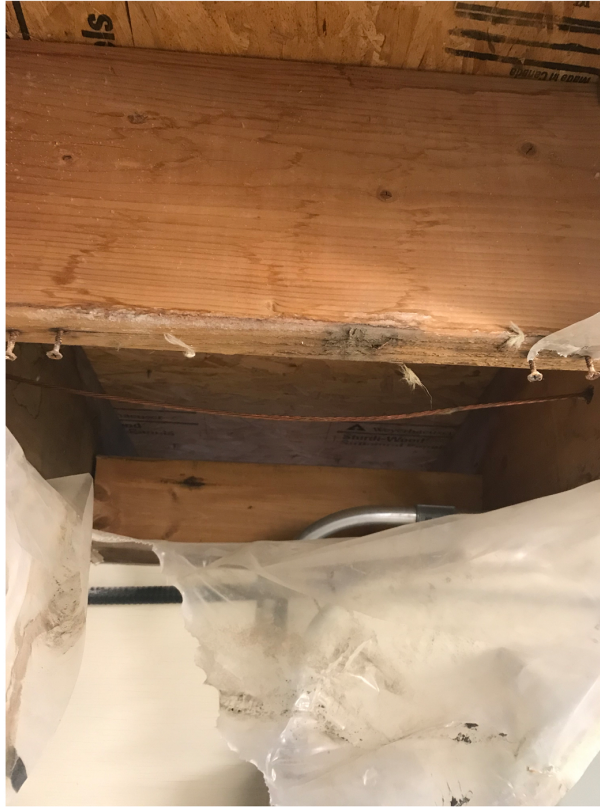
surficial damage in joists below old furnace stack in electrical room..JPG

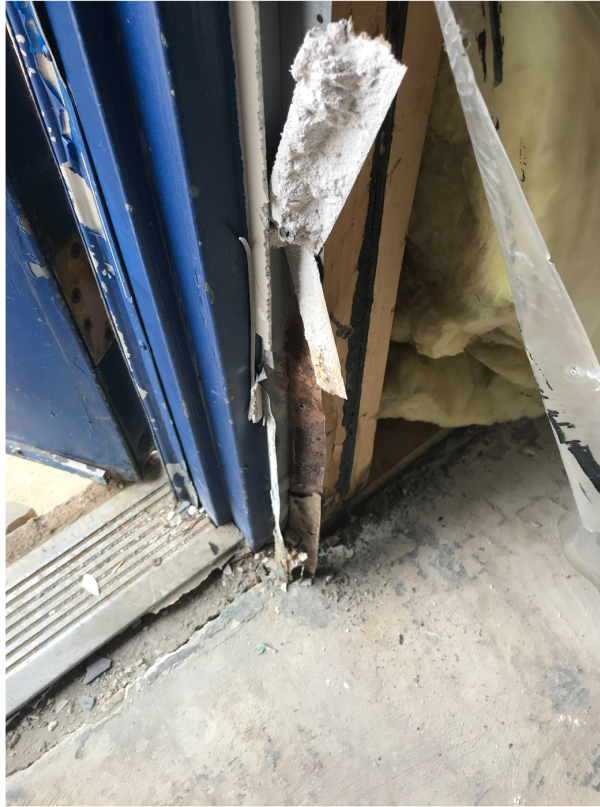
sill under doorway should be sealed with silicone.JPG

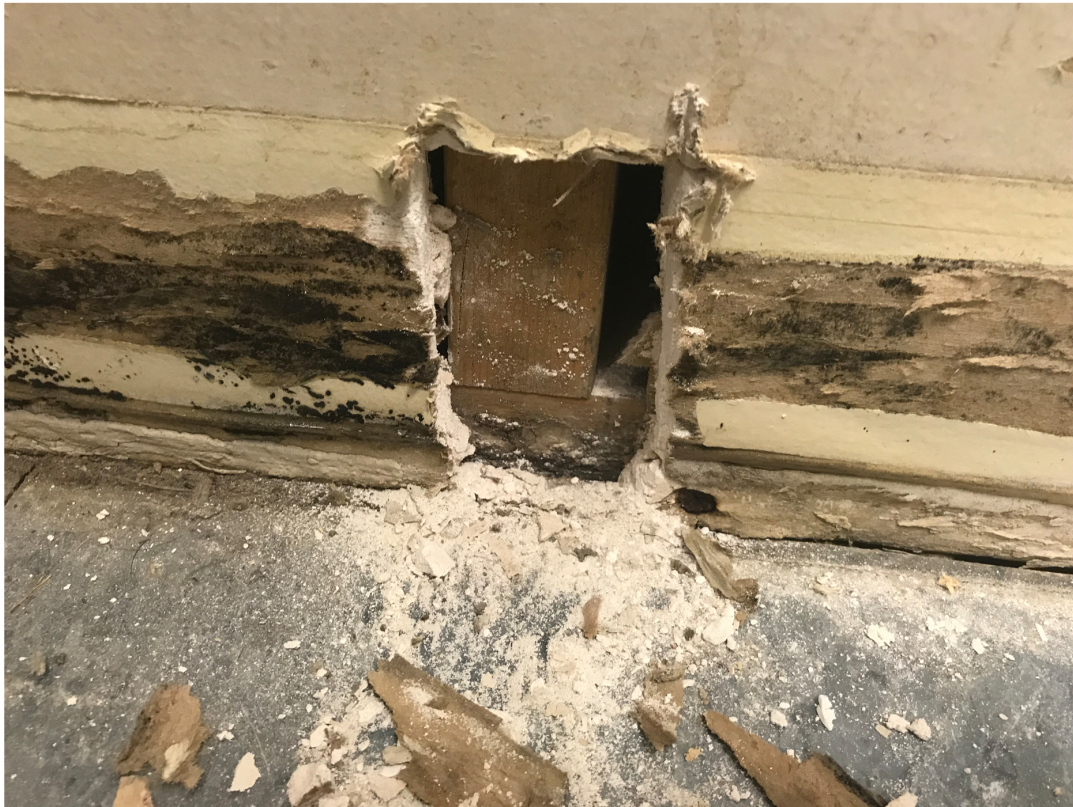
Janitor room and adjoining WC (WC4): The drywall behind the baseboard in both rooms was measured as **level 4 Stachybotrys**. This is the highest level of contamination in the Subject Building and is likely due to water on the floor of the janitor room next to the walls. Water from, for example spilled water next to the wall, could become trapped between the rubber baseboard and the wall. Warm wet drywall is prime feeding material for this type of mould. CMG removed some of the drywall material to look at the structural wall elements, and no evidence of mould was observed on the sill plate or studs in the wall there. The drywall should be removed to a height of 4'1" so that new sheets of drywall easily replace the existing drywall. Some fungicide should be sprayed on the floor after removal so that this mould does not spread. If possible the drywall should be placed so that it does not touch the floor slab or flooring and no baseboards should be replaced in these two rooms.

potential mould in janitor room. No damage to studs behind drywall.JPG

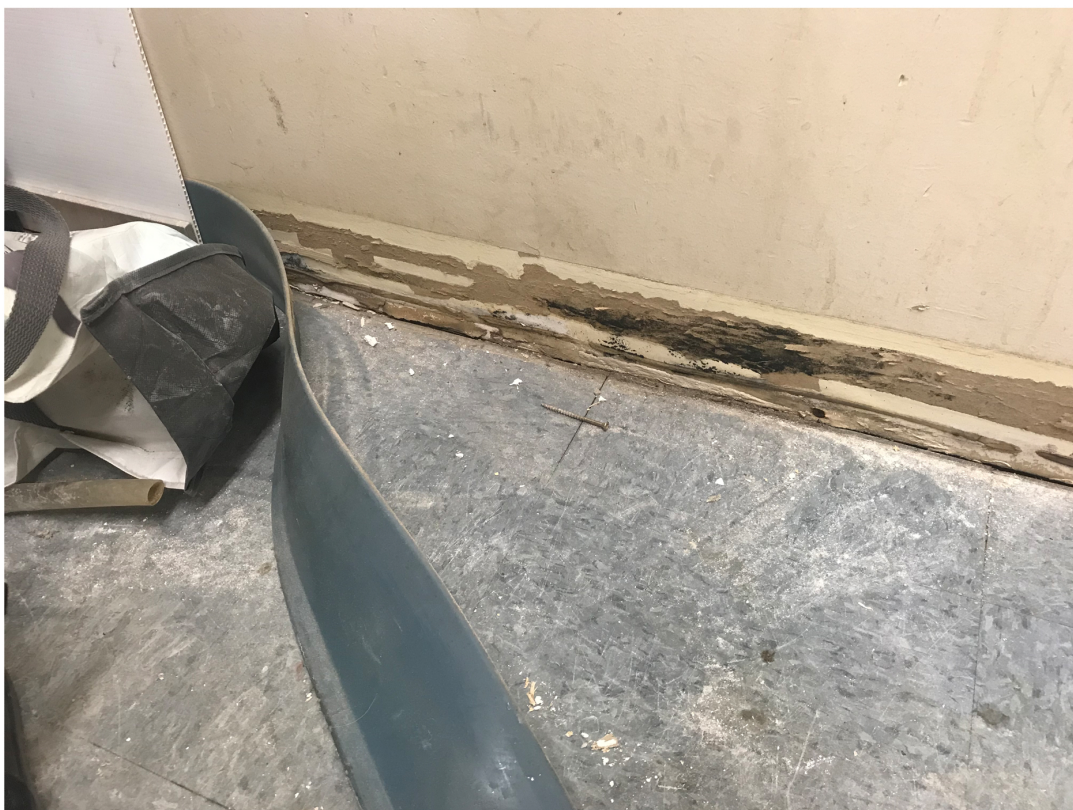
rubberized baseboard in Janitor Room harboured mould growth.JPG

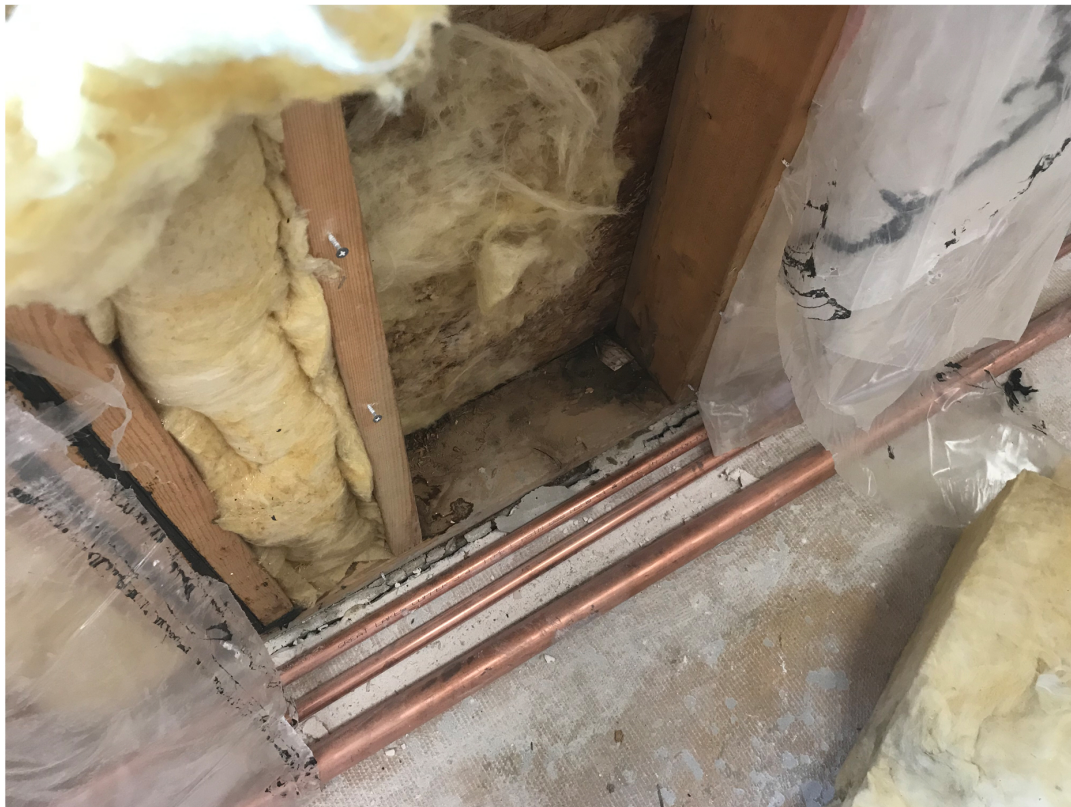
Multicultural Room (MC): Surficial damage to the sill plates and OSB was observed here and they can be sanded and sprayed with a fungicide.

2x6 sill plate in multicultural room before sample taken.JPG

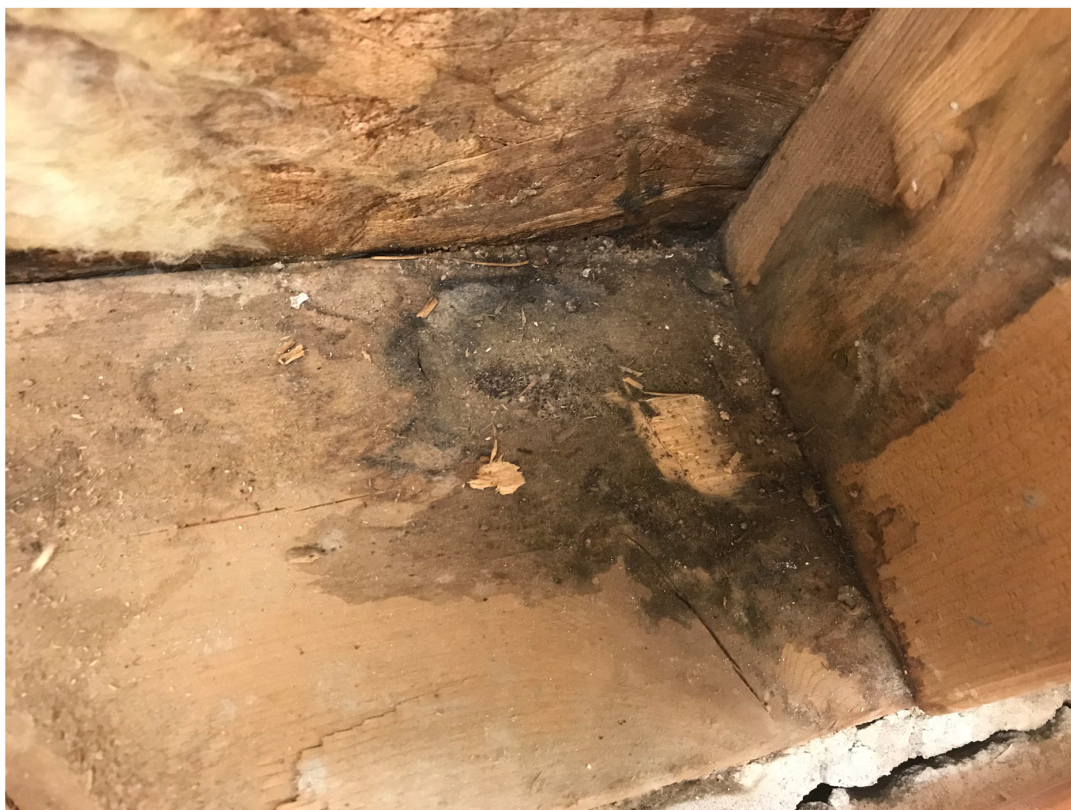
evidence staining on 2x6 sill plate is surficial.JPG

No structural elements had their function affected by rot and can all remain in place. Some fungicide can be sprayed on the affected stained sill plates and studs, and then sanded after 24 hours.

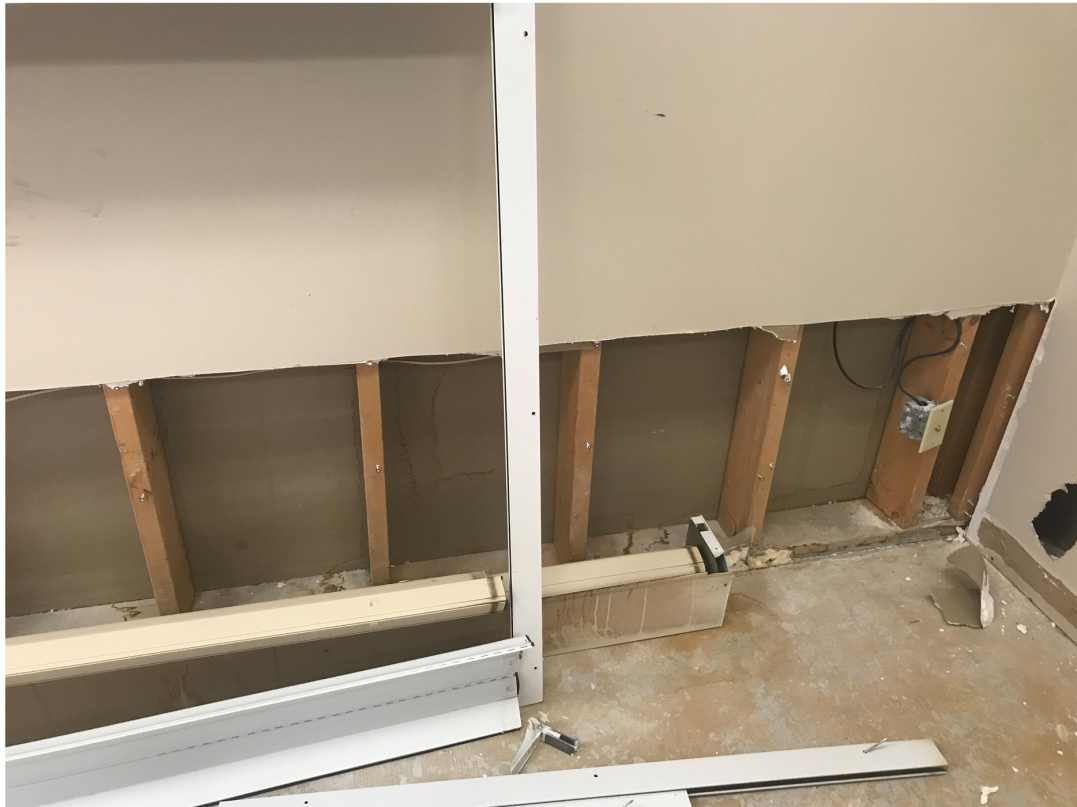
more surficial staining in multicultural room outer wall.JPG

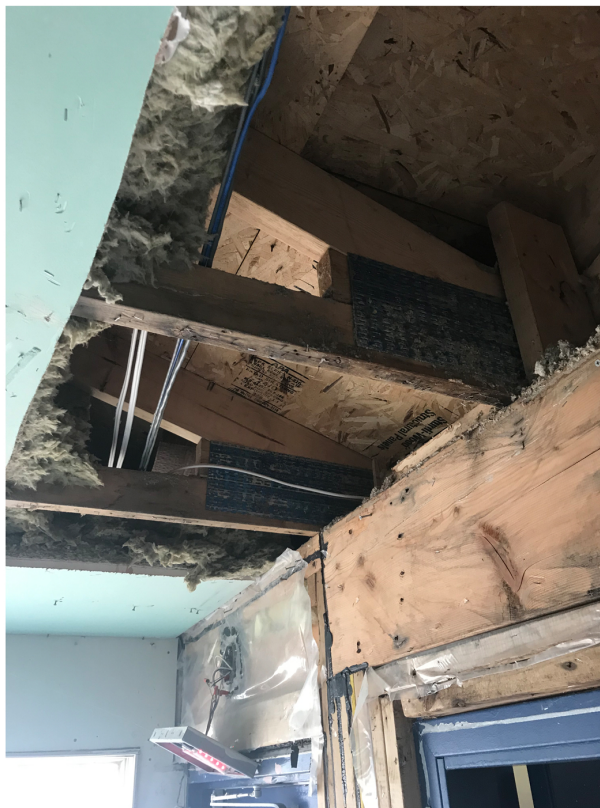
Rink Hall (RH): The Attic was was measured at 10800 spores / m<sup>3</sup>. The sample was taken near the stained valley roof joists although bulk samples of the wood revealed no mould, other areas such as drywall around the wood may have had some contamination. 4800 spores / m<sup>3</sup> (**medium**) were identified as the Cladosporium spores that will cause allergic reactions and should be handled with care, *but are not classified as toxic*. Another 1067 spores / m<sup>3</sup> (**light**) were Basidiospores that are also a concern in breathable air in large numbers (over 5000 spores / m<sup>3</sup>). The medium levels of the non-toxic Cladosporium spores indicates that there may be some insulation that should be replaced in this area. CMG recommends only removing insulation that is along the bottom 3m of the roof valley here. Since we want the attic to remain cool, some spray foam could be added to the bottom of the attic below the valley here or alternatively less insulation could be added here so that the air can flow under the valley.

rink hall rafters below a valley in roof.JPG

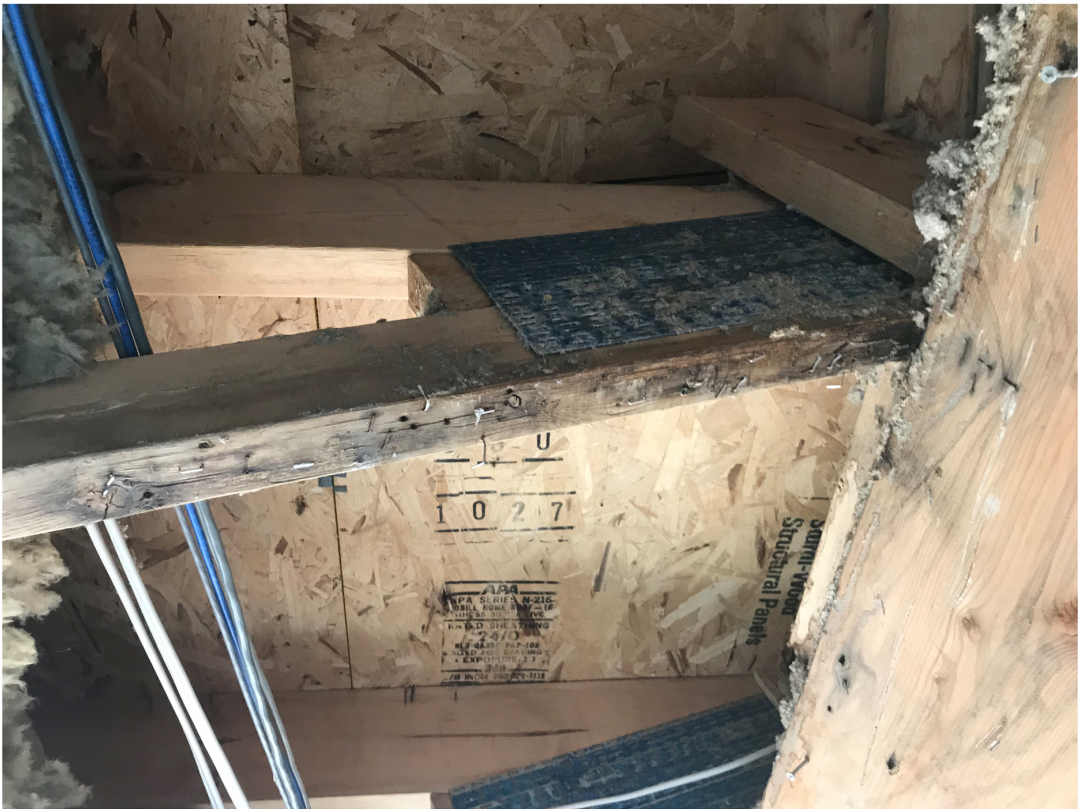
surficial damage to rafters in rink hall.JPG
