REPORT

Regional Municipality of Wood Buffalo

2020 Ice Jam Flood Event Infrastructure Performance

DECEMBER 2020

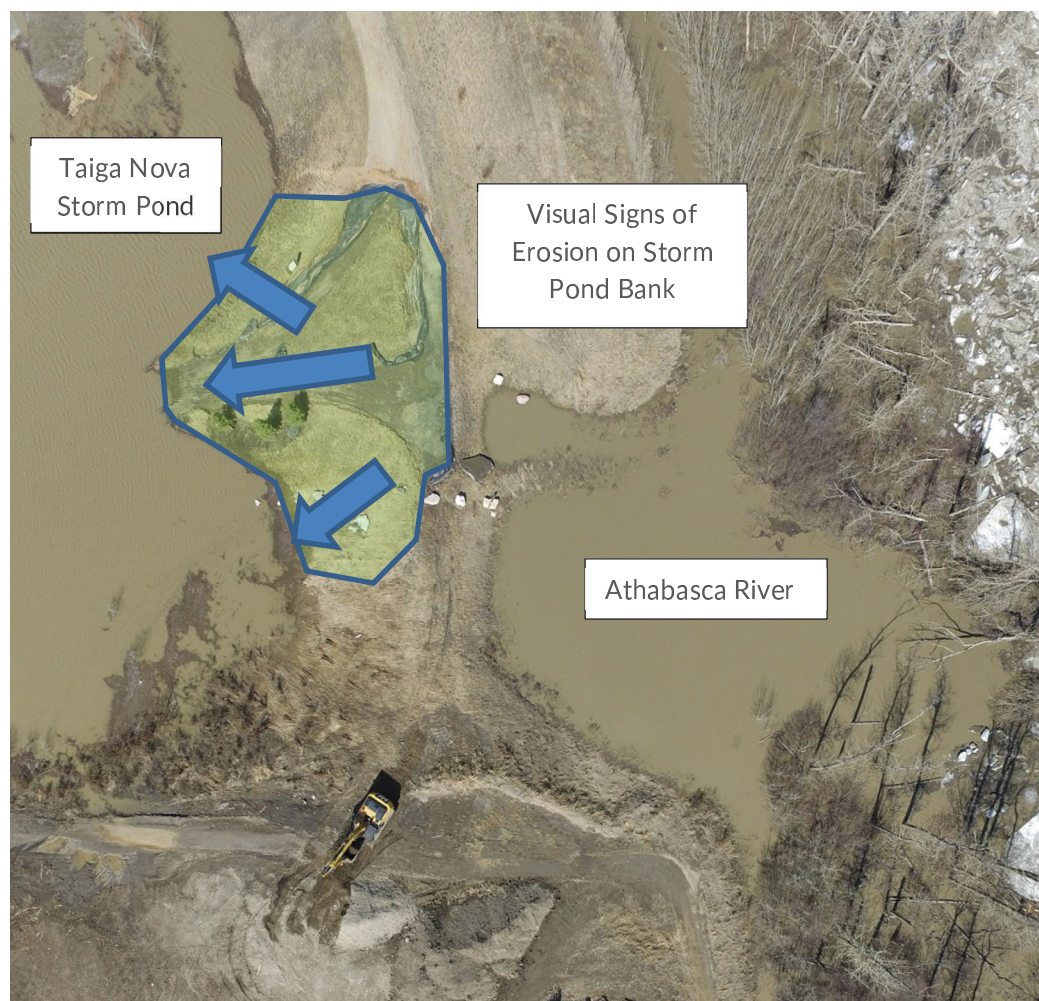
The first floodwater pathway appears to be a breach overtop of the perimeter dyke near the Taiga Nova Storm outfall. Unfortunately, there are no photos available that capture the actual flow. However, the below photo (taken April 28, 2020) shows signs of bank erosion on the inside of the dyke, as river water spilled over the dyke crest and drained toward the storm pond.

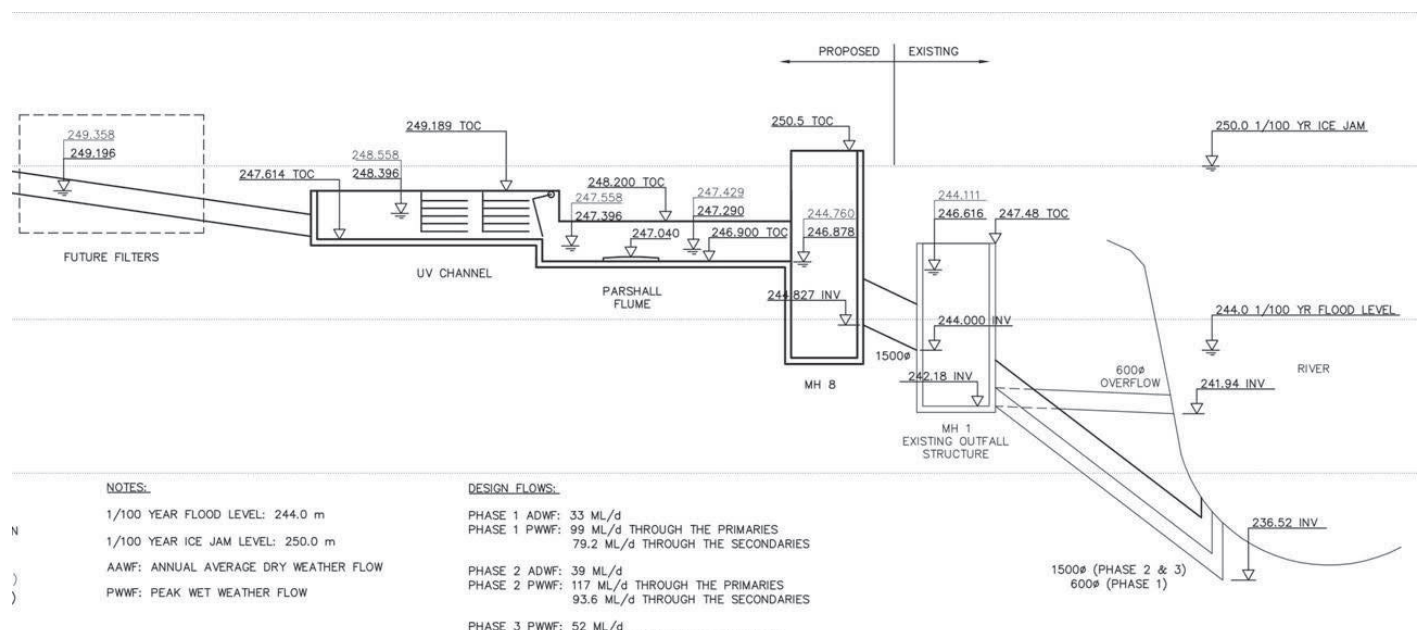
The following excerpt from the WWTP record drawings shows the schematic for the outfall pipeline. As a schematic, not all structures are shown. The structure labeled as MH1 in the schematic is representative of the three manholes that were overflowing.

One solution to prevent this line from overflowing and flooding into Taiga Nova in the future is to raise the three manholes on the outfall pipe, such that the rim is above the maximum flood elevation. This can be achieved by removing the concrete cover, installing concrete barrels to the required height, and then replacing the covers. The grading and landscaping in the vicinity of the manholes will need to be designed, including possible adjustments to the ditch line.

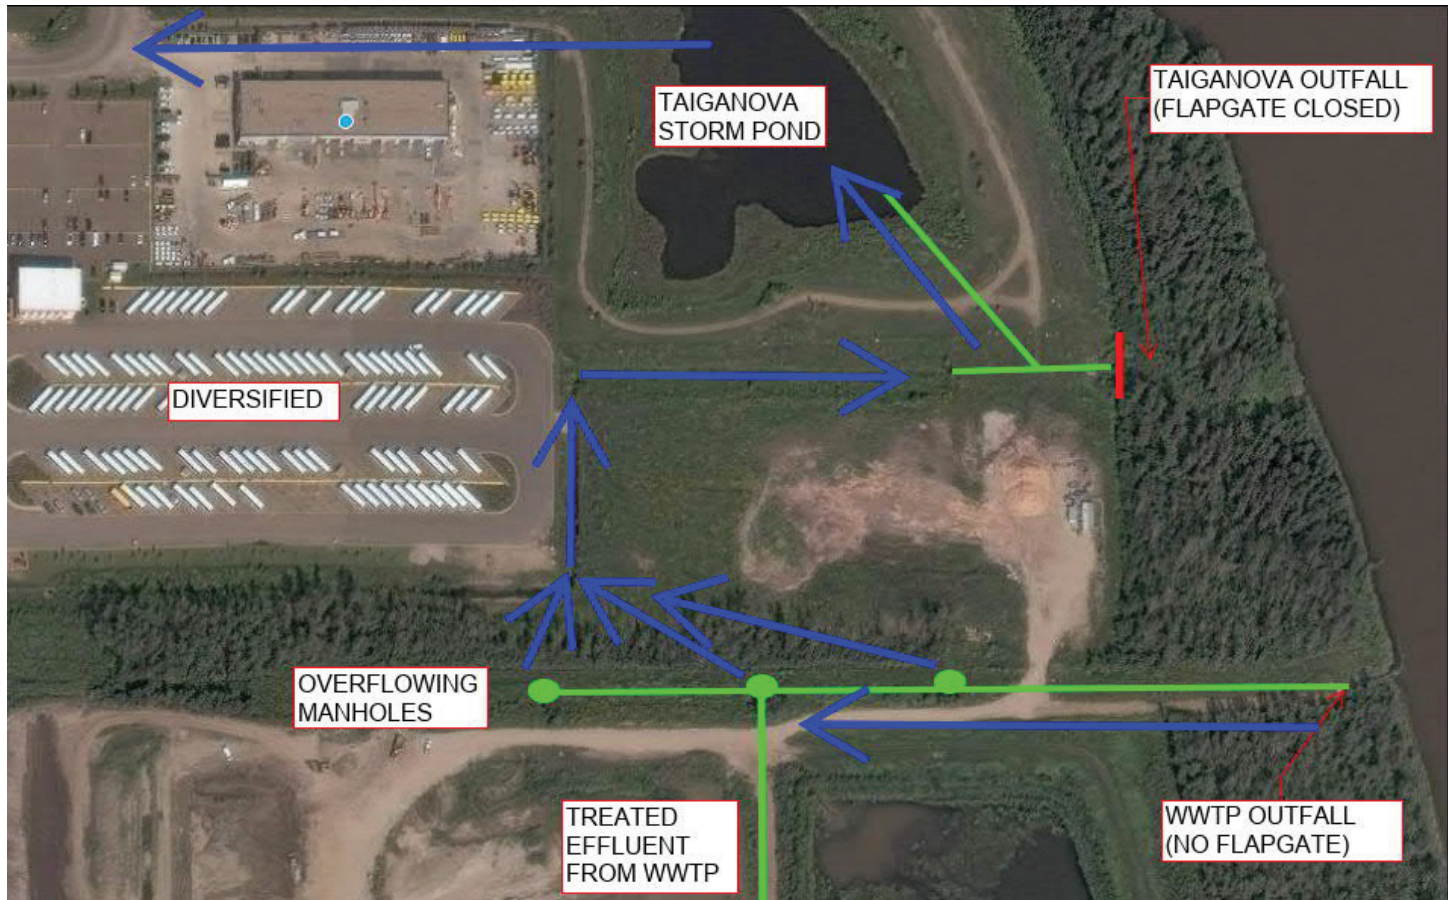
Once in the ditch, water was able to flow north to the Diversified site, then east into the junction manhole where it connects to the Taiga Nova storm outfall. As the flap-gate was closed due to the river levels, the water was then directed into the Taiga Nova storm pond. As the storm pond has already overflowed from the initial breach, this additional water likely contributed to the flooding already occurring in the industrial park. The likely pathway is indicated in the below figure.

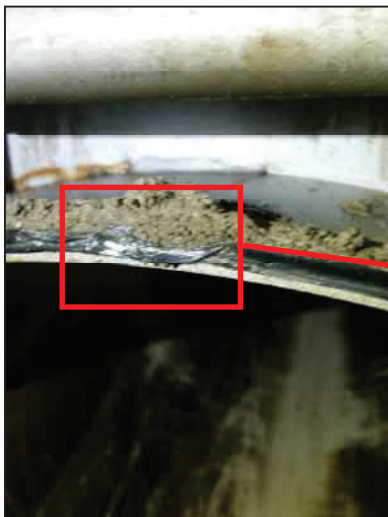
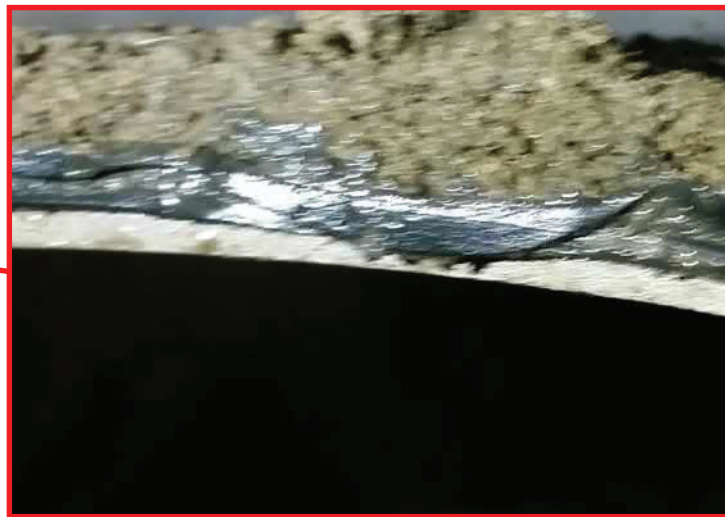
Situation: This flap gate is equipped with a neoprene lip seal secured onto the equipment wall frame. However, the upper section of the sealing system is damaged thus creating leakage. Refer to pictures below.

Lip seal damaged

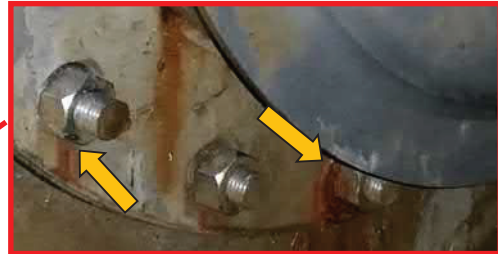
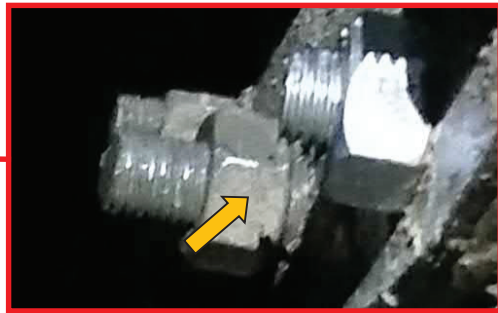
Situation : We have found several anchor nuts not properly tighten and without washers. This can create some leakage between the wall and the frame if the wall gasket is not properly compressed. Also, there was a rusted carbon steel washer that is contaminating the stainless steel flap gate. *Refer to pictures below.*

Missing and corroded washers

Loose nuts

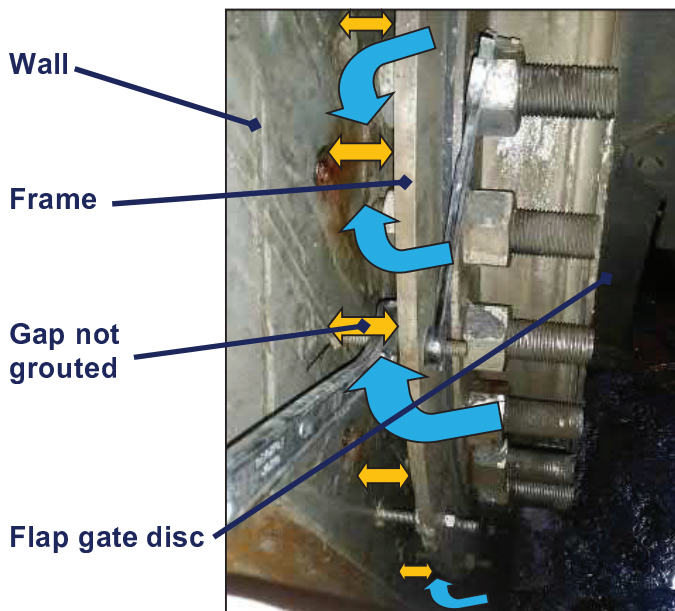
Situation: The original flap gate installation works was not properly completed. The frame was not grouted on the wall as it should be; leaving a couple inches gap all around the frame circumference thus creating heavy leakage. *Refer to pictures below.*

Water is bypassing the flap gate

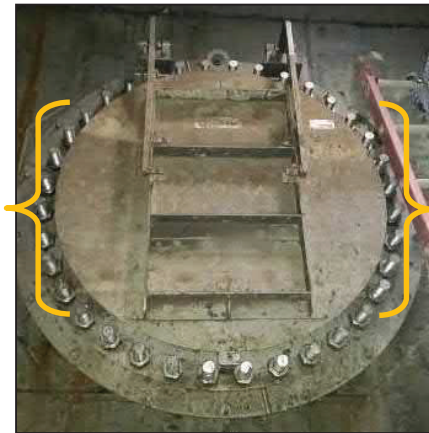
+/-2mm gap sections

Recommendations: Since the frame was not grouted yet, we have taken this “opportunity” to perform our self the required frame adjustment during this inspection. We loosen the front nuts and restraighten the frame using the backing nuts of the frame anchors. We were able to closed the gaps between the disc and the seal fairly easily. The frame is now ready to be poured. *Refer to picture below.*

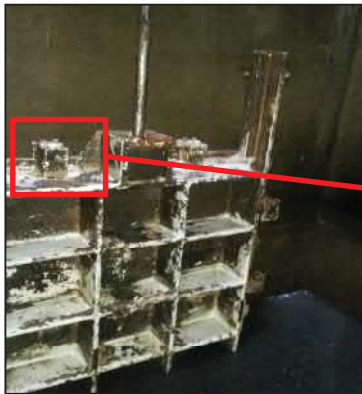
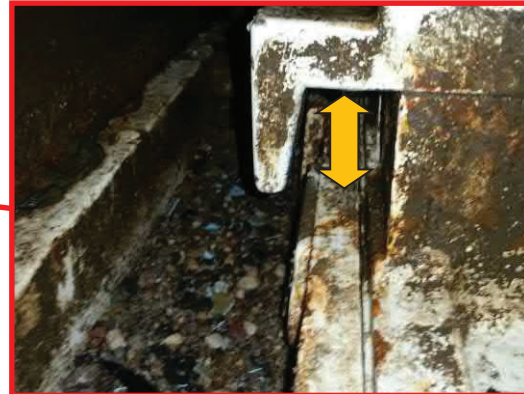
ARMCO sluice gate

Situation: The gate was automatically stopping at 75mm before reaching it full close position. After looking deeper into the actuator settings, we noticed that the full close limit switch was not properly adjusted. Therefore, this gate was heavily leaking due to this situation. Otherwise, this sluice gate is generally in good condition. *Refer to pictures below.*

Full close wedges at 75mm away

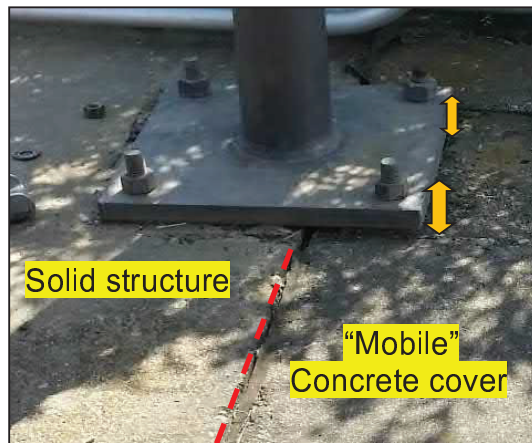
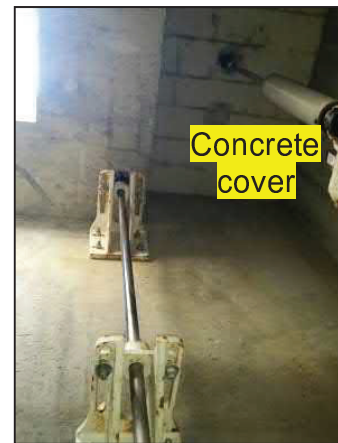
The pedestal is moving to the left because the cover is moving upward when closing the sluice gate

Operating stem and guides view from underneath

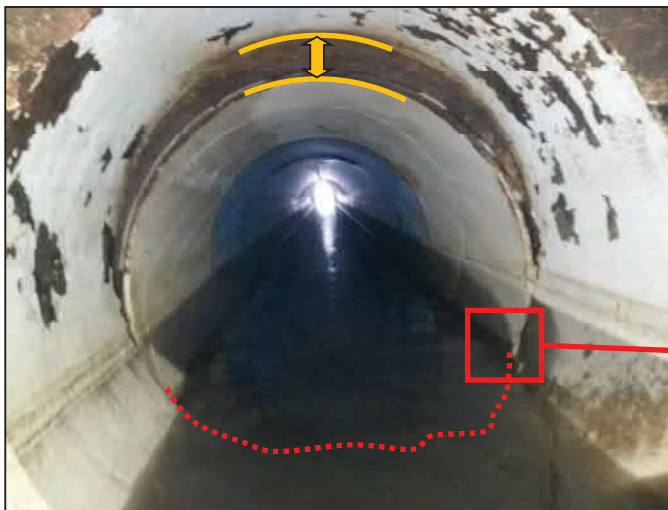
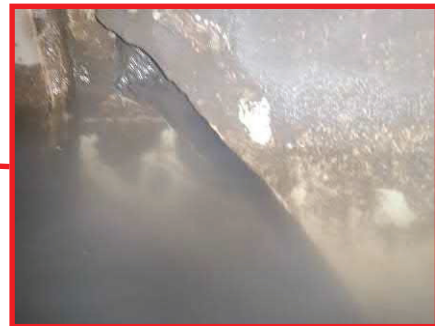
Situation: This ARMCO sluice gate is bolted directly against a “wall timble”. A wall timble is a heavy-duty frame embedded in the concrete wall with the female thread bolt pattern that is matching with the sluice gate. The gate itself has a square opening but the outfall pipe is round. The downstream side of the wall timble is design to match with the outfall pipe diameter. However, we noticed that the junction of the wall timble and the outfall pipe is broken at the bottom section. We suspect that the outfall pipe has moved downward but since the wall timble was strongly poured in the concrete wall it could not follow so it has broken at the bottom section. Also, we can see that the soil is coming out from erosion at the broken junction thus it may create supporting issues in the future. Refer to pictures below.

View inside the outfall pipe

Wall timble broken section

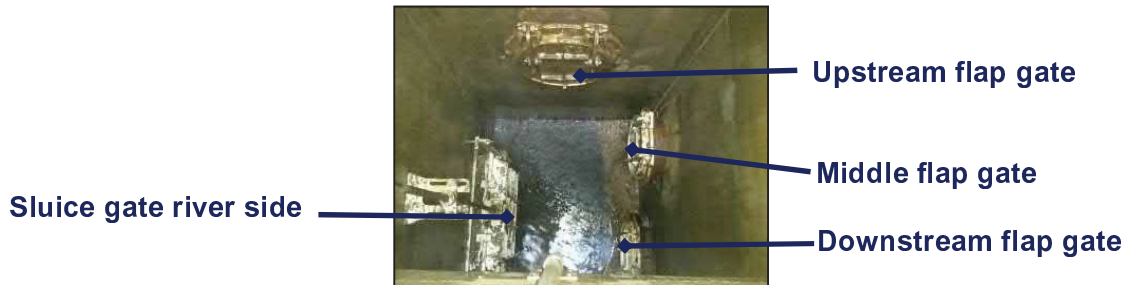
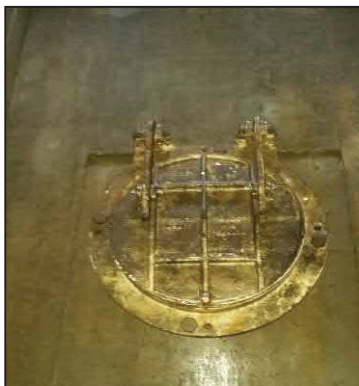
Situation: Since we were inside the outfall chamber, we took a quick look at the 3 ARMCO flap gates installed inside it. Those are all in good working condition without damages on the disc, hinges nor the frames. However, the anchor bolts are in steel and slightly corroded. Also, one anchor is loose on the middle flap gate that will need to be repaired or replaced. *Refer to pictures below.*

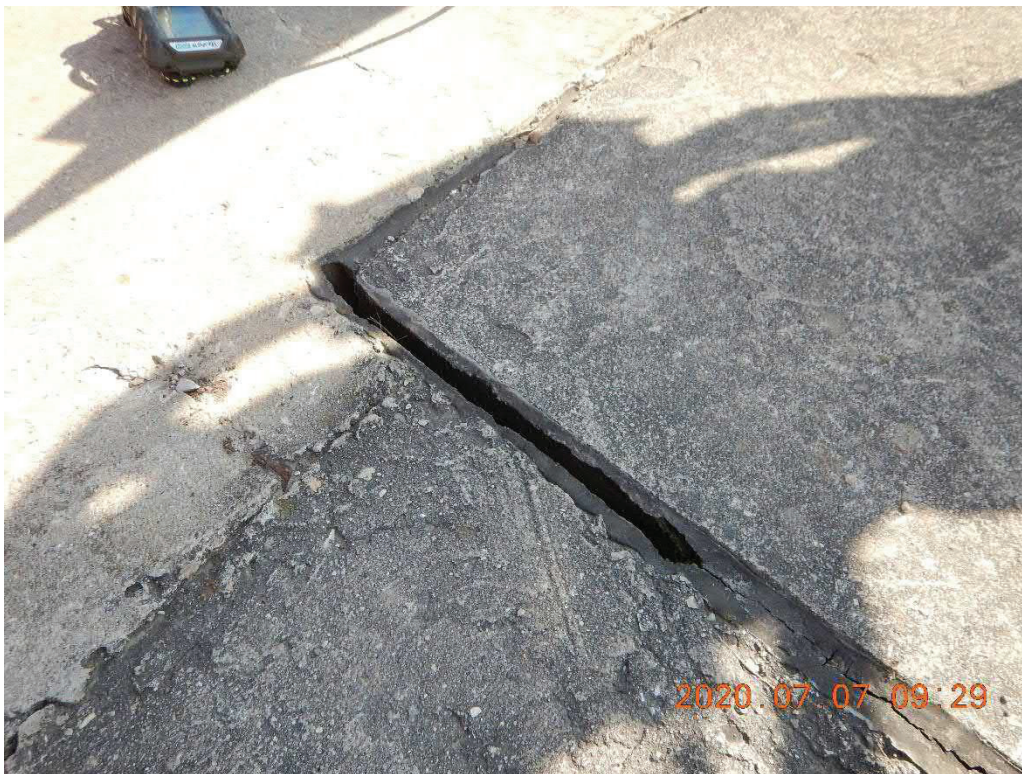
3. Deteriorated joint caulking around former concrete gate opening. Install new caulking.

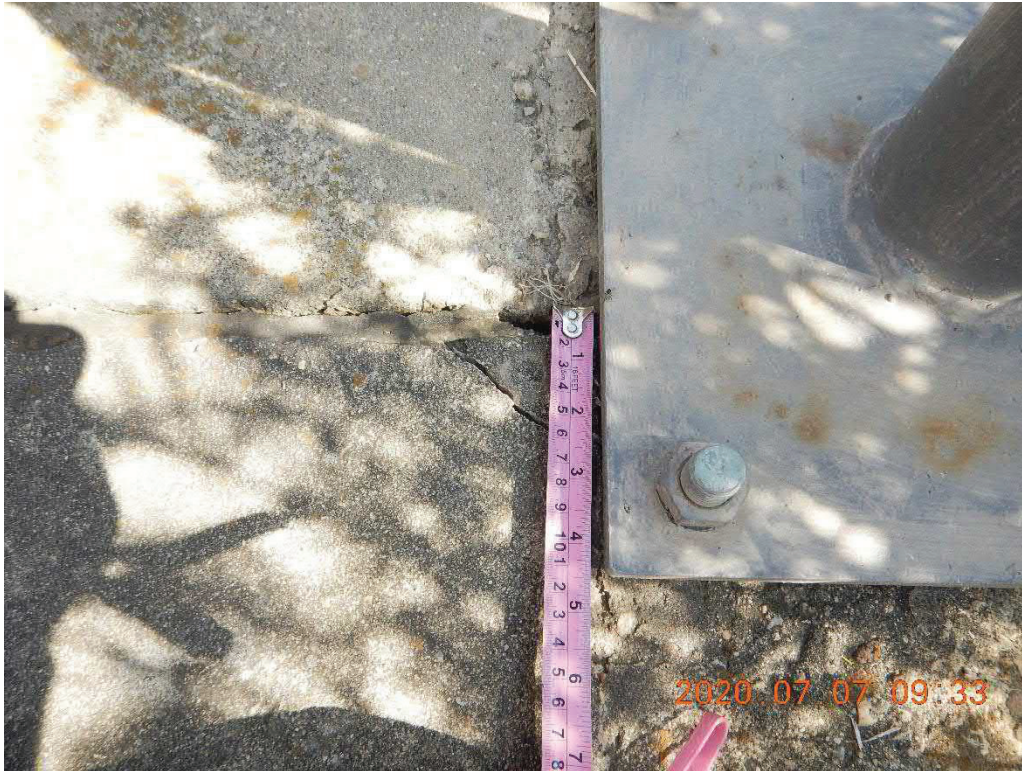
4. Bolted plate bearing 110 mm on former gate opening with cracking shown

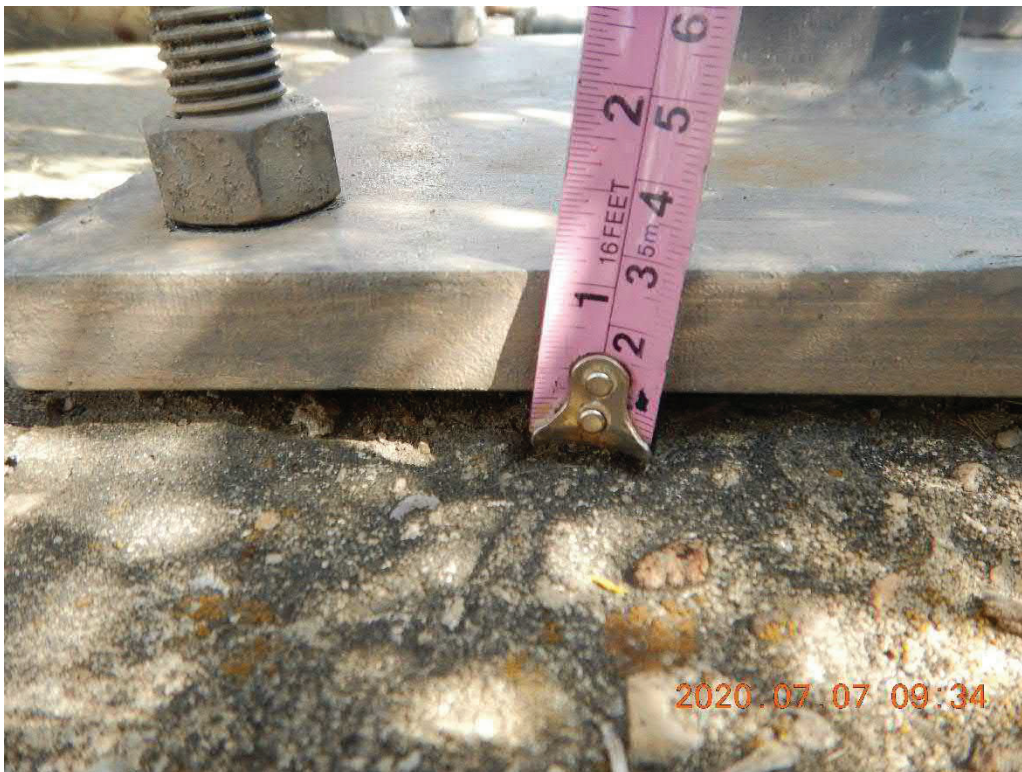
5. Bolted plate not touching concrete by 10 mm

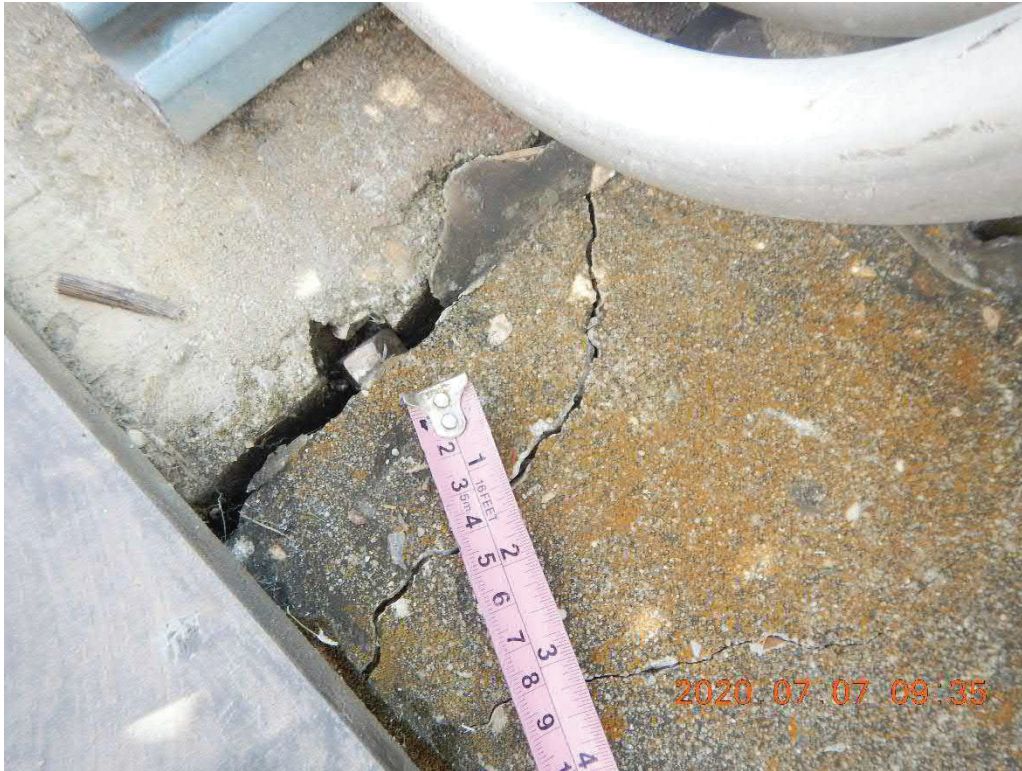
6. Cracking shown on former concrete gate opening.

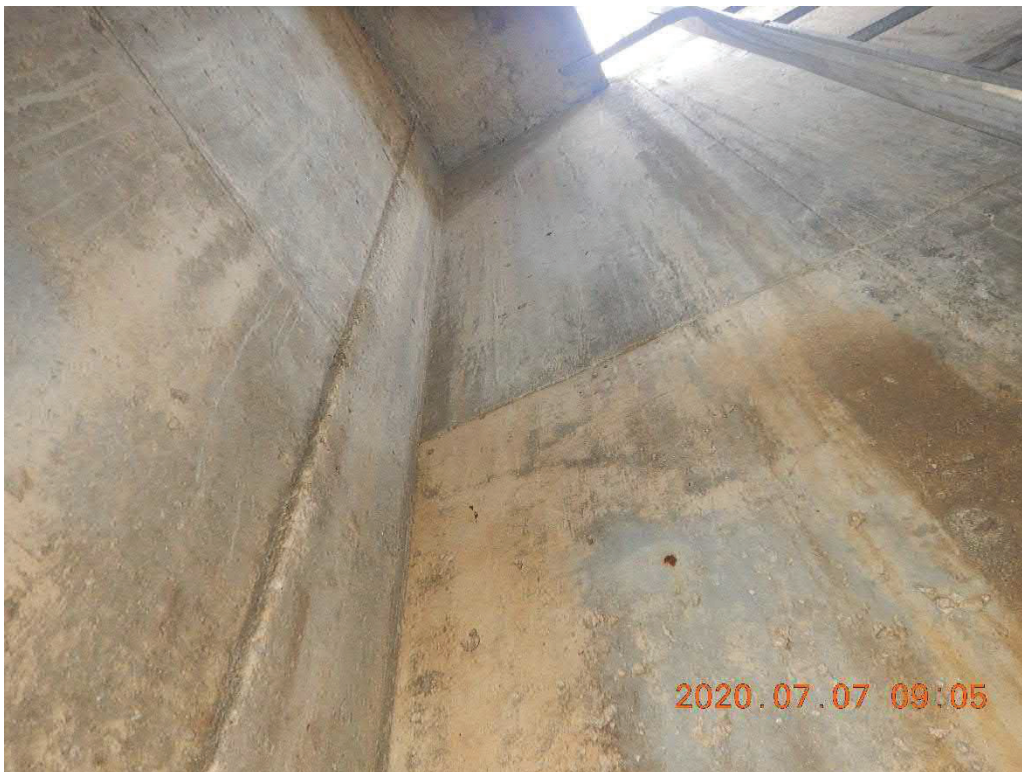
7. Looking at inside of outfall chamber walls from top platform. Concrete wall in generally good condition.

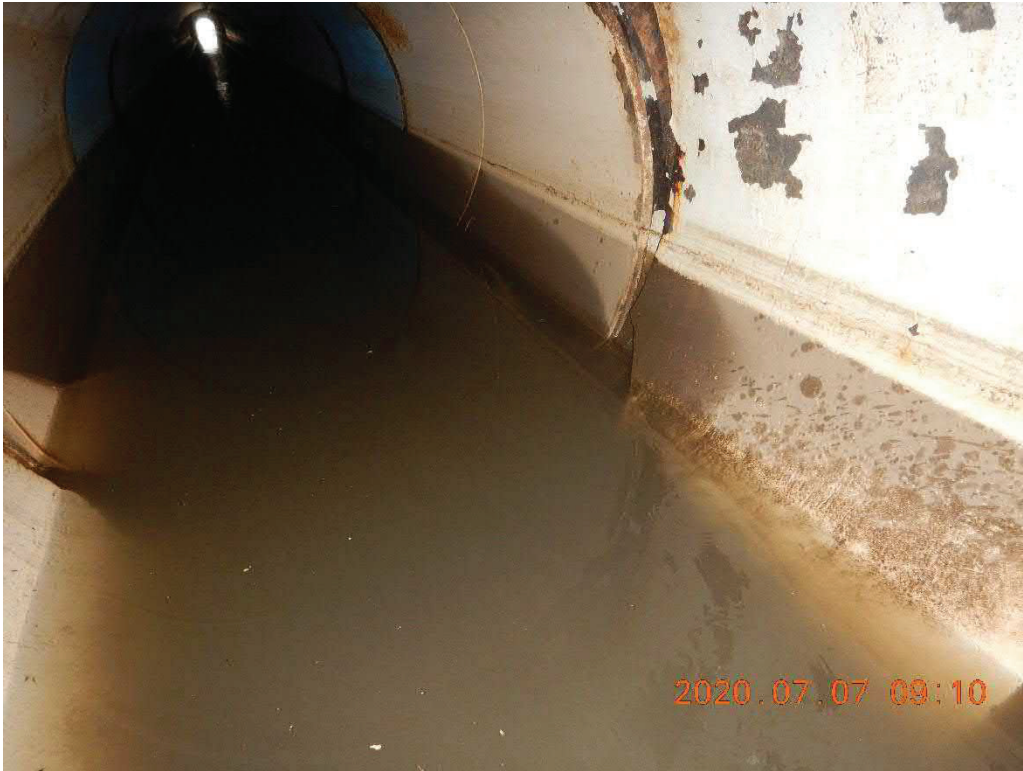
10. Damaged bottom of pipe with exposed backfill

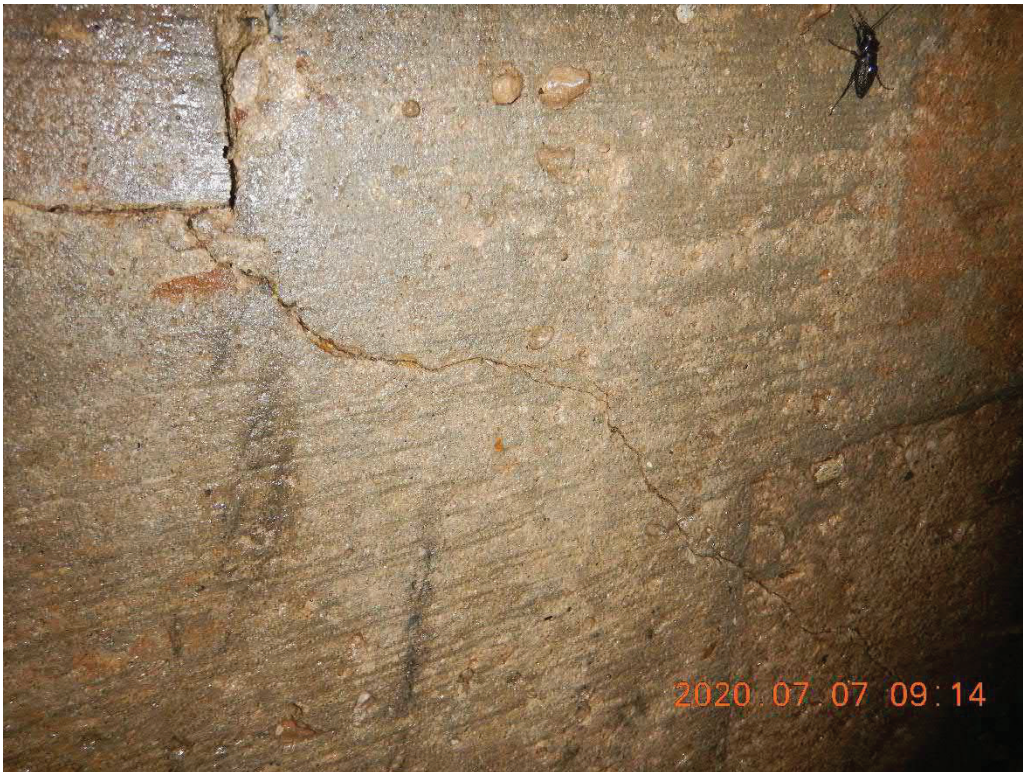
11. Hairline cracking from pipe penetration. No immediate concern.

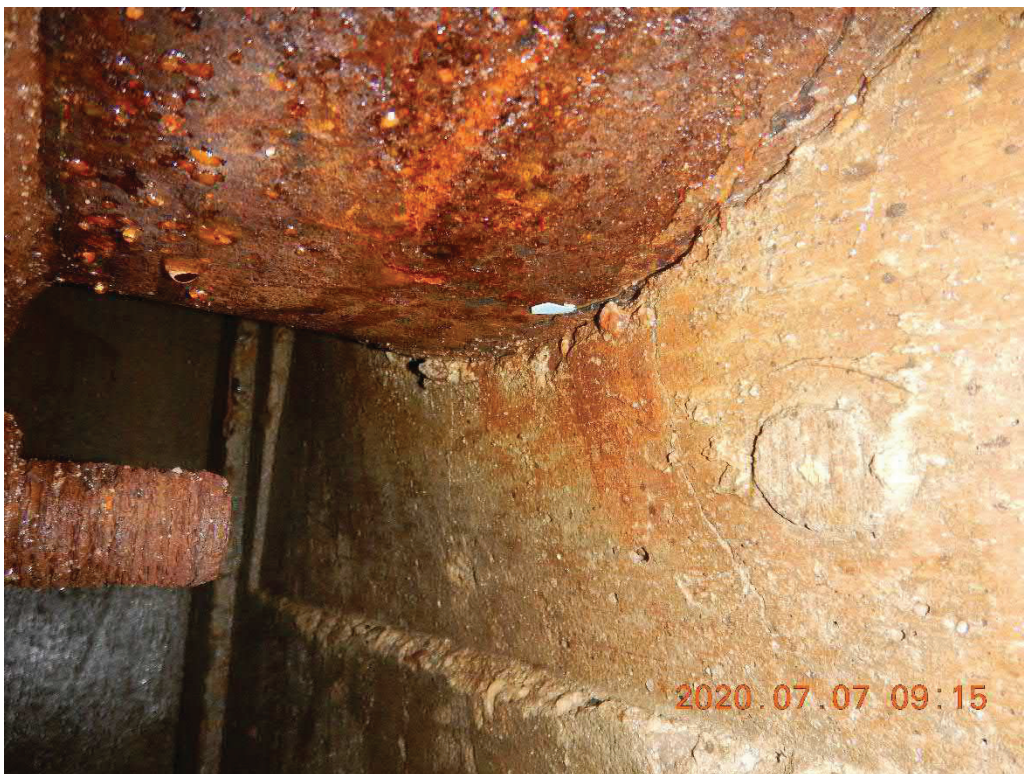
12. Looking at pipe penetration with surface corrosion on pipe.

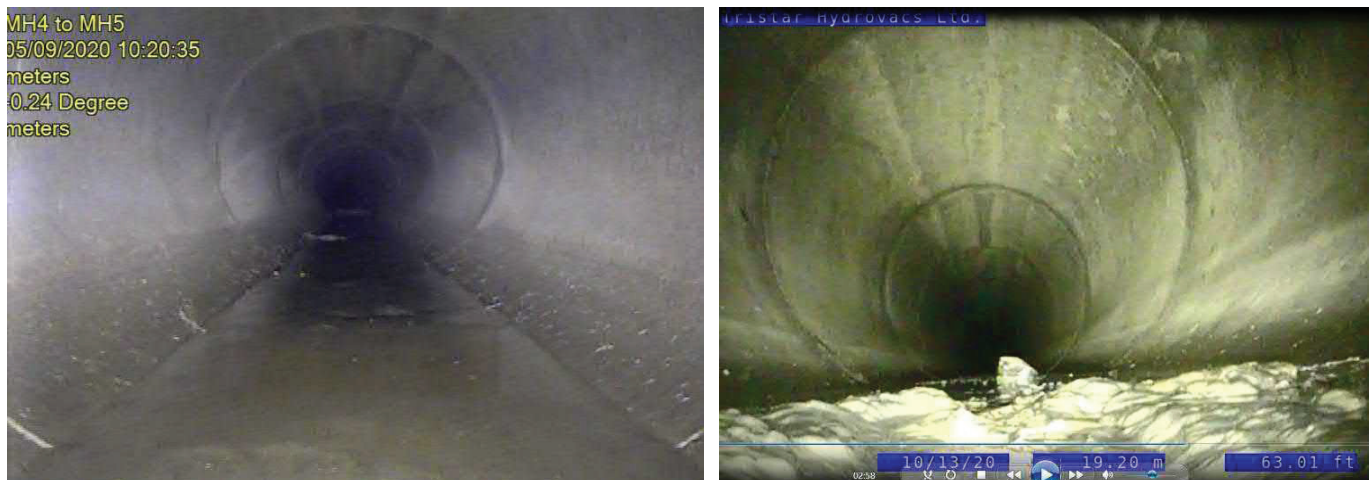
Figure 3-2
Photo Comparison MH09-04 to MH09-05

It appears that in both cases, there was water and debris buildup in the pipe. The inspection shows that further cleaning of the pipe is required to remove the remaining debris. This will require jet cleaning, followed by manual removal of the debris at the end of the line through entering the pipe and shovelling out the debris.

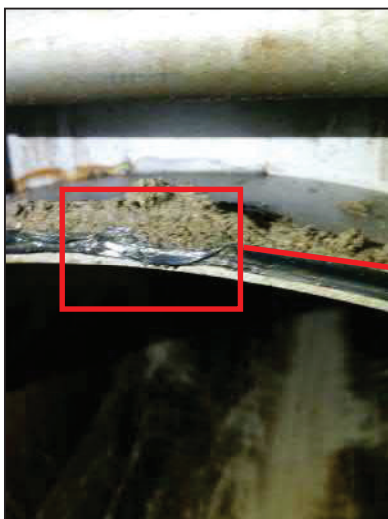
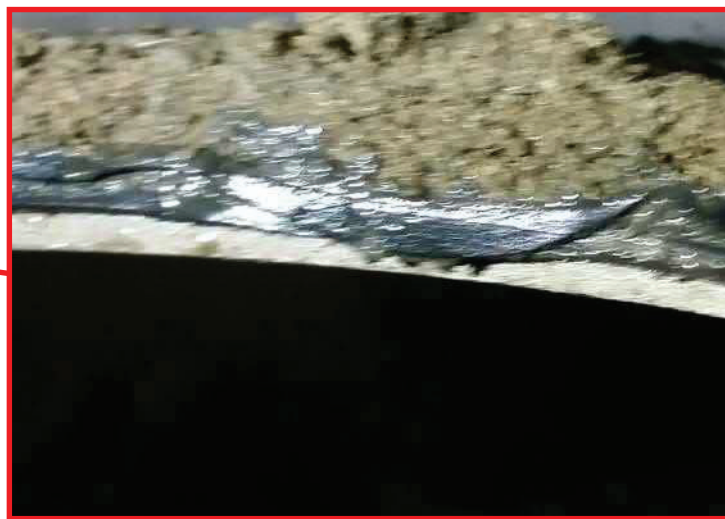
Situation: This flap gate is equipped with a neoprene lip seal secured onto the equipment wall frame. However, the upper section of the sealing system is damaged thus creating leakage. Refer to pictures below.

Lip seal damaged

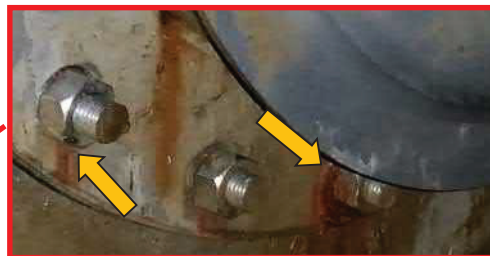
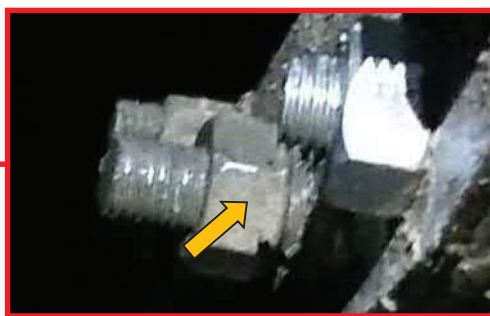
Situation : We have found several anchor nuts not properly tighten and without washers. This can create some leakage between the wall and the frame if the wall gasket is not properly compressed. Also, there was a rusted carbon steel washer that is contaminating the stainless steel flap gate. *Refer to pictures below.*

Missing and corroded washers

Loose nuts

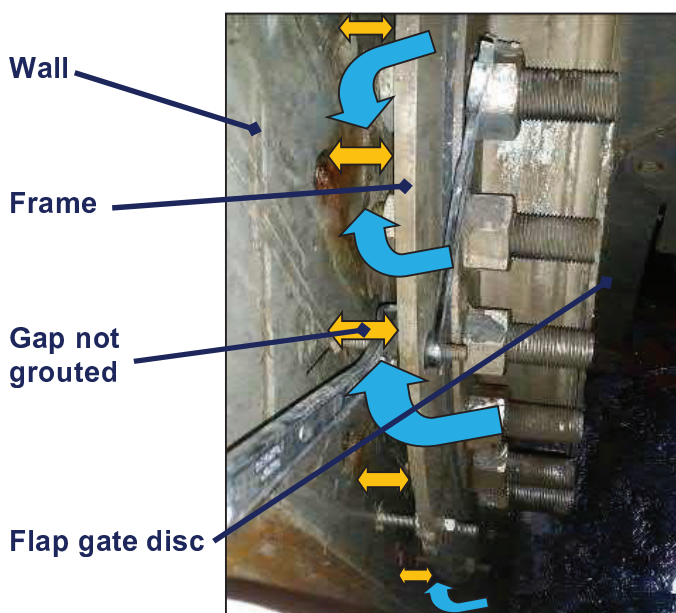
Situation: The original flap gate installation works was not properly completed. The frame was not grouted on the wall as it should be; leaving a couple inches gap all around the frame circumference thus creating heavy leakage. *Refer to pictures below.*

Water is bypassing the flap gate

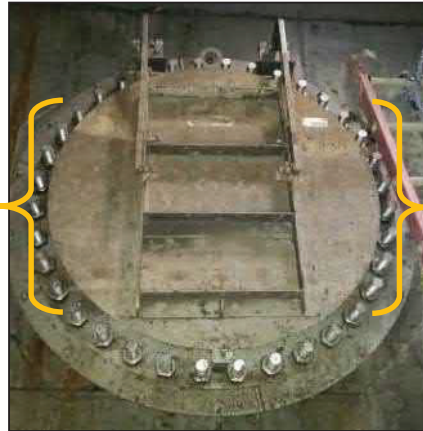
+/-2mm gap sections

Recommendations: Since the frame was not grouted yet, we have taken this “opportunity” to perform our self the required frame adjustment during this inspection. We loosen the front nuts and restraighten the frame using the backing nuts of the frame anchors. We were able to closed the gaps between the disc and the seal fairly easily. The frame is now ready to be poured. *Refer to picture below.*

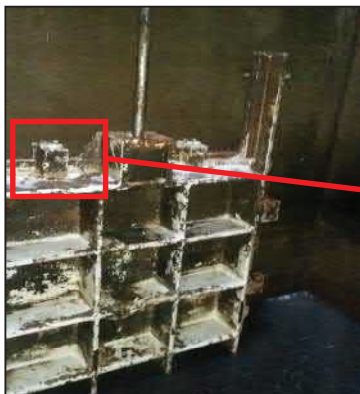
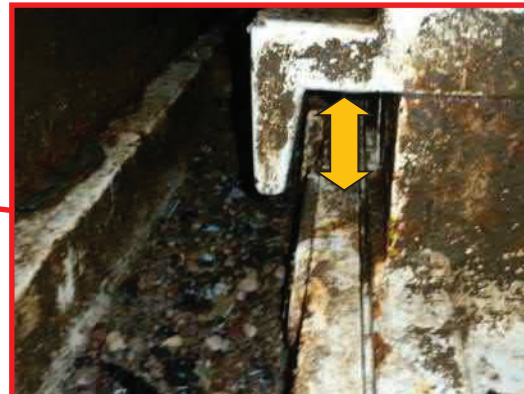
ARMCO sluice gate

Situation: The gate was automatically stopping at 75mm before reaching it full close position. After looking deeper into the actuator settings, we noticed that the full close limit switch was not properly adjusted. Therefore, this gate was heavily leaking due to this situation. Otherwise, this sluice gate is generally in good condition. Refer to pictures below.

Full close wedges at 75mm away

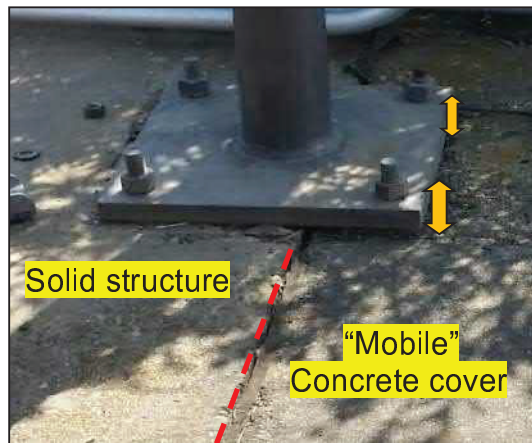
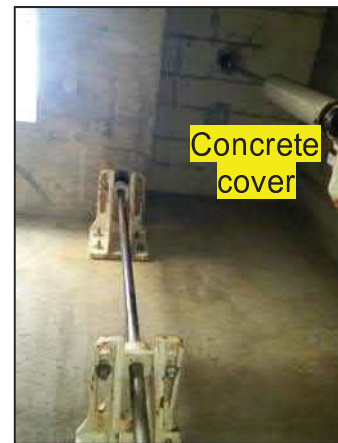
The pedestal is moving to the left because the cover is moving upward when closing the sluice gate

Operating stem and guides view from underneath

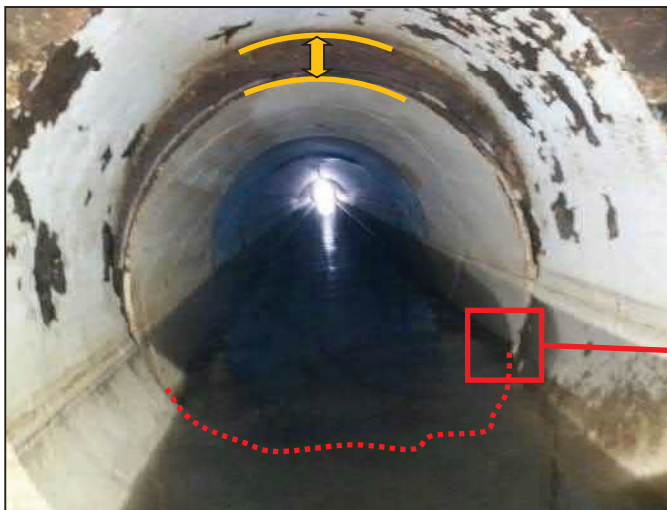
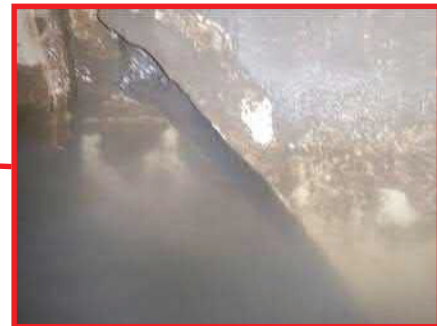
Situation: This ARMCO sluice gate is bolted directly against a “wall timble”. A wall timble is a heavy-duty frame embedded in the concrete wall with the female thread bolt pattern that is matching with the sluice gate. The gate itself has a square opening but the outfall pipe is round. The downstream side of the wall timble is design to match with the outfall pipe diameter. However, we noticed that the junction of the wall timble and the outfall pipe is broken at the bottom section. We suspect that the outfall pipe has moved downward but since the wall timble was strongly poured in the concrete wall it could not follow so it has broken at the bottom section. Also, we can see that the soil is coming out from erosion at the broken junction thus it may create supporting issues in the future. Refer to pictures below.

View inside the outfall pipe

Wall timble broken section

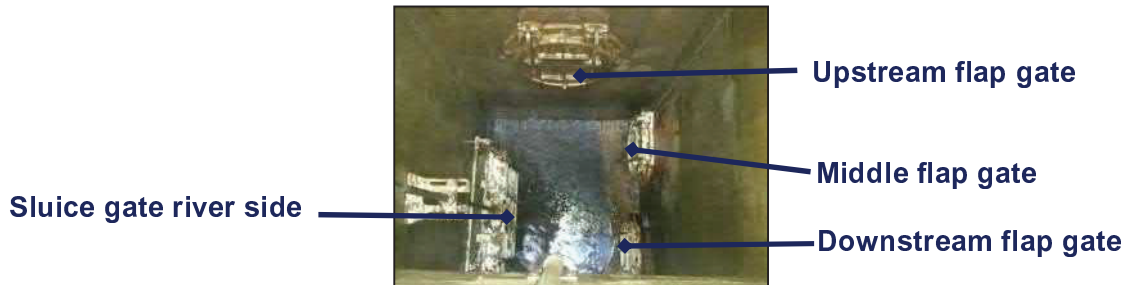
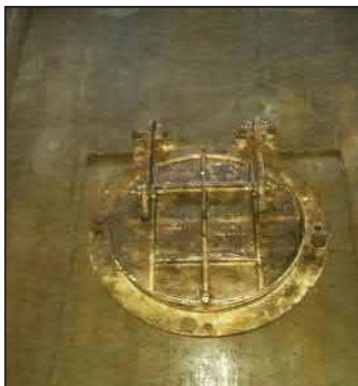
Situation: Since we were inside the outfall chamber, we took a quick look at the 3 ARMCO flap gates installed inside it. Those are all in good working condition without damages on the disc, hinges nor the frames. However, the anchor bolts are in steel and slightly corroded. Also, one anchor is loose on the middle flap gate that will need to be repaired or replaced. Refer to pictures below.
