Anzac Community Centre

Building Envelope & Mould Remediation
Report; Addendum 1

May 17, 2018

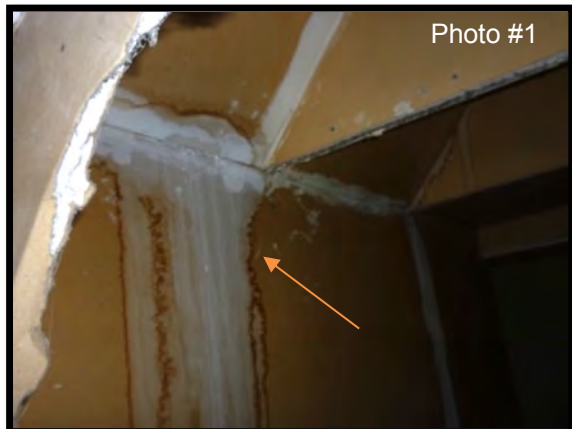
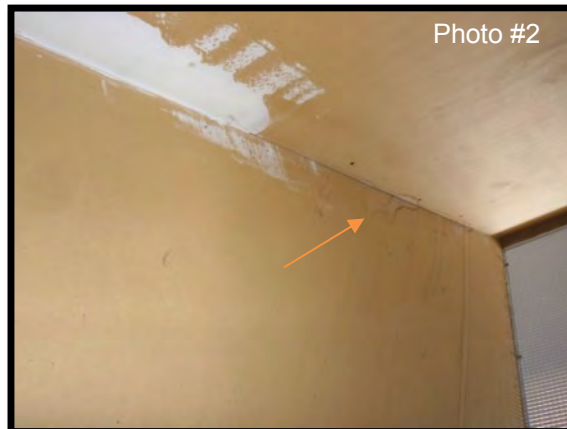
5.1 TOWER/SKYLIGHT AREA

Water damage was observed on the drywall within the access area for the tower/skylight situated in the attic

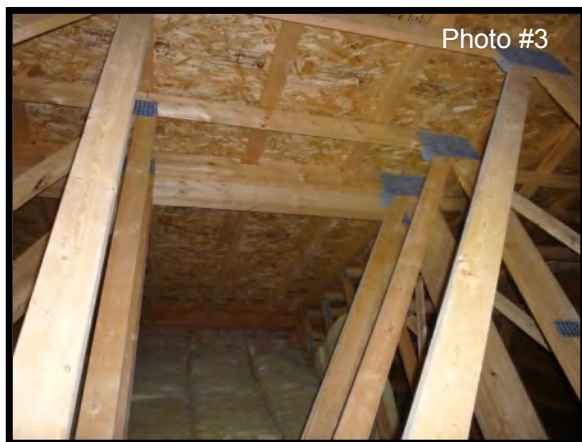
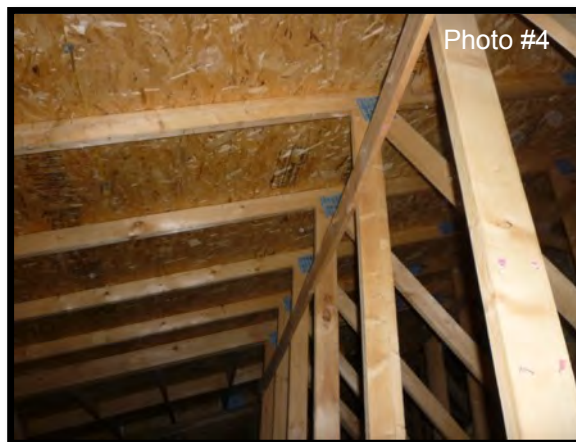
In most areas the trusses and underside of the roof sheeting appear to be in generally good structural condition

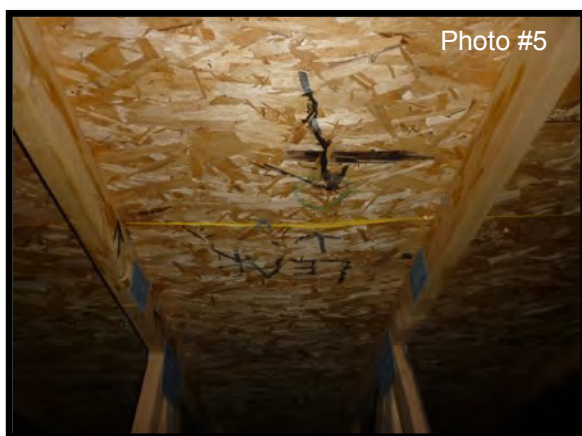
Areas where water infiltration had caused damage to the attic sheeting had been previously labeled

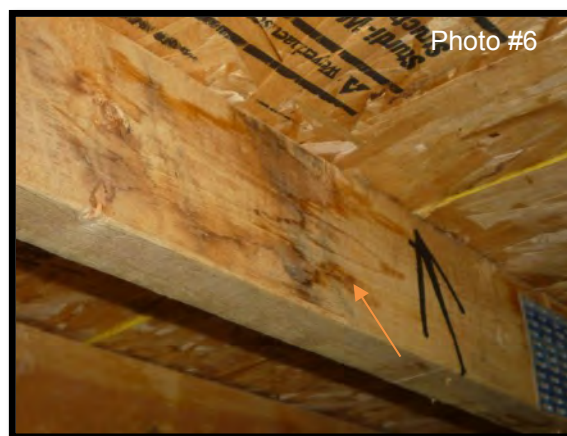
Localized areas of water staining and suspected fungal amplification are present where leakage was labeled

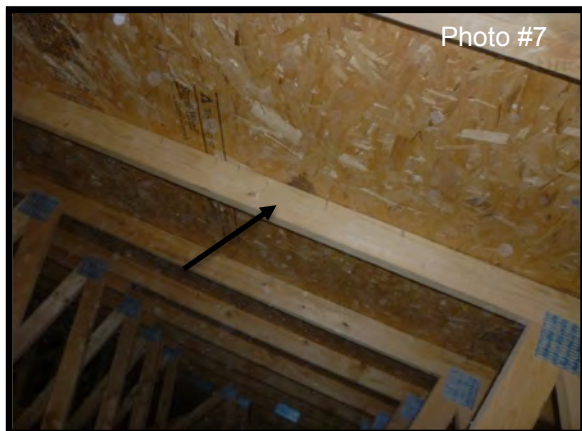
Additional photo showing a localized water stain on the underside of the roof sheathing

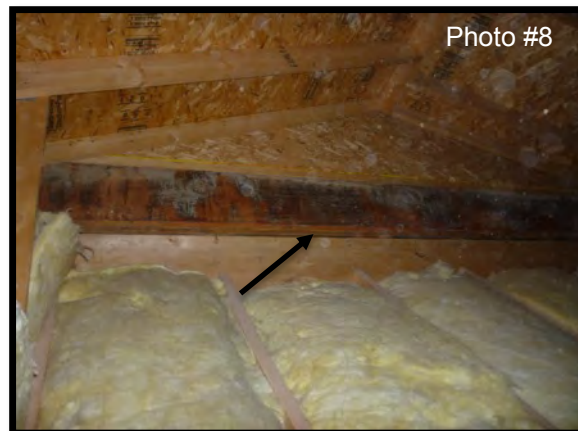
Mould growth was observed on a glulam beam adjacent to the skylight/tower

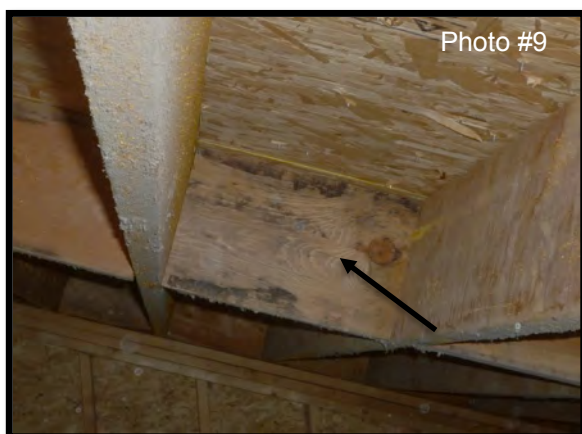
Mould growth was noted on several cross members above the hall area

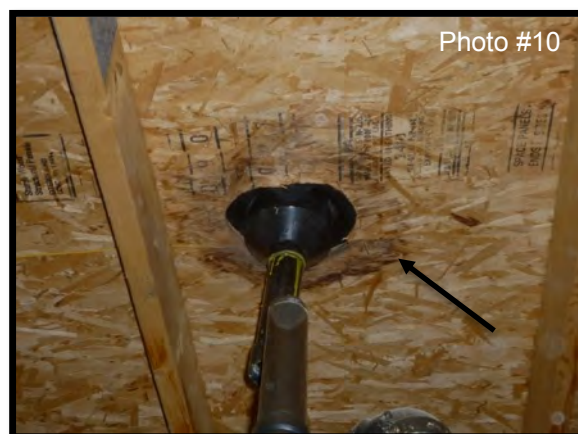
Water damage on the roof sheathing around a plumbing stack situated above the hall area bathrooms

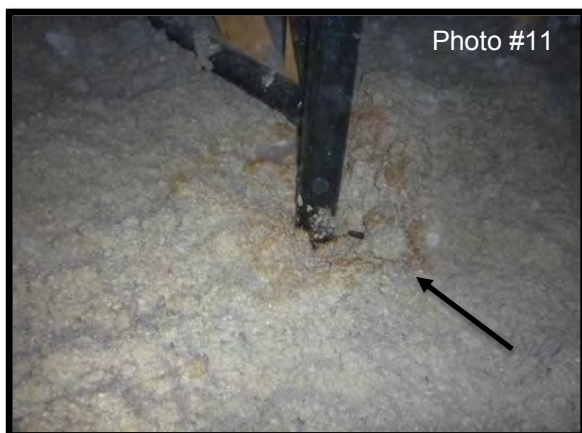
Leakage from around the plumbing stacks had caused water damage and compaction of the attic insulation

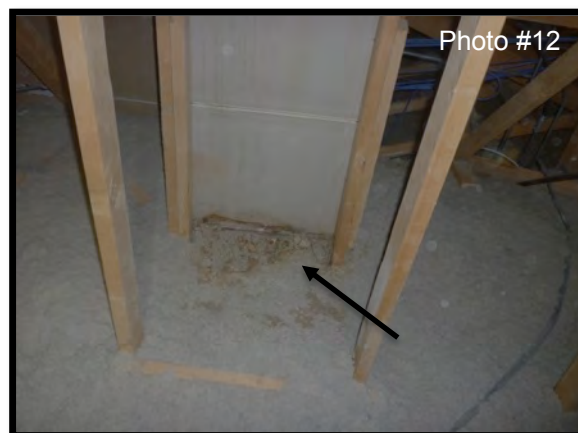
Water stained insulation and drywall within the attic adjacent to the access hatch in Janitor's Room 118

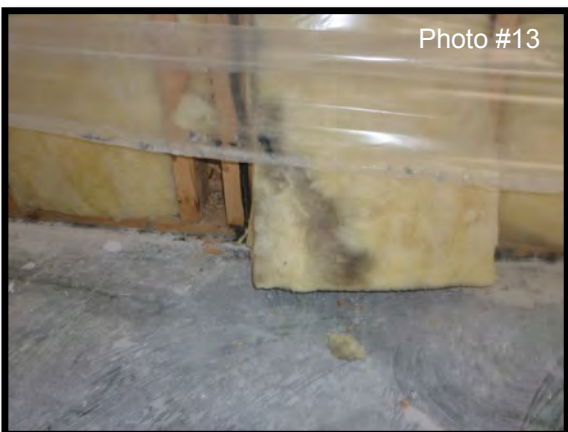
Staining was noted on the exterior wall insulation throughout the facility

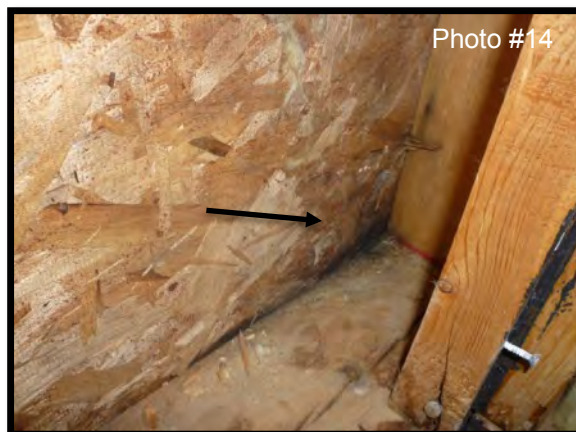
Mould growth was confirmed on the exterior OSB sheathing throughout the perimeter of the facility

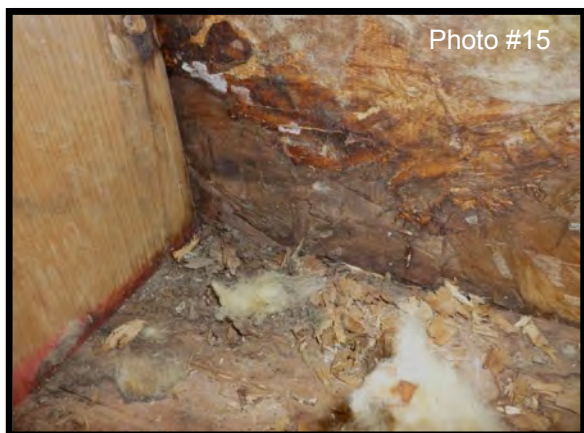
In several areas, the exterior OSB sheathing was heavily damaged

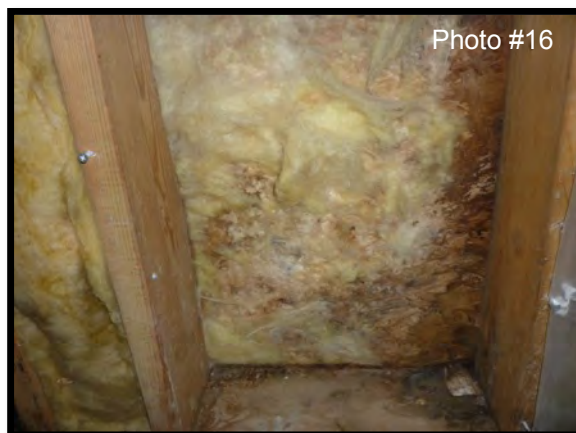
Additional photo showing mould growth and damage on the exterior OSB sheathing

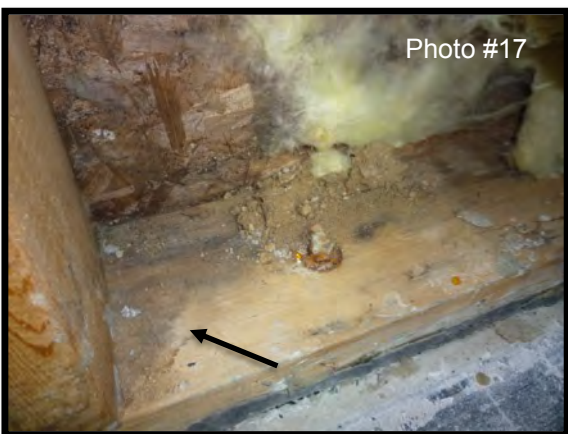
The exterior baseplates had visible water staining and mould growth in several areas

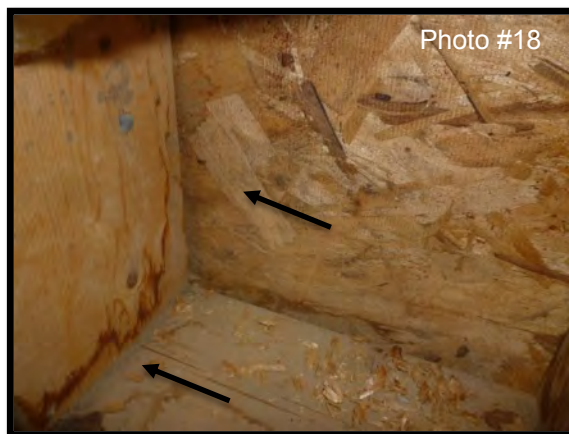
Additional photo showing water stains on a vertical wall stud and fungal amplification on the OSB sheathing

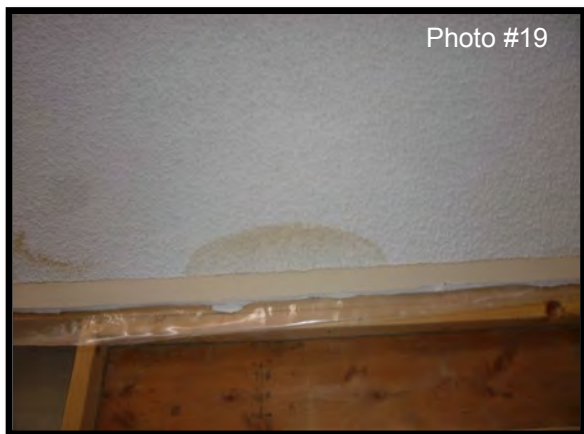
Water staining was observed on the ceiling in the lobby area. Trace amounts of mould growth were confirmed

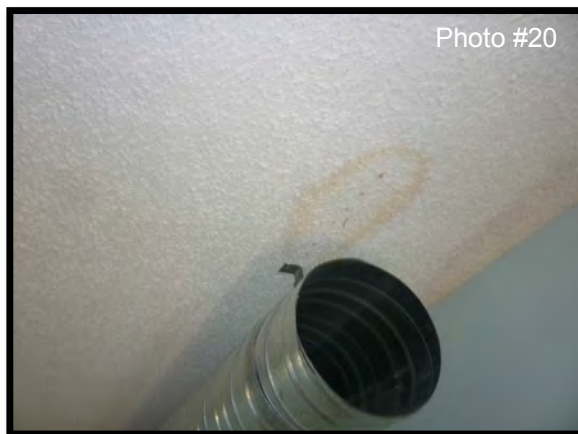
Water staining was also noted on the ceiling in Office RM 124

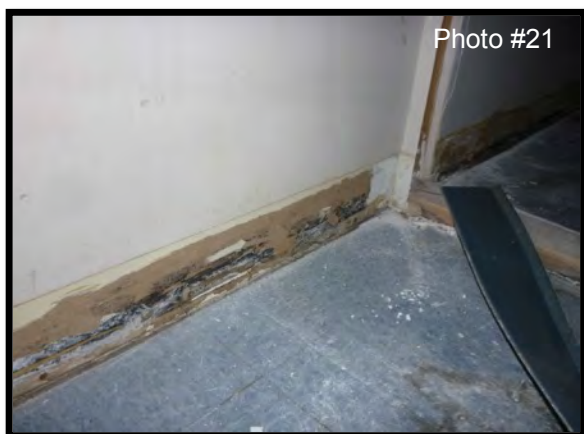
Mould growth was noted on the bottom of the walls in the janitors room (RM 115)

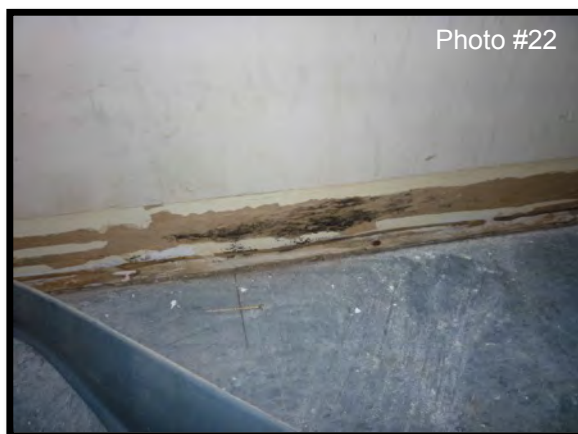
Mould growth was also evident on the bottom of interior walls within the health room, the office bathrooms, and the boardroom

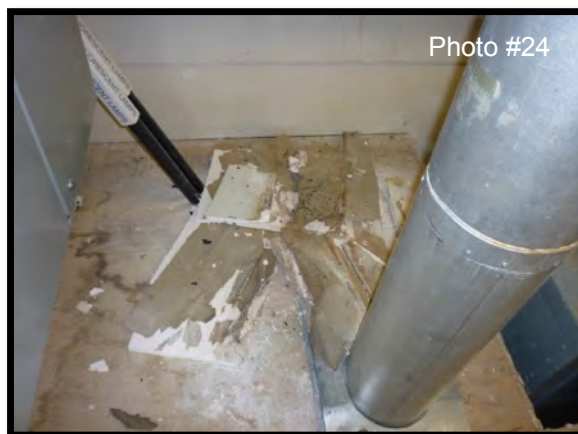
Mould growth and water damage were evident on the ceiling in the mezzanine of Mechanical Room 122

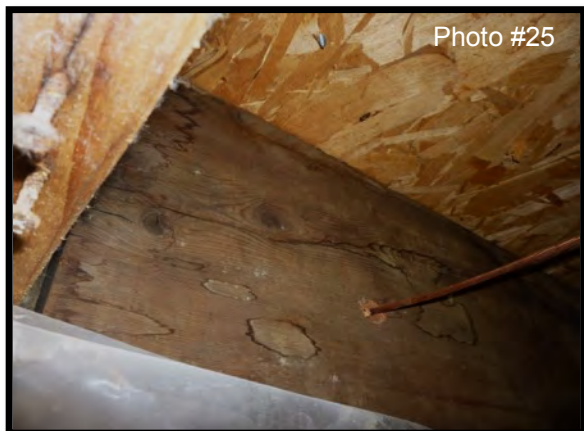
Water staining was observed on a beam in the ceiling cavity above the mezzanine of Mechanical Room 122

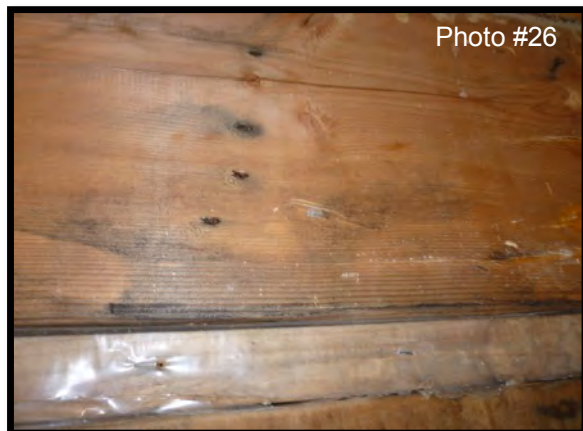
Mould growth on a door header outside Rink Hall
Mechanical Room 114

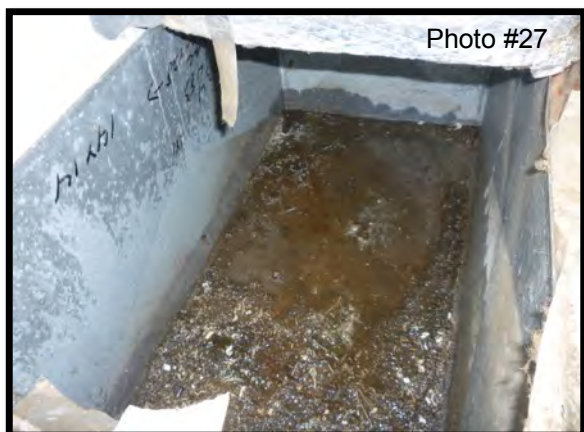
Water pooling and debris were noted in the basin underneath the combustion air duct in Mech. Rm. 114

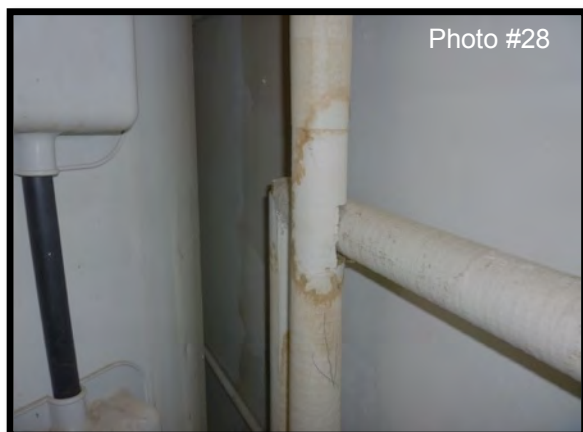
Water staining was noted on the pipe insulation covering in several areas

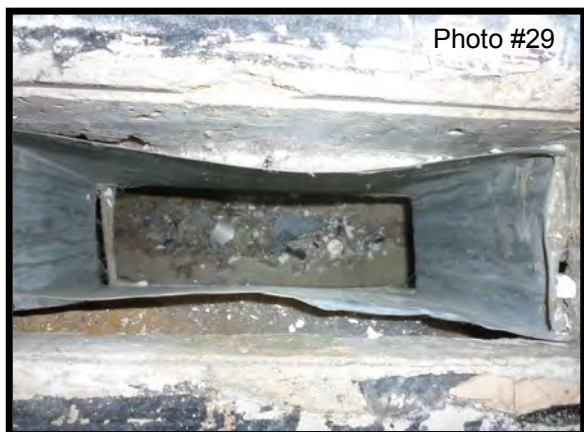
Debris was observed in the in ground supply air ducts.
Water pooling inside the ducts is a known concern

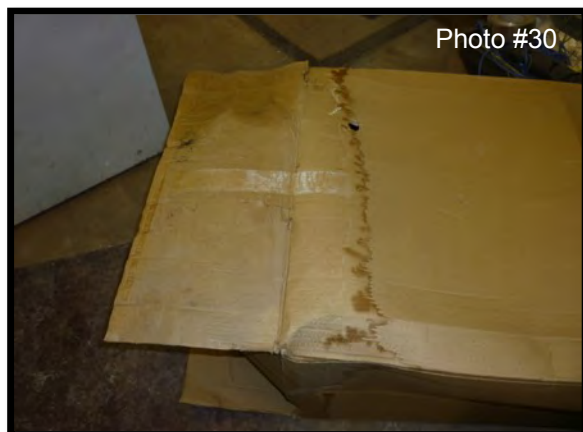
Water staining was noted on stored items within Mech.
Rm. 114

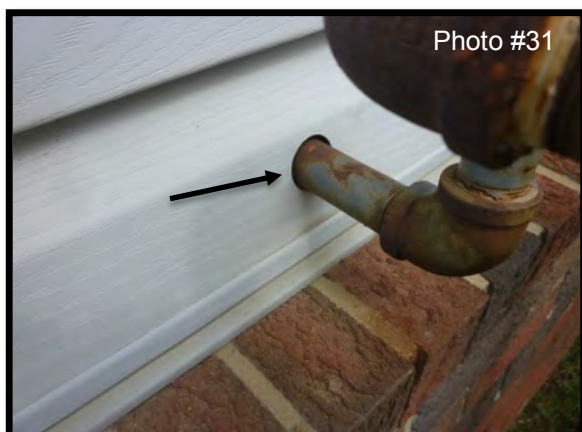
Multiple unsealed penetrations in the exterior siding were noted

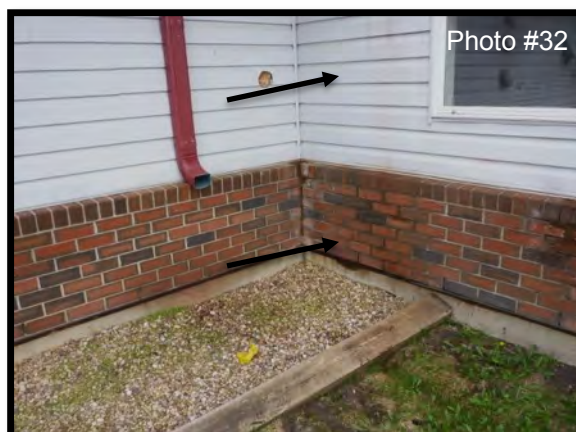
Heavy water staining was noted on the exterior siding and brick cladding in several areas.

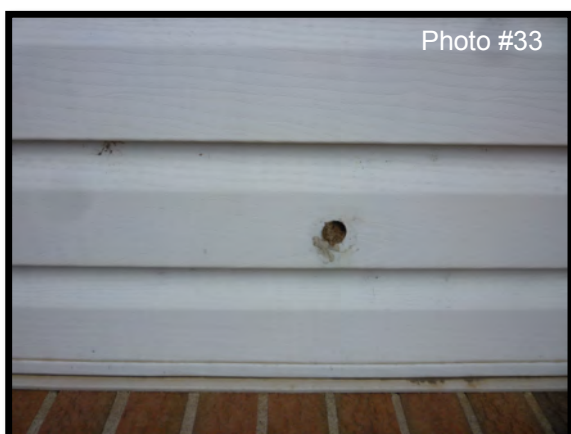
Additional photo showing an unsealed penetration in the exterior siding

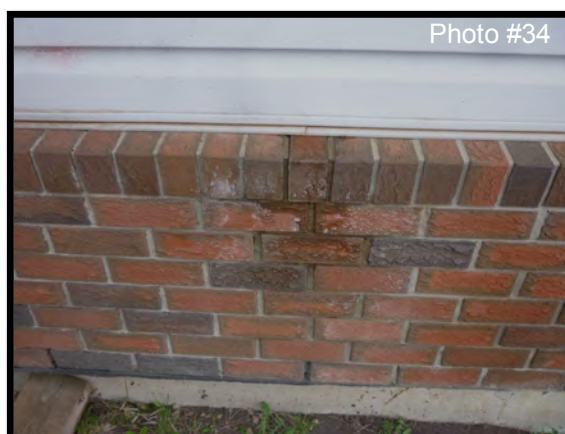
Additional photo showing water staining on the exterior brick cladding

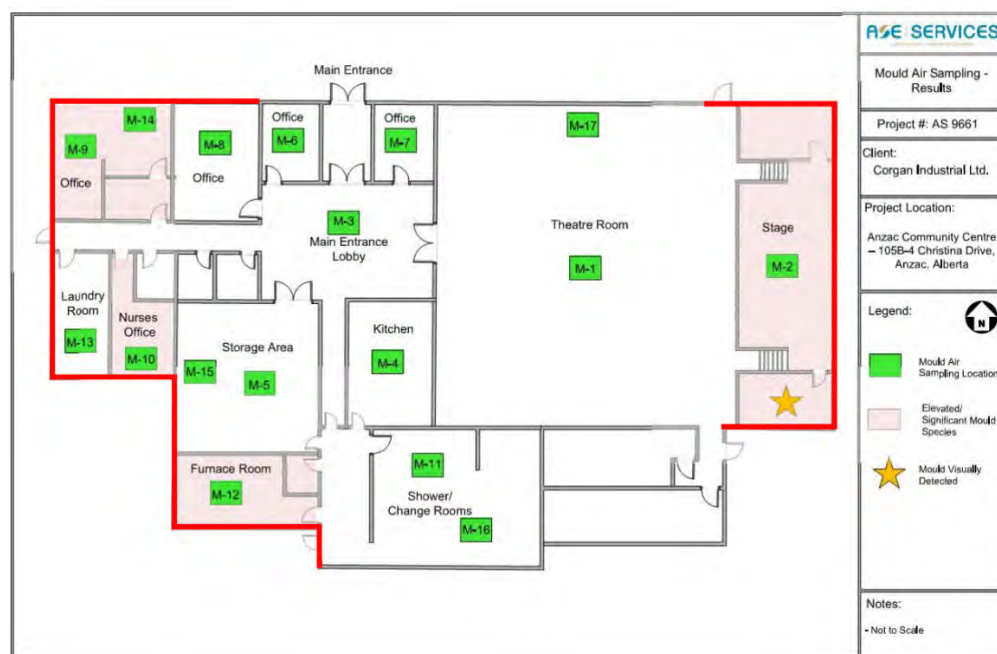
Image 1: Alberta Safety and Environmental Services Mould Locations

Stantec agrees with Alberta Safety and Environmental Services recommendation that these areas will need to be inspected and properly remediated. For proper identification of hazardous materials, it is recommended a qualified testing agency is hired to do destructive analysis and testing. Once the scope of the hazardous materials is determined a professional abatement contractor should be engaged to remove all the hazards. All potential and confirmed mould and water damaged materials should be properly remediated following the appropriate high, moderate, or low risk procedures as outlined in Government of Alberta – Best Practices Mould at the Work Site. Following the removal of all hazardous materials, final air sampling should be conducted to ensure the building is safe for re-occupancy.

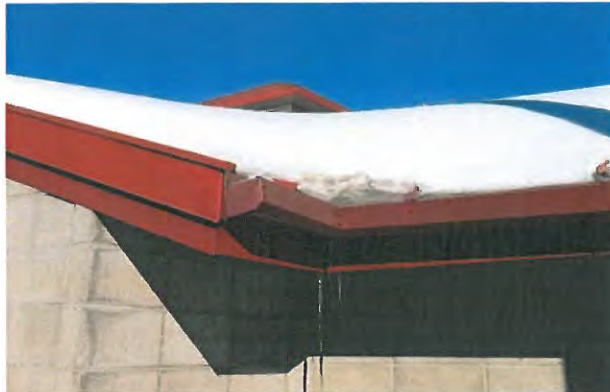
- Significant ice damming was observed on roof areas above the main washrooms (Photo 3), the rink hall entrance (Photo 4), and the nurse's office (Photo 5). Ice damming occurs when the underside of the snow cover melts as a result of exposure to a heat source. Heat sources can be from heat loss in the attic space or the surface of the metal roof due solar heat gain. When the melted water flows over colder sections of the roof and eavestrough, ice formations occur. Ice damming can be minimized by keeping the attic space cold, but this can be impeded by leakage of warm air into the attic, heat loss from uninsulated ducts and pipes, heat loss through the attic insulation and insufficient ventilation in the attic. Comments and observations from our review of the attic are included in Section 3.3 of this report. Attic ventilation is achieved through vented soffits and roof vents; however, no roof vents were visible on the roof at the time of our review. We also could not confirm if there were any ridge vents at the peaks of the metal roof. We recommend further review to assess how the roof is vented.

Photo 3: Ice damming above southwest washrooms

- As a result of ice damming, visible damage has occurred to the eavestroughs (Photos 3 to 5). Snow guards can help reduce the risk of this damage by preventing snow and ice from sliding off the roof. The roof also appears to have been patched above the nurse's office (Photo 5). Roof repairs including new snow guards and eavestroughs are recommended. Heat tracing eavestroughs and downspouts could also be considered.

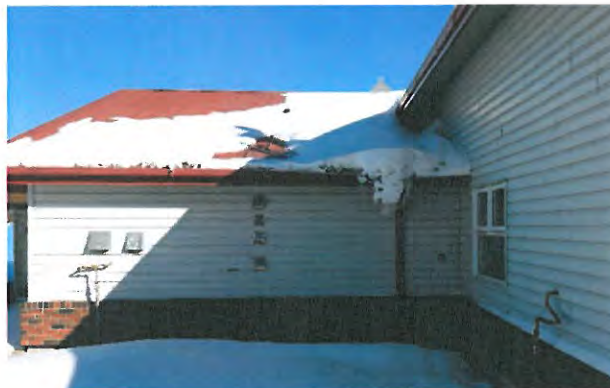
Photo 5: Ice damming above nurse's office

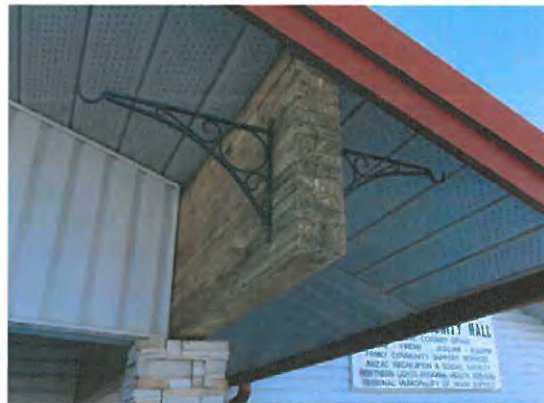
- Roof canopies above the main building entrances are supported by exposed glulam beams, which are supported by exterior columns and the exterior wall (Photo 6). Thermal scans of the exterior walls at the beam connections found noticeable heat loss due to thermal bridging through the wood framing (Image 1, Photo 7). Air leakage was also detected at some of these locations (Image 2, Photo 8). In addition to air vapour barrier repairs, we recommend adding insulation to either the beams or exterior walls to reduce the amount of heat loss at the beam connections.

Photo 6: Exposed end of typical glulam beam

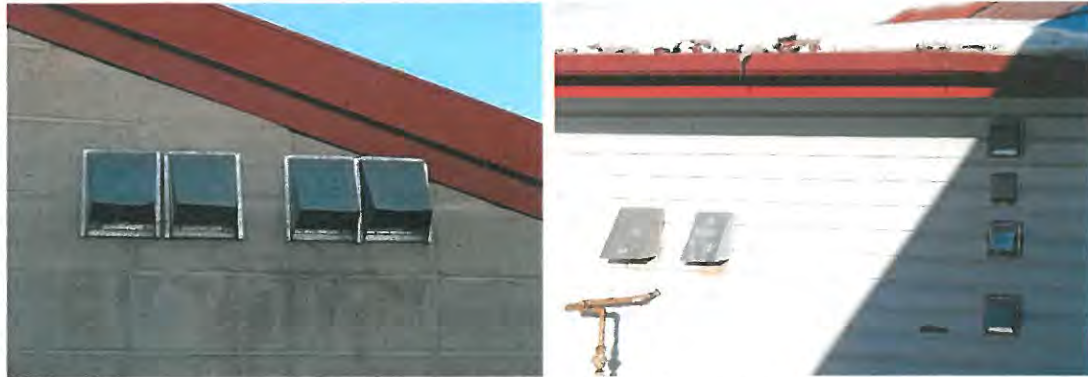
- Wall-mounted exhaust vents appear to be poorly detailed, with top flanges reverse lapped over cladding and fascia (Photos 9 and 10). It is our understanding the exterior walls will be re-clad as part of the renovation project, at which time we anticipate the vents will be re-detailed.

Photos 9 and 10: Reverse lapped vent covers

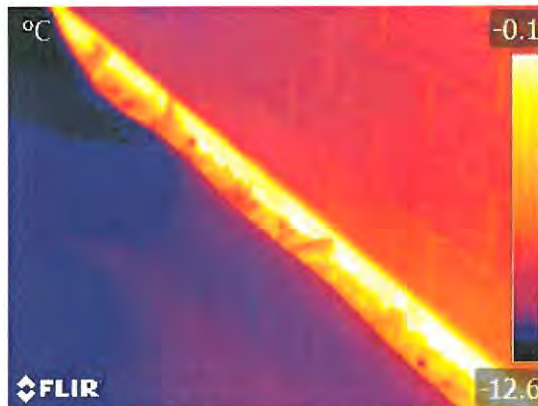
- Thermal scans of the exterior walls found noticeable heat loss through the exposed concrete foundation (Image 3, Photo 11). This appears to be due to thermal bridging through the uninsulated concrete. We recommend adding exterior insulation to reduce the thermal bridging at these locations.

Image 3: Heat loss through exposed concrete

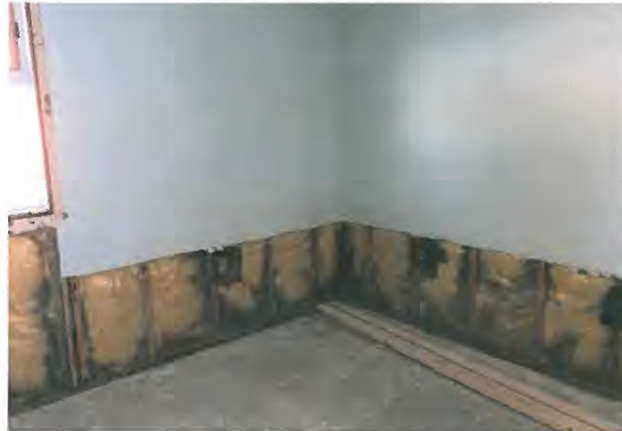
Photo 12: Stained insulation in north office

We recommend testing of interior finishes for mould growth and subsequent remedial work as required including, but not limited to replacement of interior gypsum board and stained batt insulation, and resealing of the polyethylene sheet vapour barrier at penetrations and wall-to-floor junctions with acoustical sealant. Alternatively, the polyethylene sheet vapour barrier and batt insulation could be replaced with closed cell spray-applied air barrier/vapour retarder insulating urethane foam, or it could be completely removed if an exterior air vapour barrier and insulation is provided when the building is re-clad.

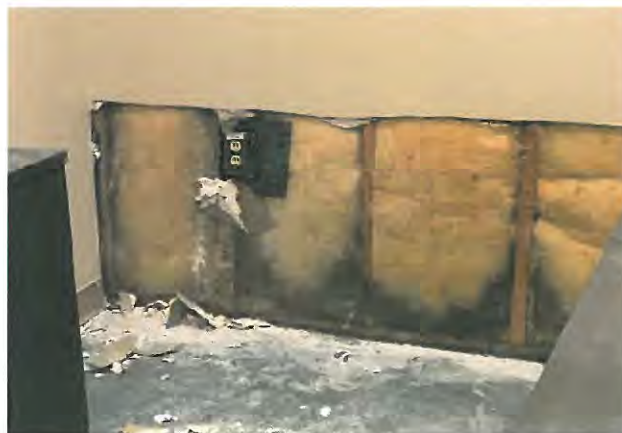
Photo 13: Stained insulation in nurse's office

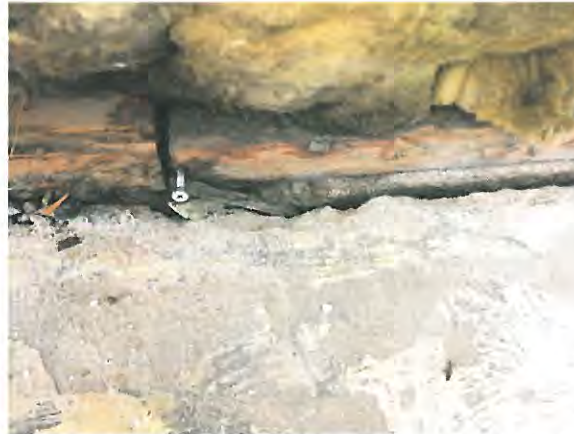
- A joint was observed between the interior floor slab and concrete grade beam (Photo 14 by Stantec). This appears to be a construction joint and it is likely separated due to movement of the slab. It is our understanding the site experiences periodic flooding, which can cause underlying soils to swell and push up on the slab. We anticipate that there is no reinforcement between the slab and grade beam, likely to allow for movement of the slab caused by movement of the soil. The joint could be filled with a sealant or grout to fill the void, however, on-going movement may still occur, which could lead to further separation of the joint.

Photo 14: Joint between interior slab and grade beam under typical exterior wall

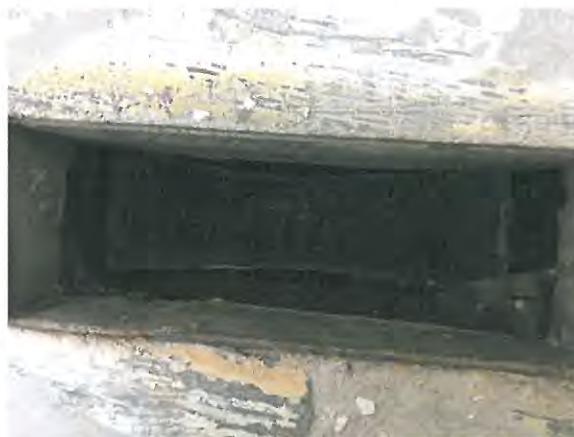
Photo 15: Separated duct at slab penetration

- The cause of the flooding is not known at this time; however, during the renovations, the perimeter grade on the exterior of the building should be sloped to provide drainage of surface water away from the building. Geotechnical review would be required to determine if there is a groundwater issue.
- The interior slab is also penetrated by heating ducts, which are located below the slab. It is our understanding these ducts are being abandoned. The abandoned ducts can be filled with concrete to provide a continuous concrete slab surface.

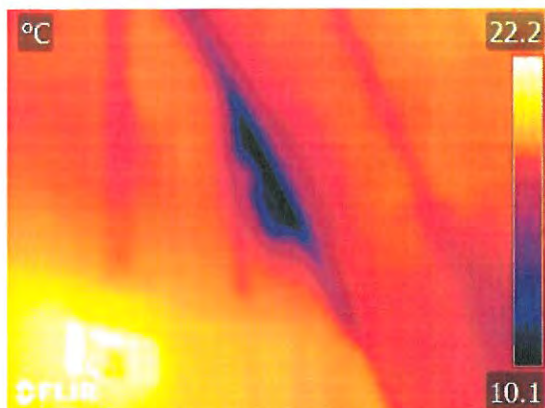
- Thermal scans of the interior found numerous cold spots in wall areas adjacent to unconditioned attic spaces (Images 4 to 9). At most locations, the cold spots were found to be locations of missing or fallen batt insulation. At one location between the kitchen and rink hall, a draft was also detected (Image 9, Photo 20). This was found to be due to a discontinuity in the vapour barrier between the kitchen ceiling and rink hall ceiling, which are located at different elevations (Photo 22). This air leakage may have also contributed to the previously noted moisture damage, which had occurred near Grid D11 (Photo 23).

Image 4: Cold spot in foyer/boardroom wall

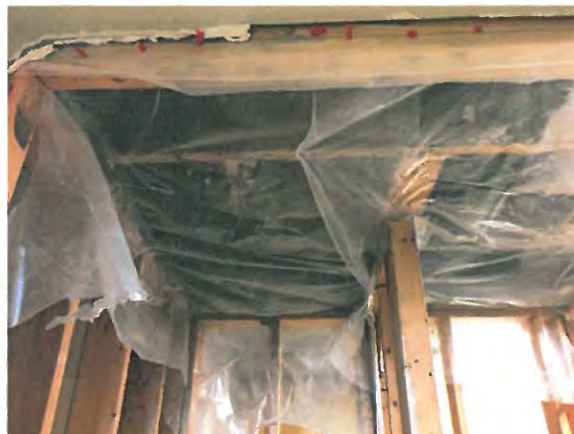
Photo 23: Location of moisture damaged ceiling near Grid D11 per A201

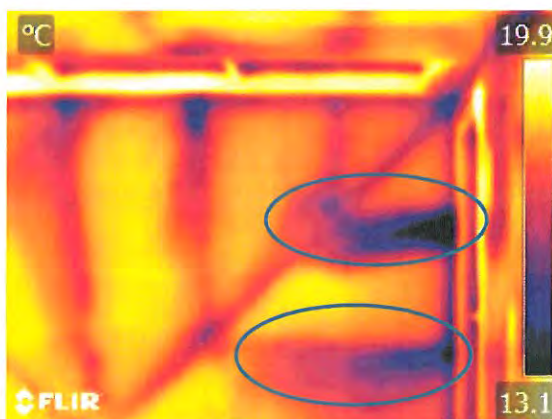
- Thermal scans of the upper walls and ceiling in the foyer identified several locations of increased heat loss (Images 10 and 11). There was no access to this ceiling space to confirm the cause of these thermal anomalies; however, we suspect it is similar to the thermal anomalies observed near the lower ceilings.

Image 10: Thermal anomalies in foyer ceiling

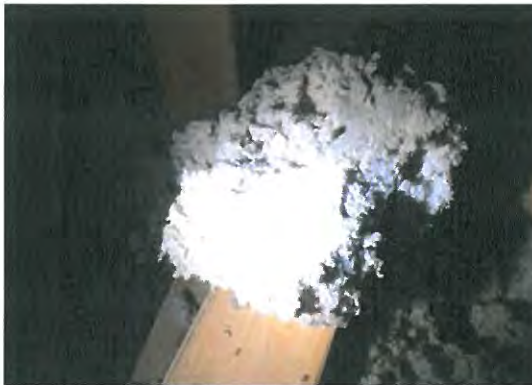
- The attic space above the lower ceiling levels is accessed by two access hatches located in the janitor's room and bar area (Figure 2). The attic hatches consist of an opening framed between the bottom chords of the roof trusses with an insulated wood box serving as the hatch cover. No access hatches are provided to access the ceiling spaces above the main hall and mezzanine (Area 2 in Figure 2); however, a previously made opening the hall ceiling (circled in Figure 2) indicated that this attic space was filled with approximately 6" of loose cellulose insulation with a large air space between the top of the insulate the roof. With the exception of the rink hall and the foyer ceiling/walls in Area 1, which are insulated with batt, all ceiling spaces appeared to be insulated with loose blown-in cellulose insulation. The thickness of this insulation was found to be between 6" and 8". It is difficult to determine what the original thickness would have been since it has been disturbed and has compressed over time from moisture accumulation in the attic (Photos 26 and 27).

Photo 27: Compressed attic insulation

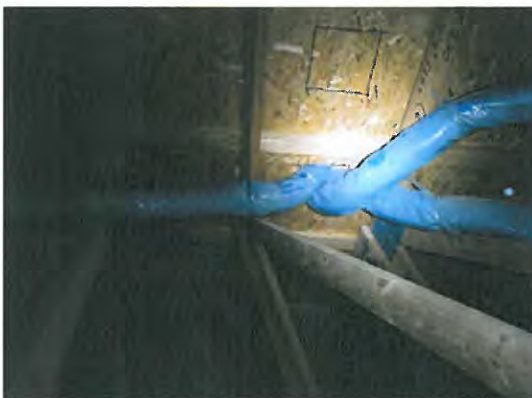
- Flexible insulated exhaust ducts are routed through the attic space to rooftop and wall-mounted vents (Photos 9 and 28). It is not good practice to route multiple ducts to one roof vent. It is also not good practice to run exhaust ducts horizontally through the attic space, as noted above the main washrooms (Photo 29). There is a risk of condensation and ice forming along these ducts where they sag, have excessive runs, or have bends or kinks that result in a reduction in the duct diameter. Ideally, these ducts should be routed directly up from the ceiling penetration to a roof vent.

Photo 28: Exhaust ducts terminating at roof vent

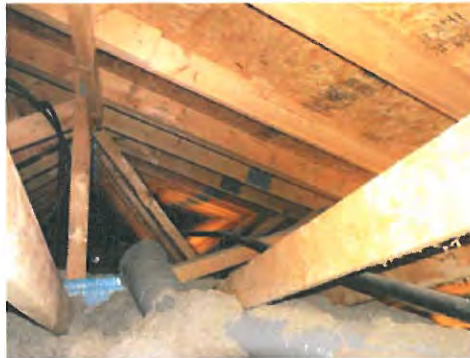
Photo 29: Duct running under insulation across attic floor

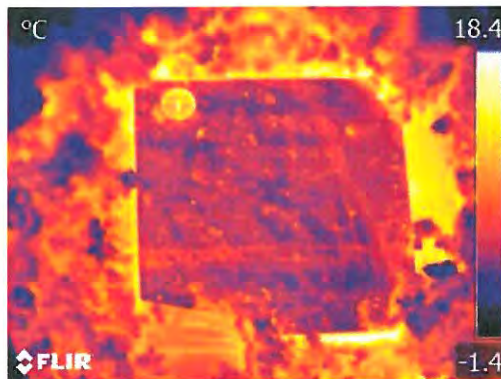
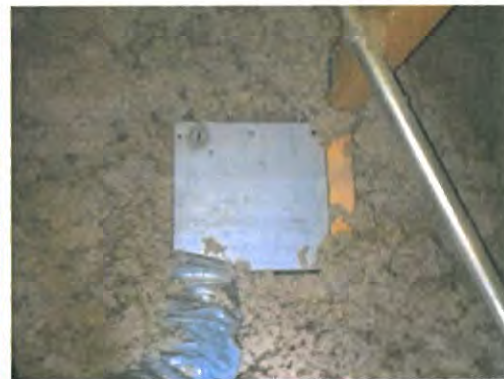
- The fans attached to these ducts were found to be uninsulated and unsealed (Image 12, Photo 30). Air leakage around the main washroom fans likely contributed to the moisture damage previously found in the in the ceiling near Grid D11. Heat loss through the uninsulated fan enclosures can also contribute to ice damming by increasing the air temperature in the attic. We therefore recommend that all exhaust fans be sealed and insulated. This usually involves installing a poly boot over the fan, and sealing it to the polyethylene vapour barrier and duct wrap.

Image 12: Thermal image of typical exhaust fan

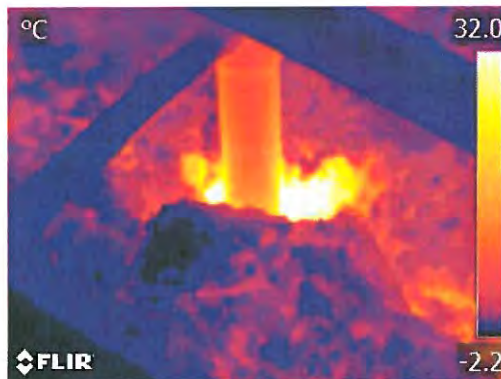
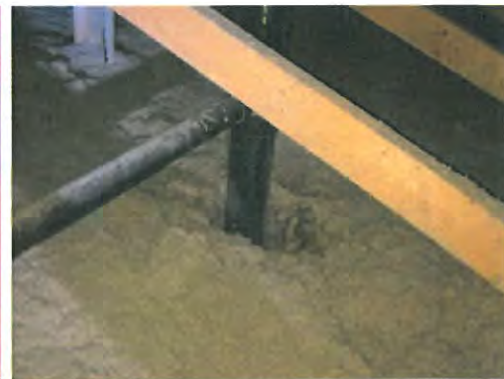
- Pipe vents are not insulated (Image 13, Photo 31). Heat loss from these pipes can also contribute to ice damming. We therefore recommend insulating them.

Image 13: Thermal image of an exhaust pipe

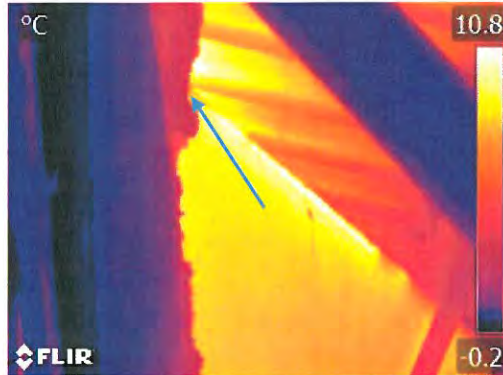
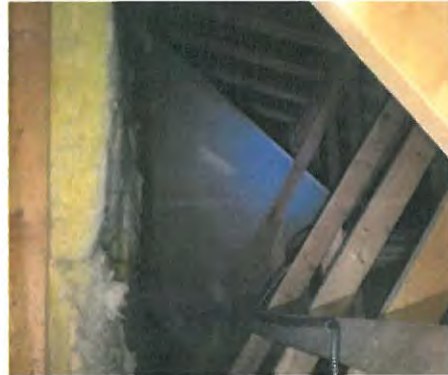
- Return air ducts from the foyer do not appear to be insulated (Image 14, Photo 32). Air leakage also appears to be occurring through the top of the duct penetration (see arrow on Image 14). Further review is recommended to determine if these ducts could be removed, or insulated and sealed.

Image 14: Thermal image of return air duct

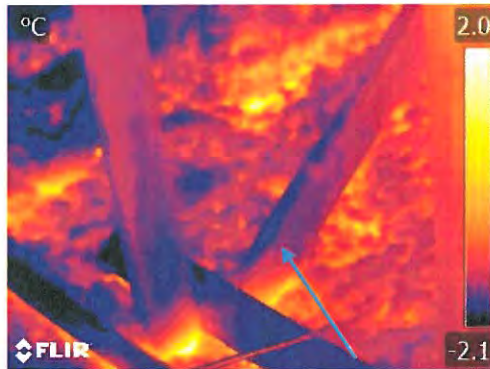
- Thermal scans also found numerous hot spots in the attic at low spots in the insulation, at transitions between interior walls and ceilings, and at electrical penetrations (Images 15 to 17). Most of the heat loss at these locations is due to insufficient insulation or thermal bridging; however, there may also be discontinuities in the vapour barrier, such as between the kitchen and rink hall. Further review would be required to confirm.

Image 15: Heat loss at low spots in insulation
