2020 Ice Jam Flood Event

Performance of Municipal Infrastructure

December 15, 2020

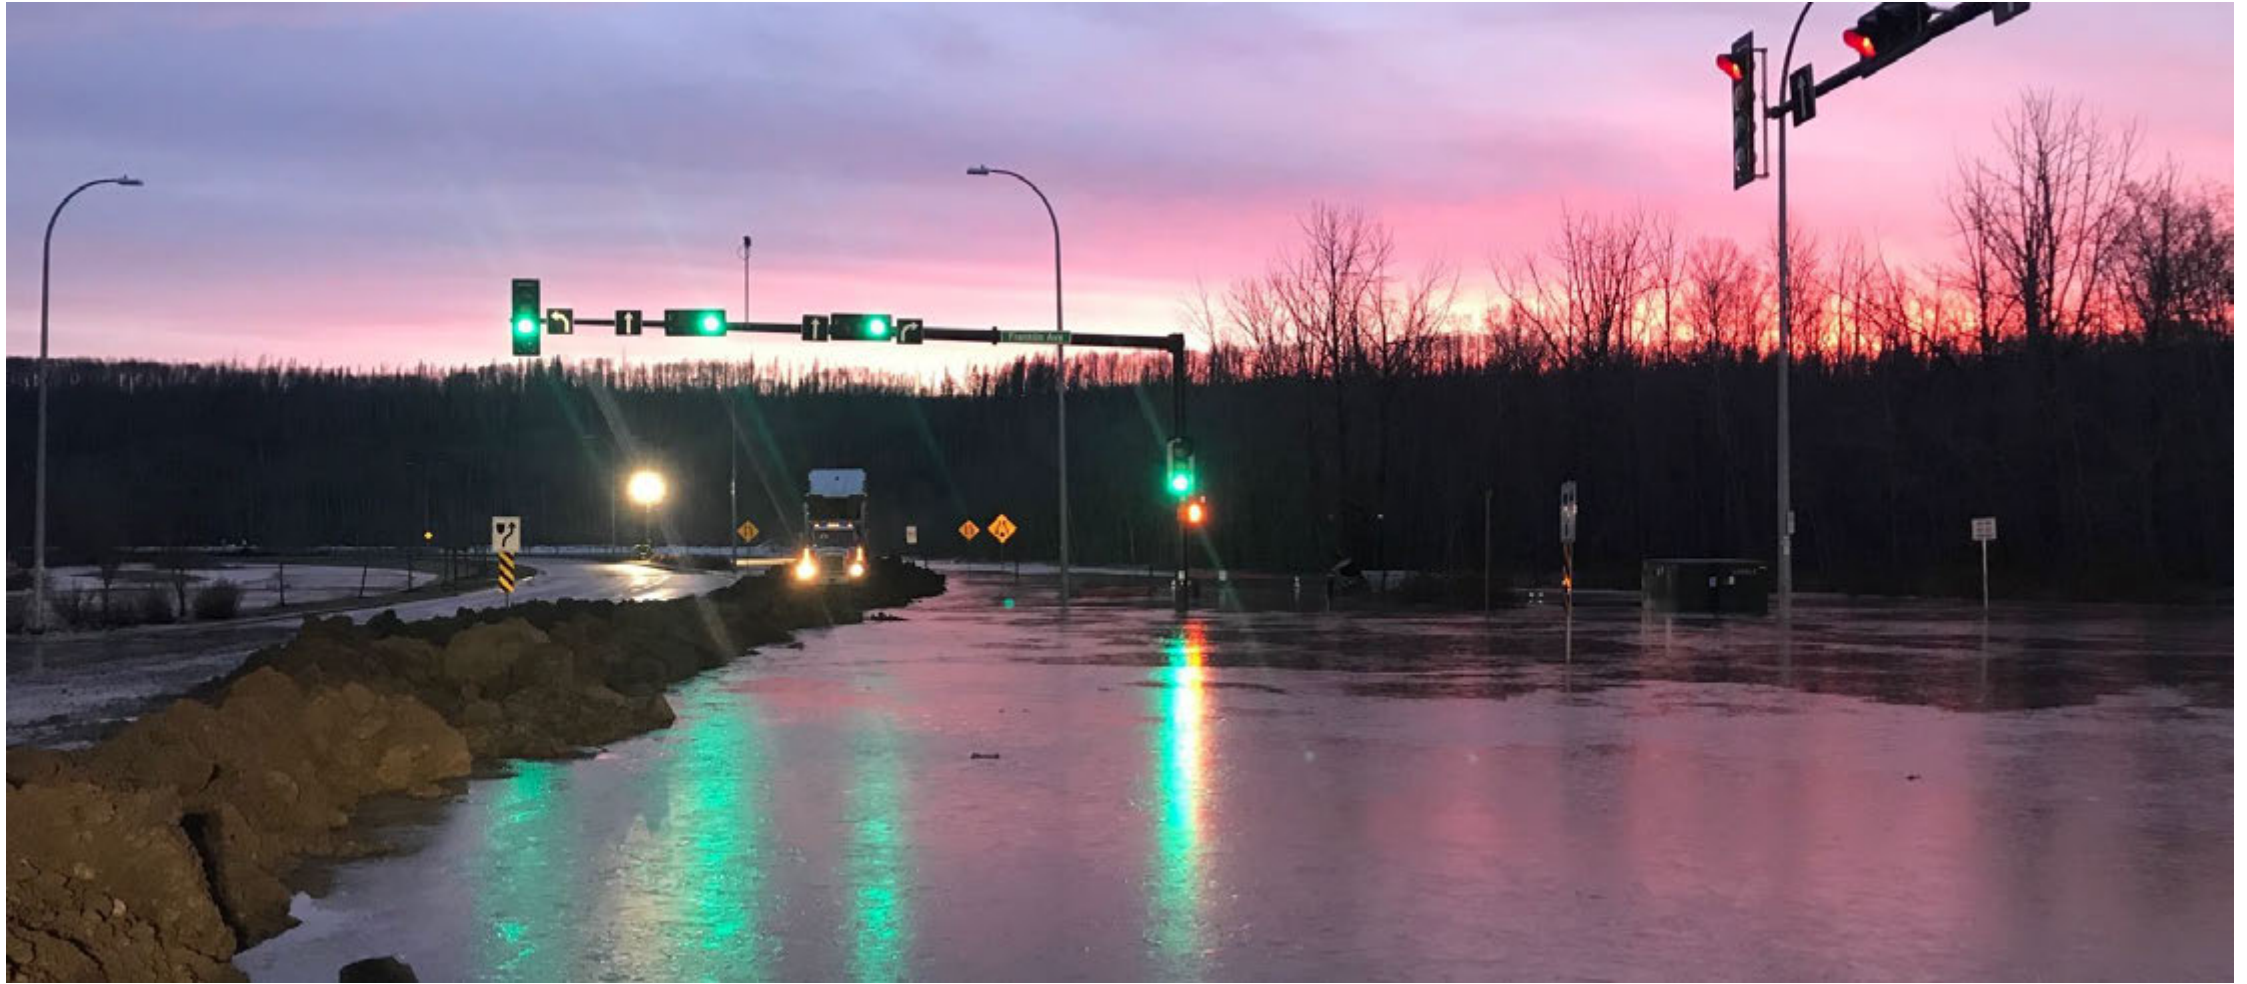
Emergency Dyke Construction CWD @ Franklin

- All of the emergency dykes successfully constructed EXCEPT for Riedel Street
- Emergency dykes were holding back ~1m of water
- Water still rising inside of the dykes
- At 1:30 pm April 27, emergency dyke construction abandoned due to rising waters and concern for worker safety

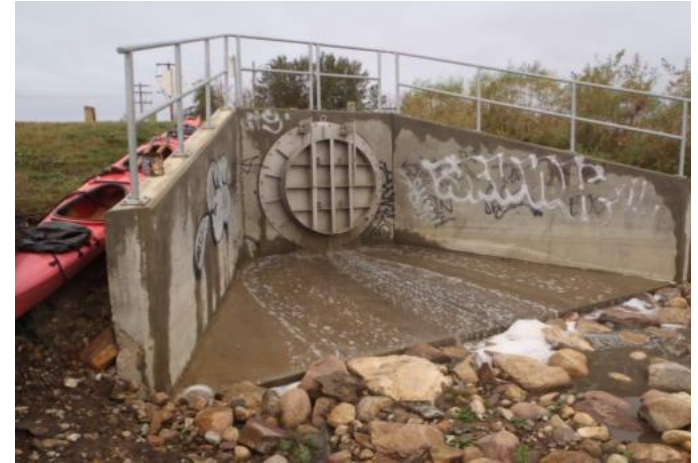
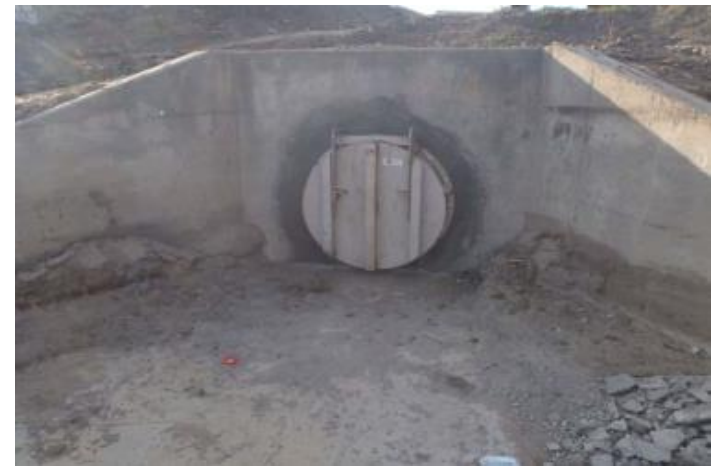
Storm Outfalls and Flapgates

- Storm sewers from Lower Townsite discharge directly to the river
- Outfalls include a flapgate, which opens to allow flow out, but closes to prevent backflow from the river.
- No evidence flap gates failed during 2020 flood

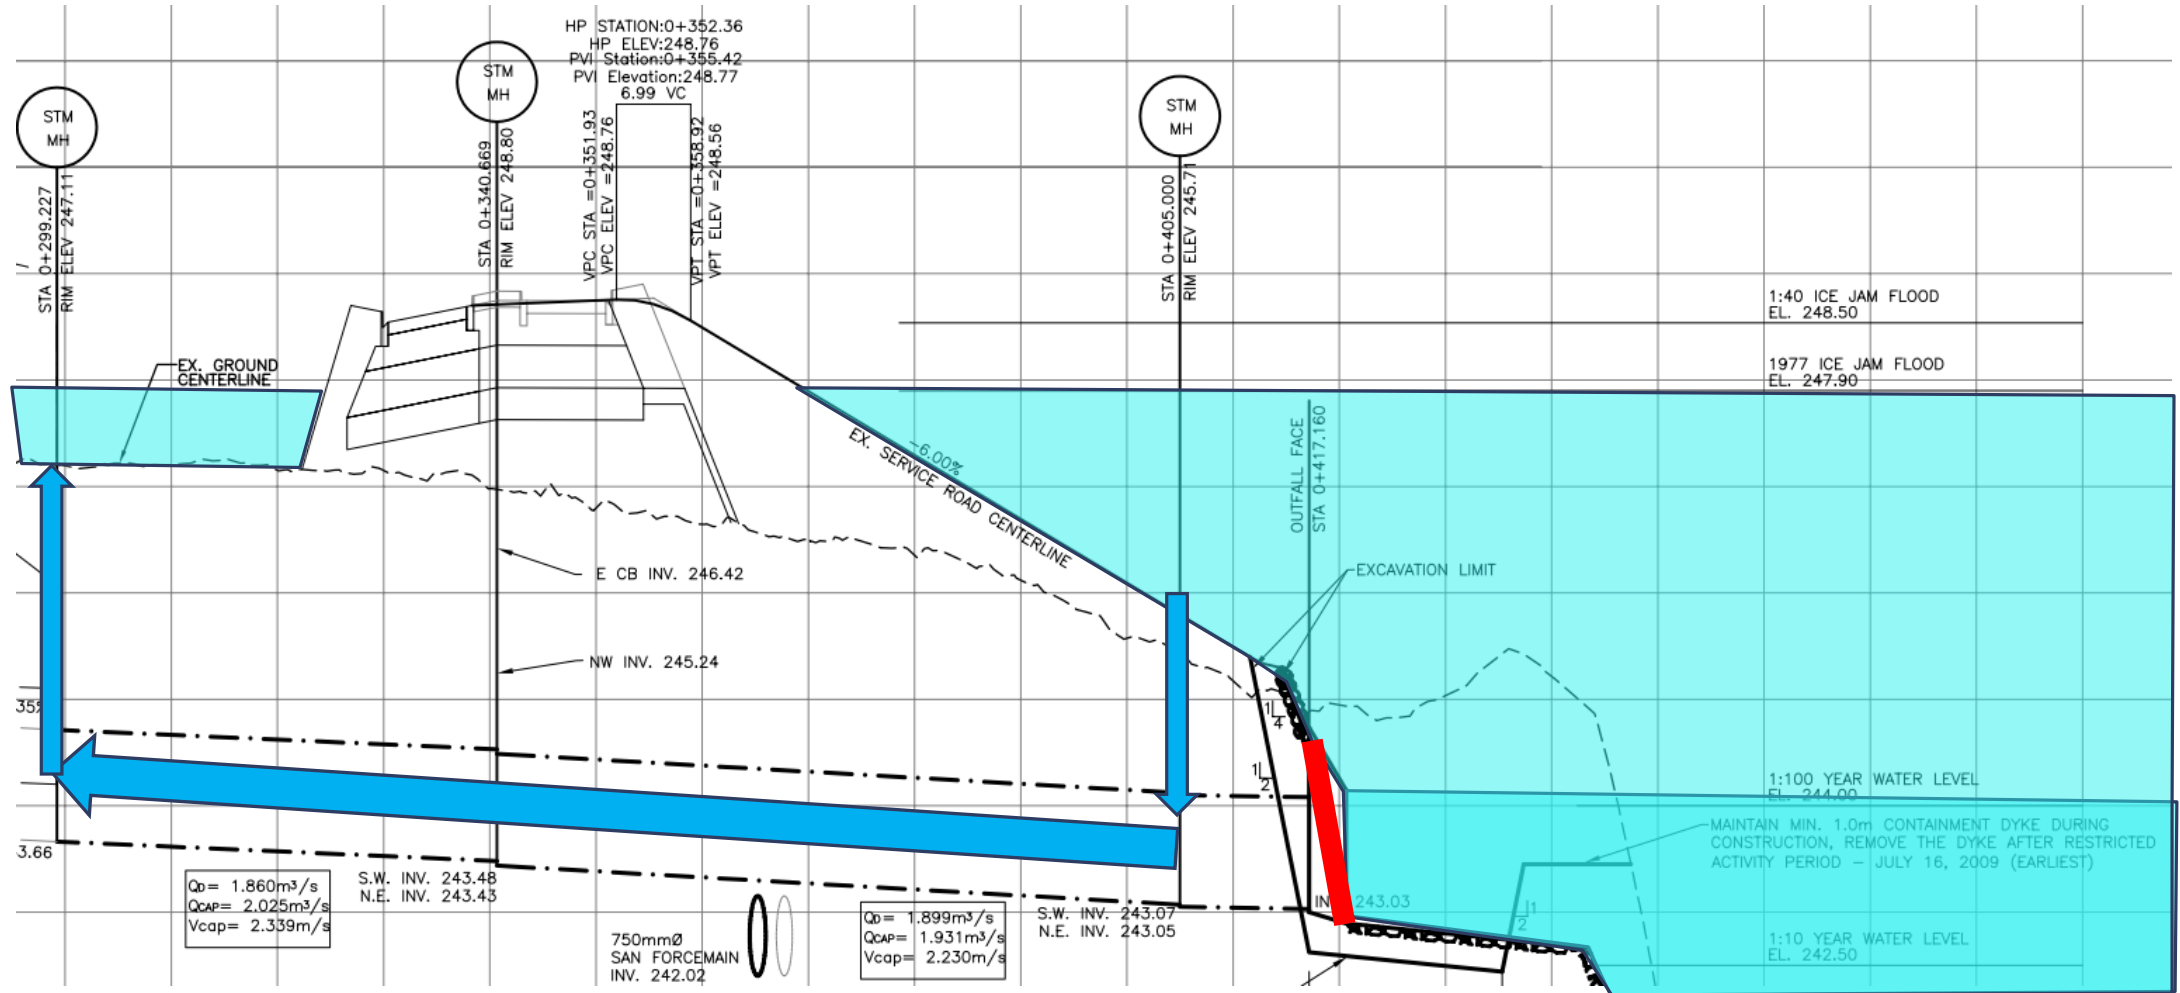
Underground Flooding Pathway Example

- Flood water was observed inside of the dykes before overland breaches occurred.
- Water continued to rise inside of dykes, despite emergency dyke construction.
- Underground pathways allowed water to bypass the flap gates flooding both the storm and sanitary sewers.
- Once inside the dyke system, water will keep flowing until equalization

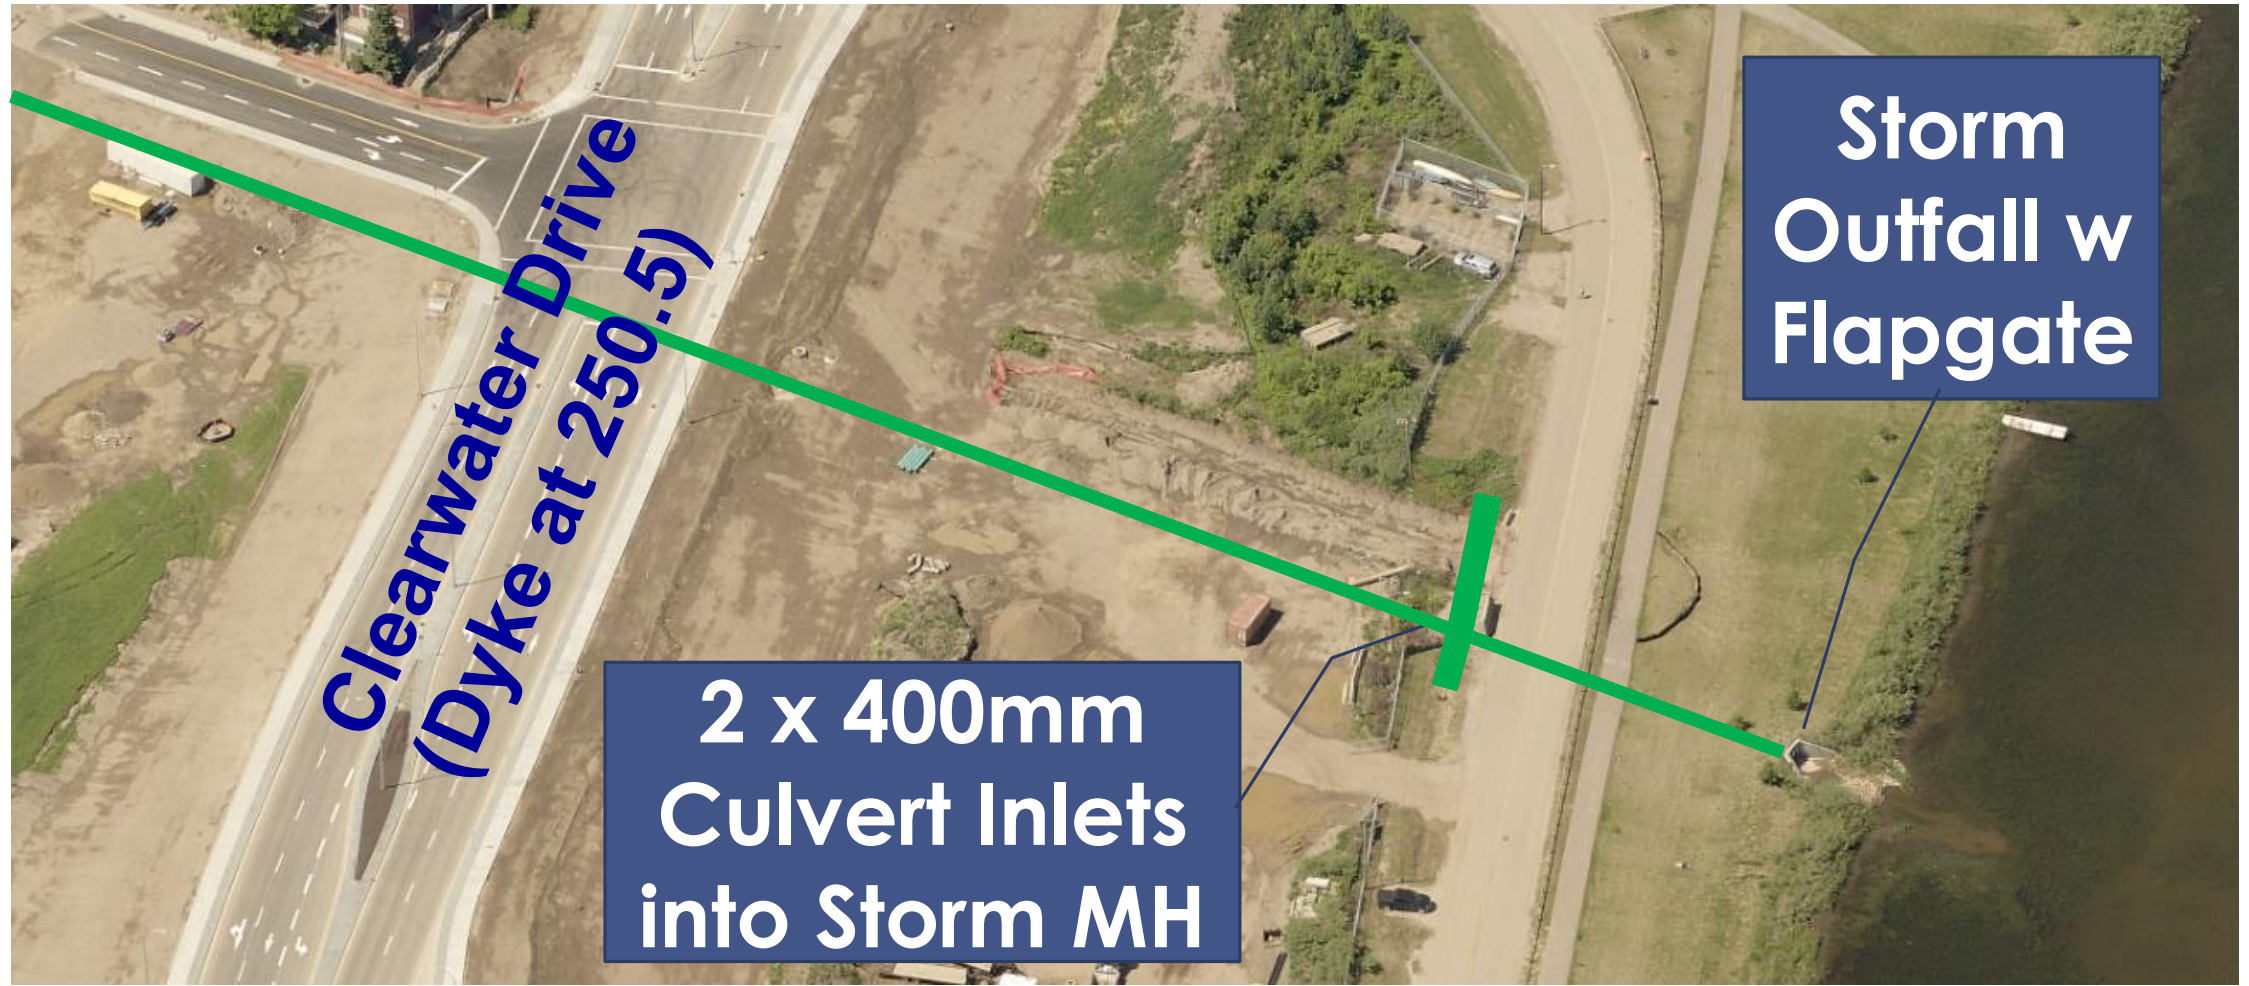
Main Street Outfall

8. Underground flood pathways exist at multiple locations that will need to be reviewed and mitigated:
 - a) Main Street, Hardin Street Outfalls
 - b) Riedel Street / Riverwalk Villas
 - c) Wastewater Treatment Plant -> Taiga Nova
 - d) Other sites, depending on location and placement of temporary and final dyke alignment

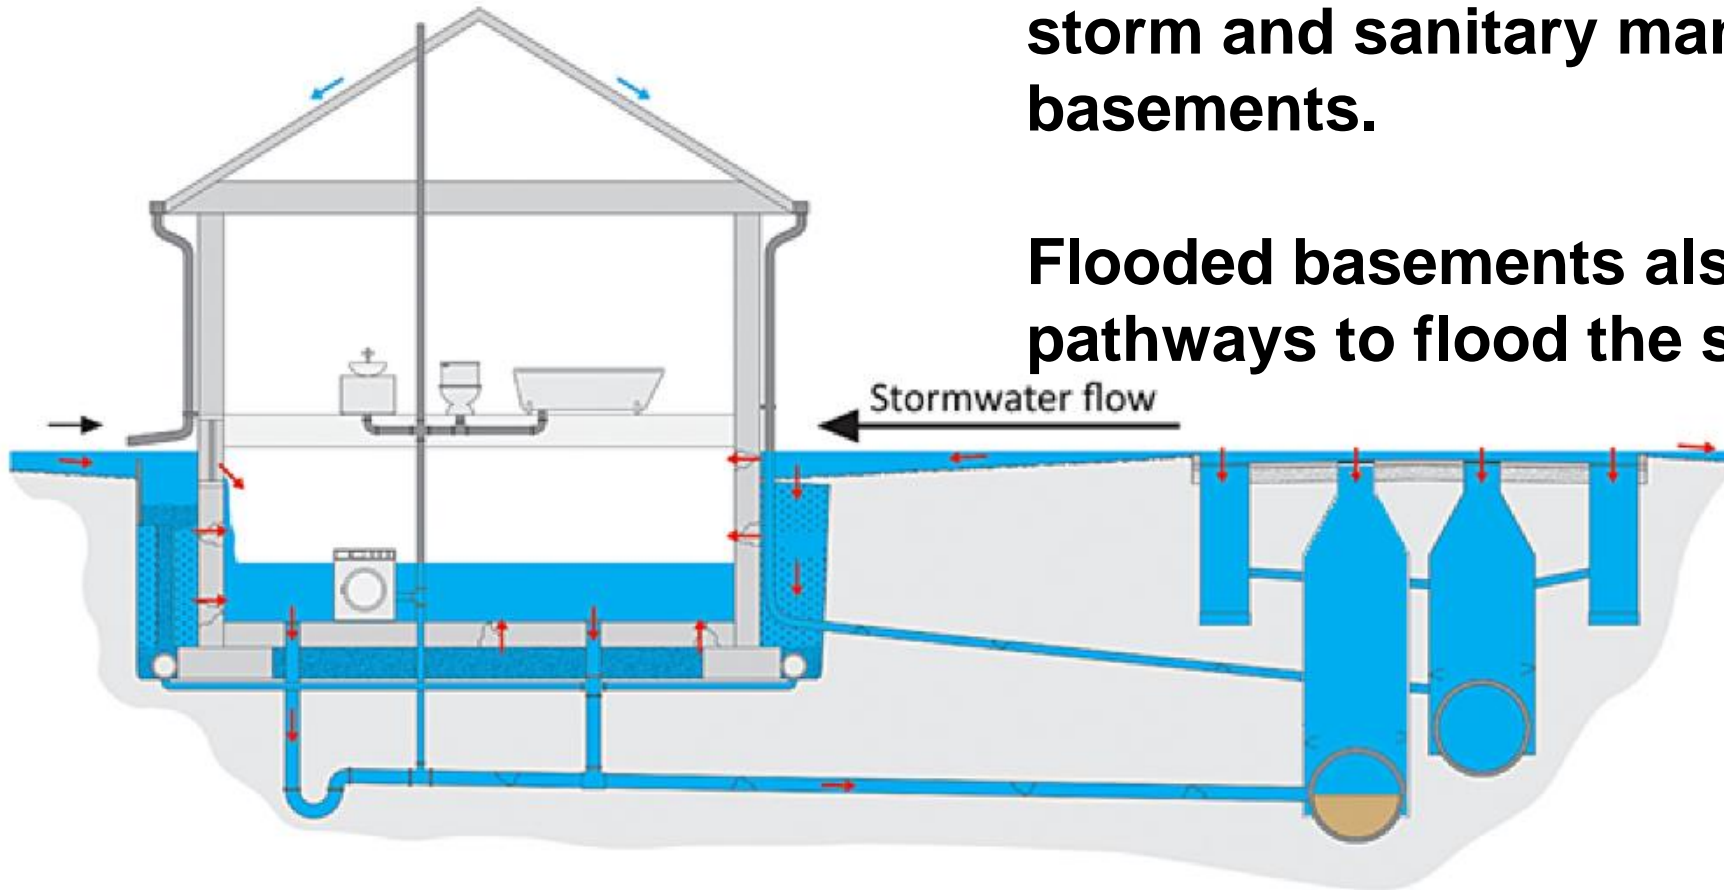
River Water Flood Damage

Flood water will follow path of least resistance to fill low points, including storm and sanitary manholes, and basements.

Flooded basements also provide more pathways to flood the sanitary system.

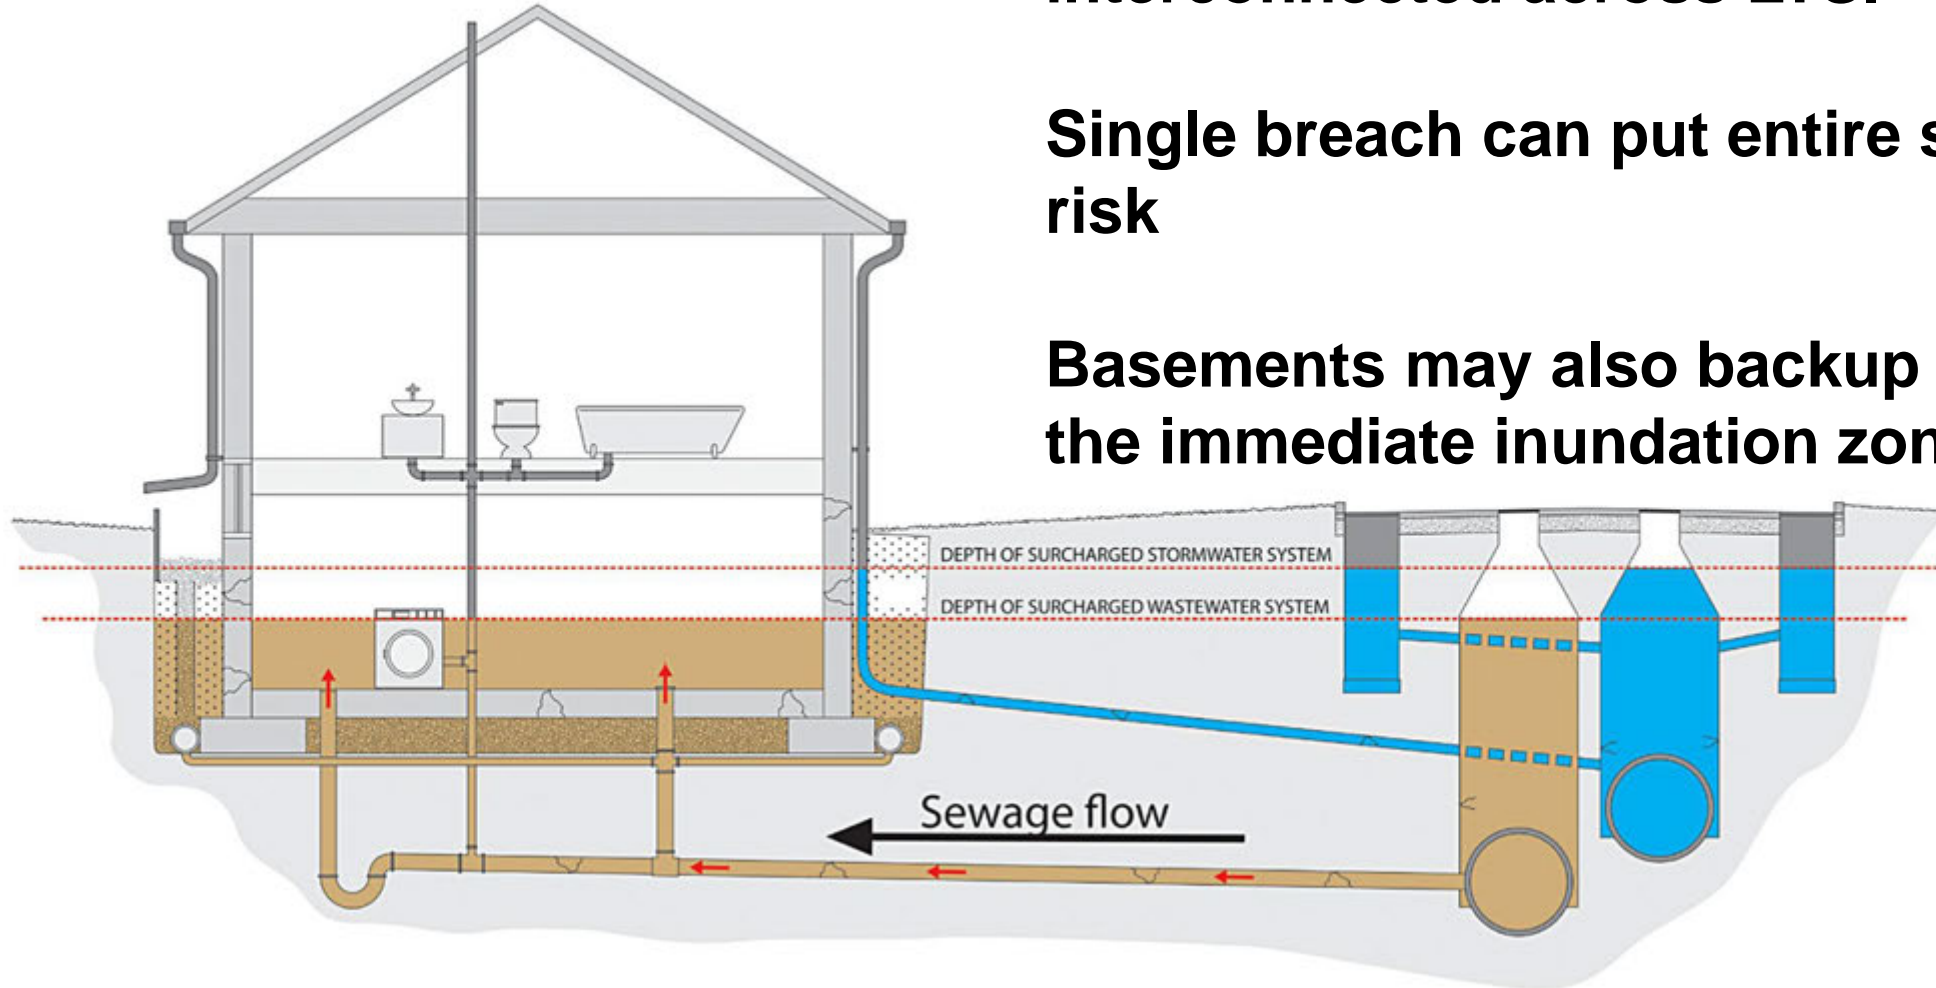
Sewage Back-Up Damages

Sanitary Sewer collection system is interconnected across LTS.

Single breach can put entire system at risk

Basements may also backup outside of the immediate inundation zone.

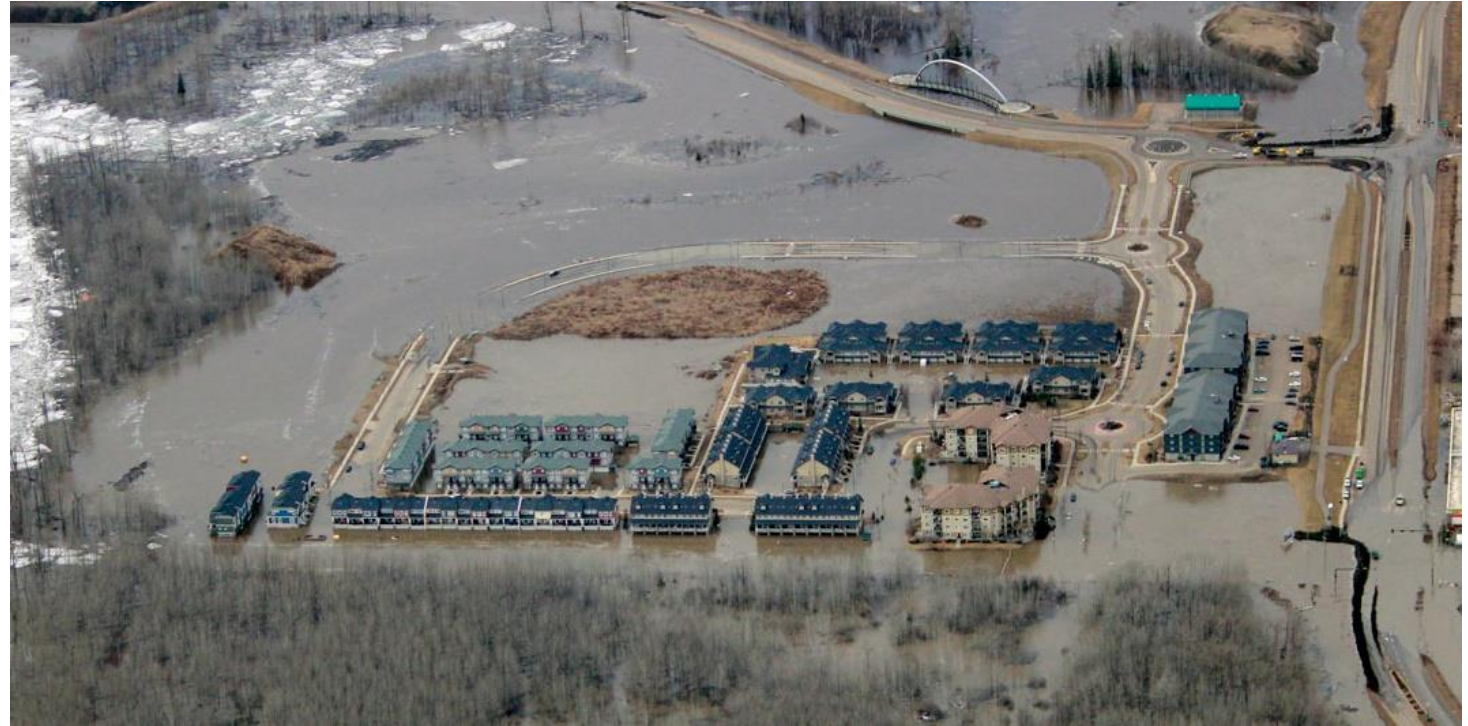
Longboat Landing

- Storm system is separate from rest of Lower Townsite (dedicated outfall)
- Original storm pond & outfall washed out in 2013 Hangingstone River floods
- Developer was approved to reinstall back flow preventer
- Inspection on November 30 identified that no backflow preventer was in place.

- Flood waters breached Denholm Gate and Fontaine Crescent from river
- Flood extent and damage independent of absent flap gate.

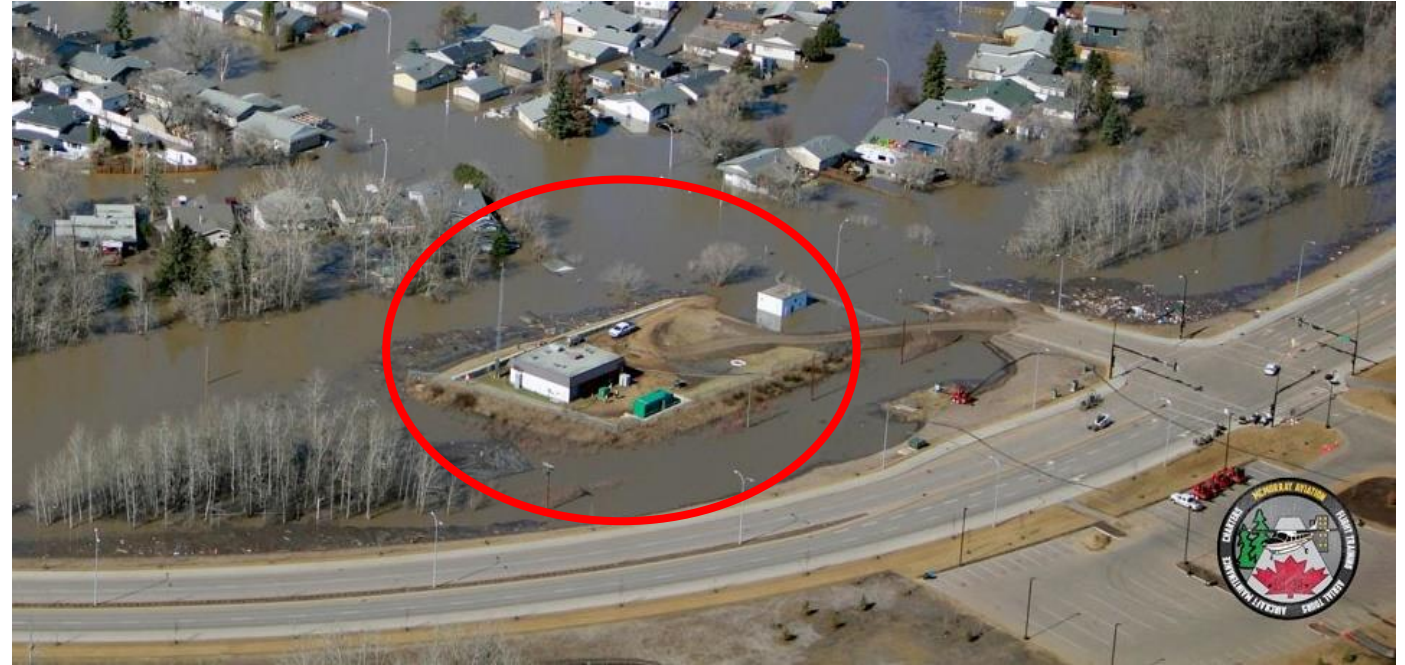
Lift Station 1A

- Floor slab at flood risk
- Dykes Constructed around LS1A in 2013 to 250.0
- Dykes prevented flooding and submergence of mechanical and electrical systems

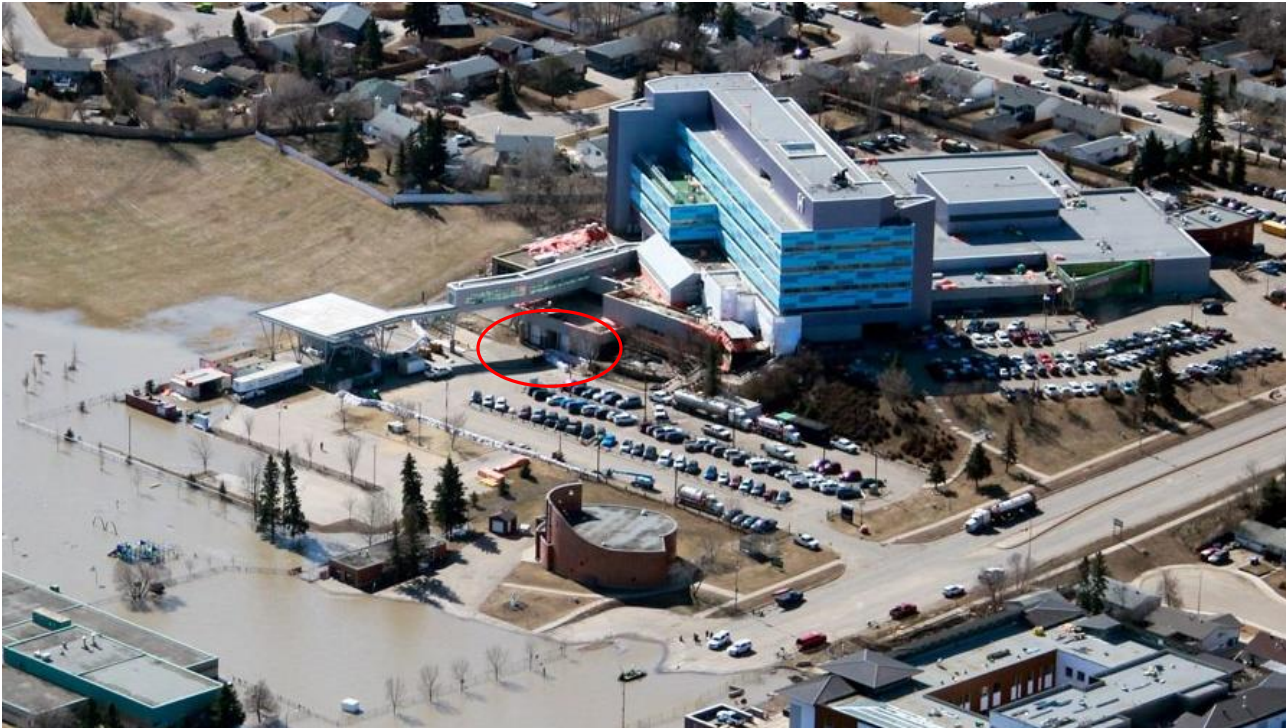
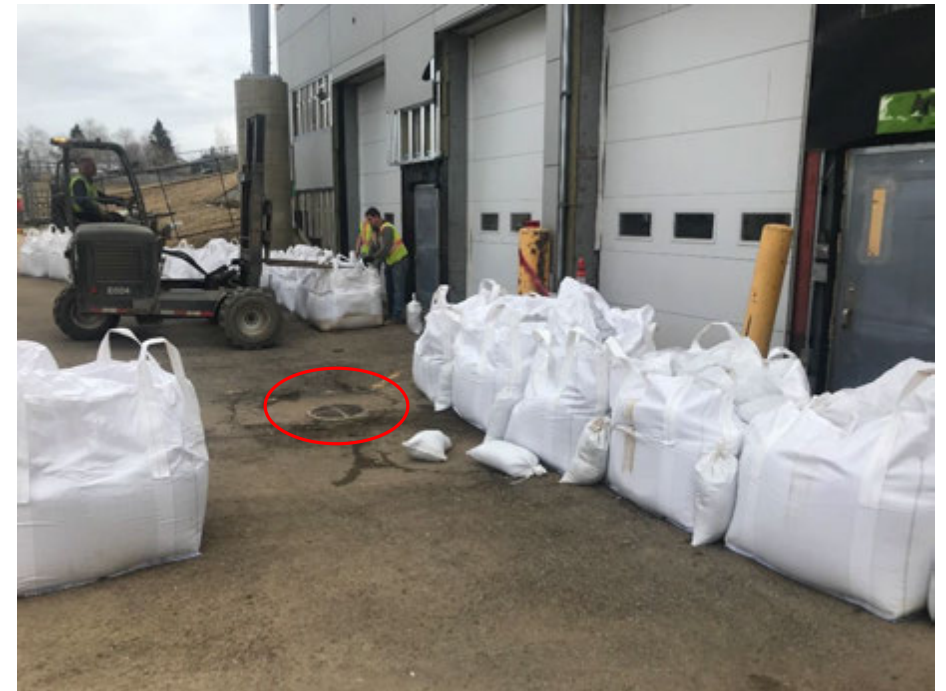
Hospital

- Bay doors and mechanical room at risk of flooding.
- Manholes plugged with sandbags to slow flood waters.

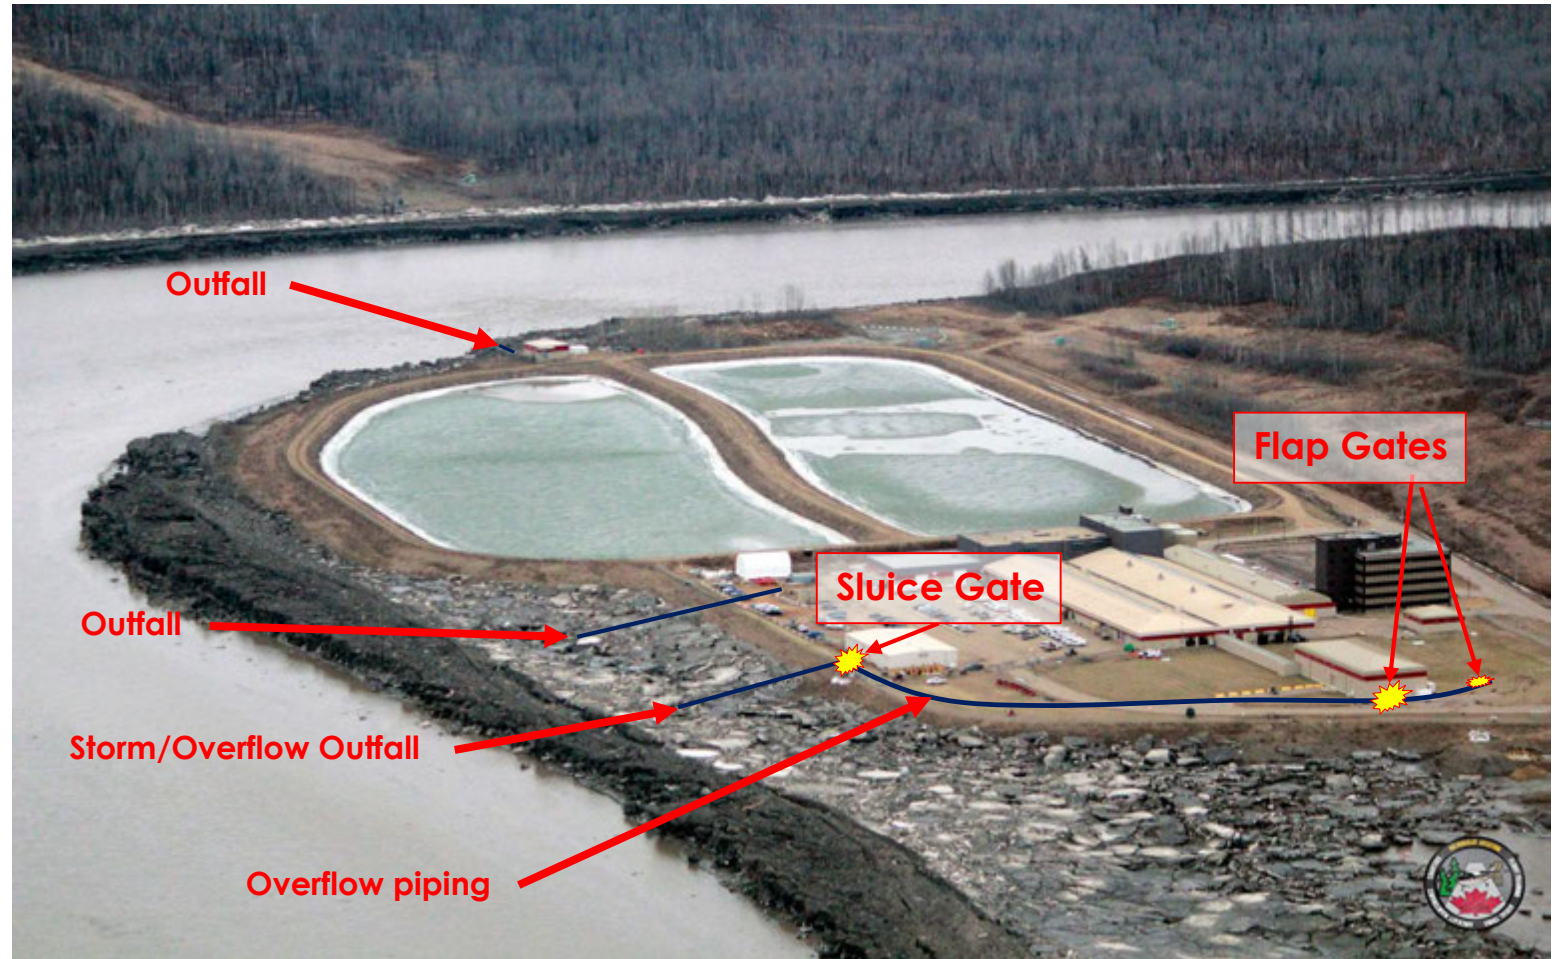
Water Treatment Plant – Infrastructure

- Outfalls damaged by river ice
- Sluice gate at outfall not sealed
- Flap gates bypassed at clearwell overflow piping

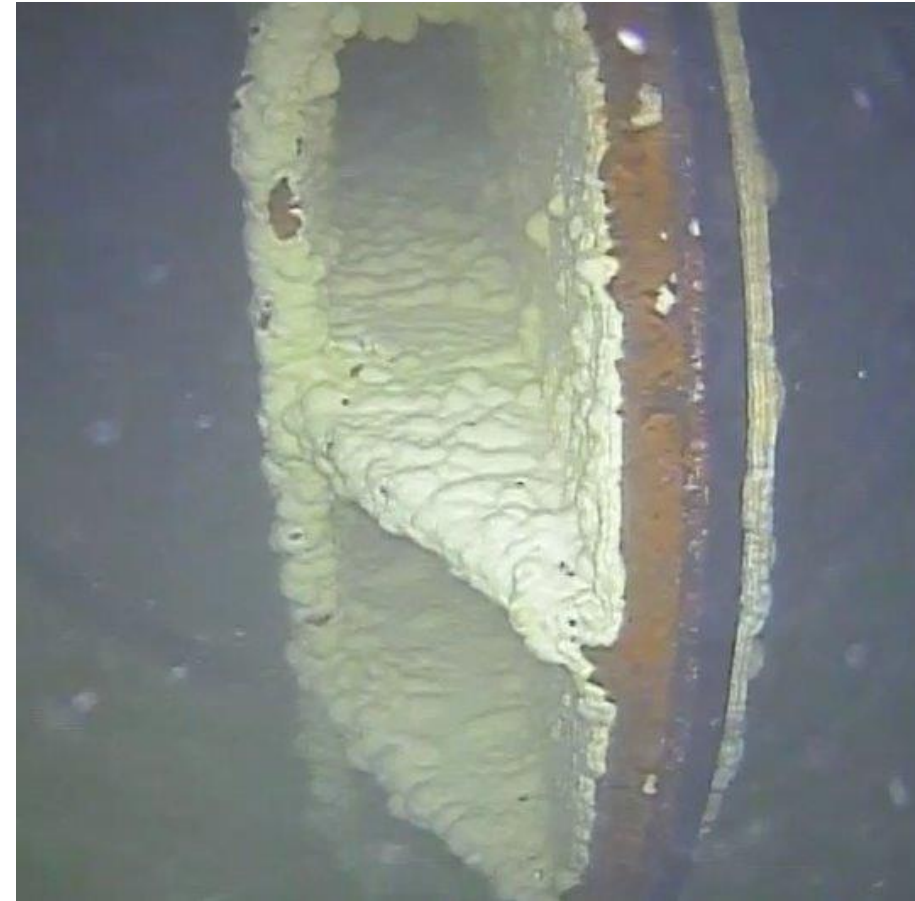
Water Treatment Plant – Failure Mechanisms

- River Water flowed into a Clearwell storage cell and quickly entered the pumping chamber. This was due to the close proximity of the overflow trough to the pump chamber.
- Operations had limited information that the Clearwell had been breached so contaminated water was pumped through the distribution network.

- Operations attempted to isolate the affected Clearwells but could not due to buildup of precipitate on the isolation valves.
- Boil Water Order implemented in coordination with AHS / AEP

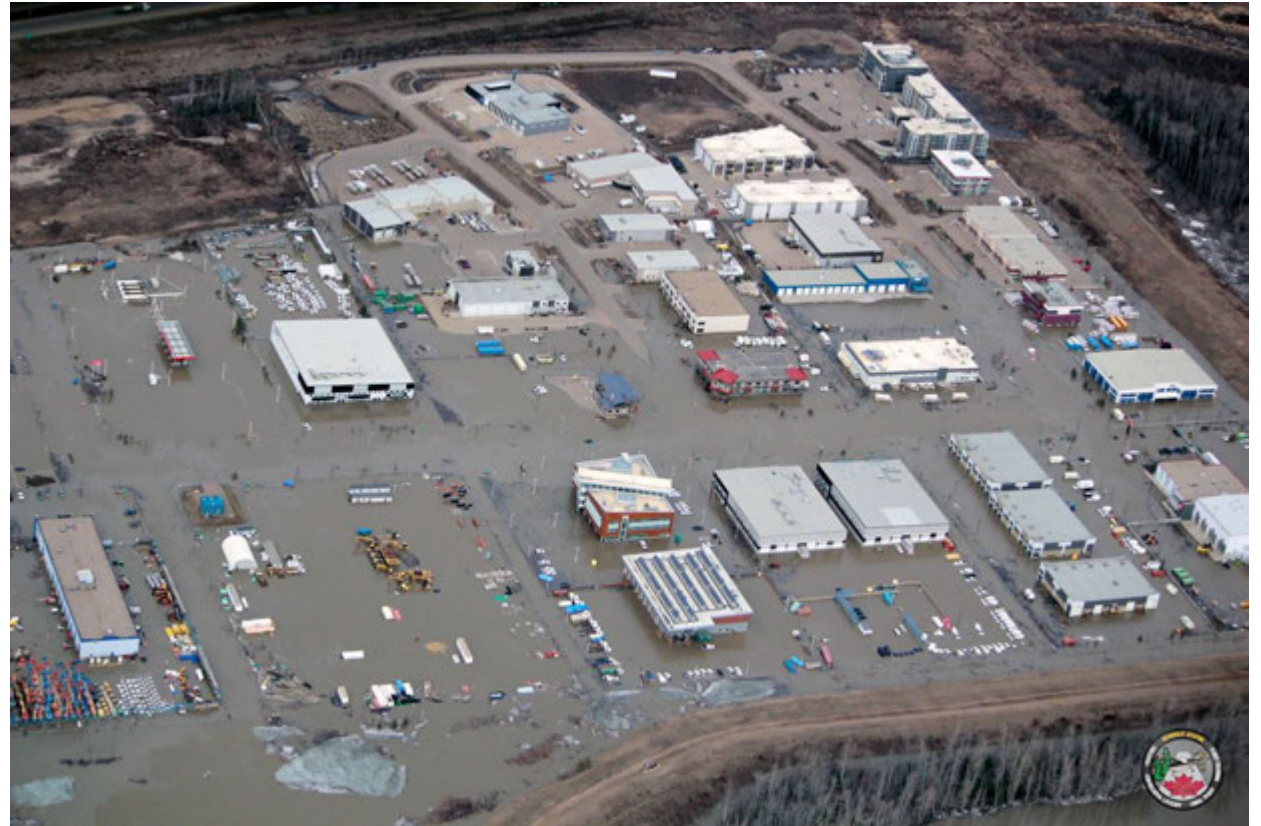
Taiga Nova Eco Industrial Park

- First Community to be flood-impacted (mandatory evacuation order 10:23am April 26)
- Two flooding mechanisms:
 1. Initial dyke breach
 2. Backflow from WWTP outfall

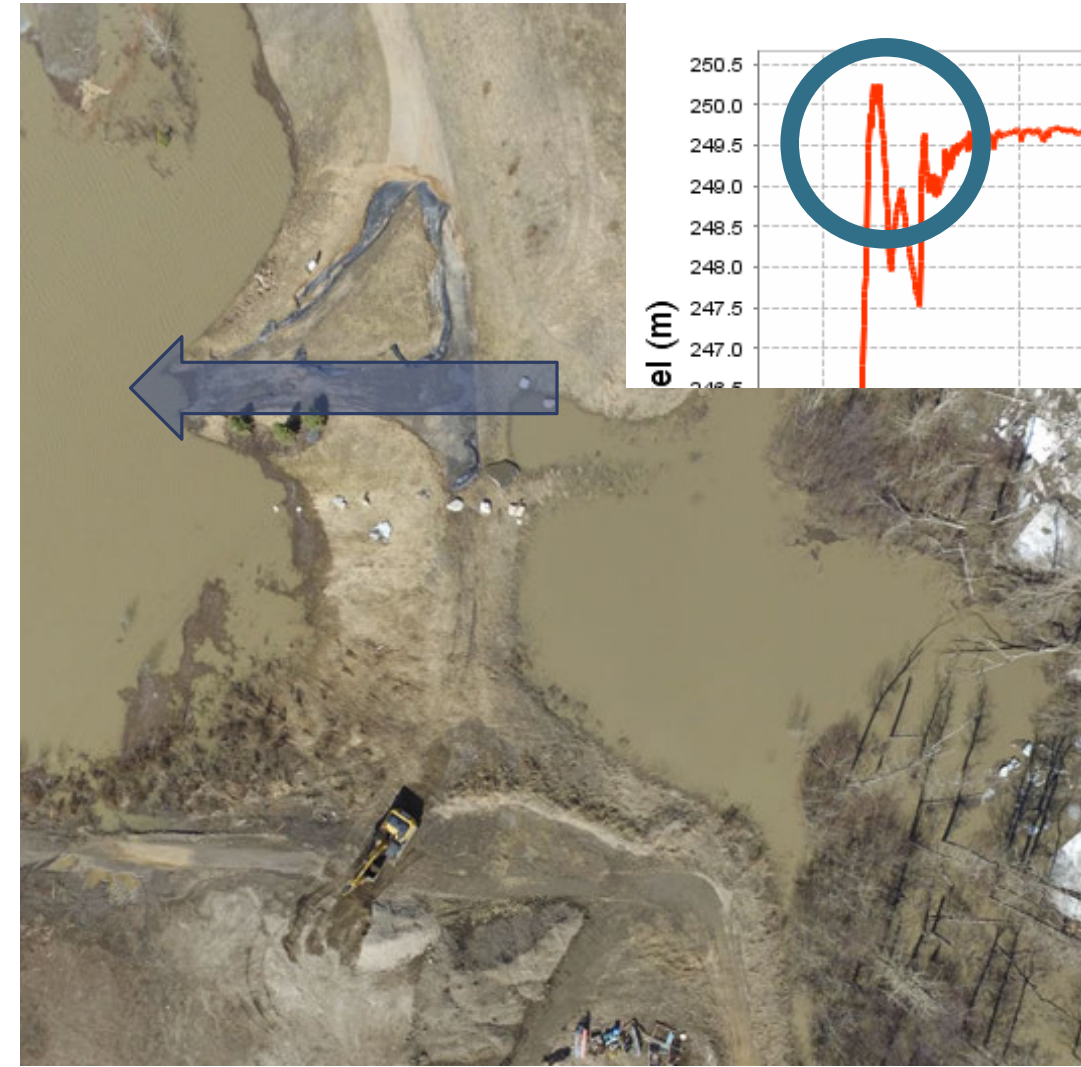
Taiga Nova Eco Industrial Park

- Initial “spike” on Athabasca River caused water levels to breach dyke at storm pond
- Visible erosion in drone photos
- Storm pond backed up, causing flooding in eco park
- Breach was temporary – river dropped below dyke crest

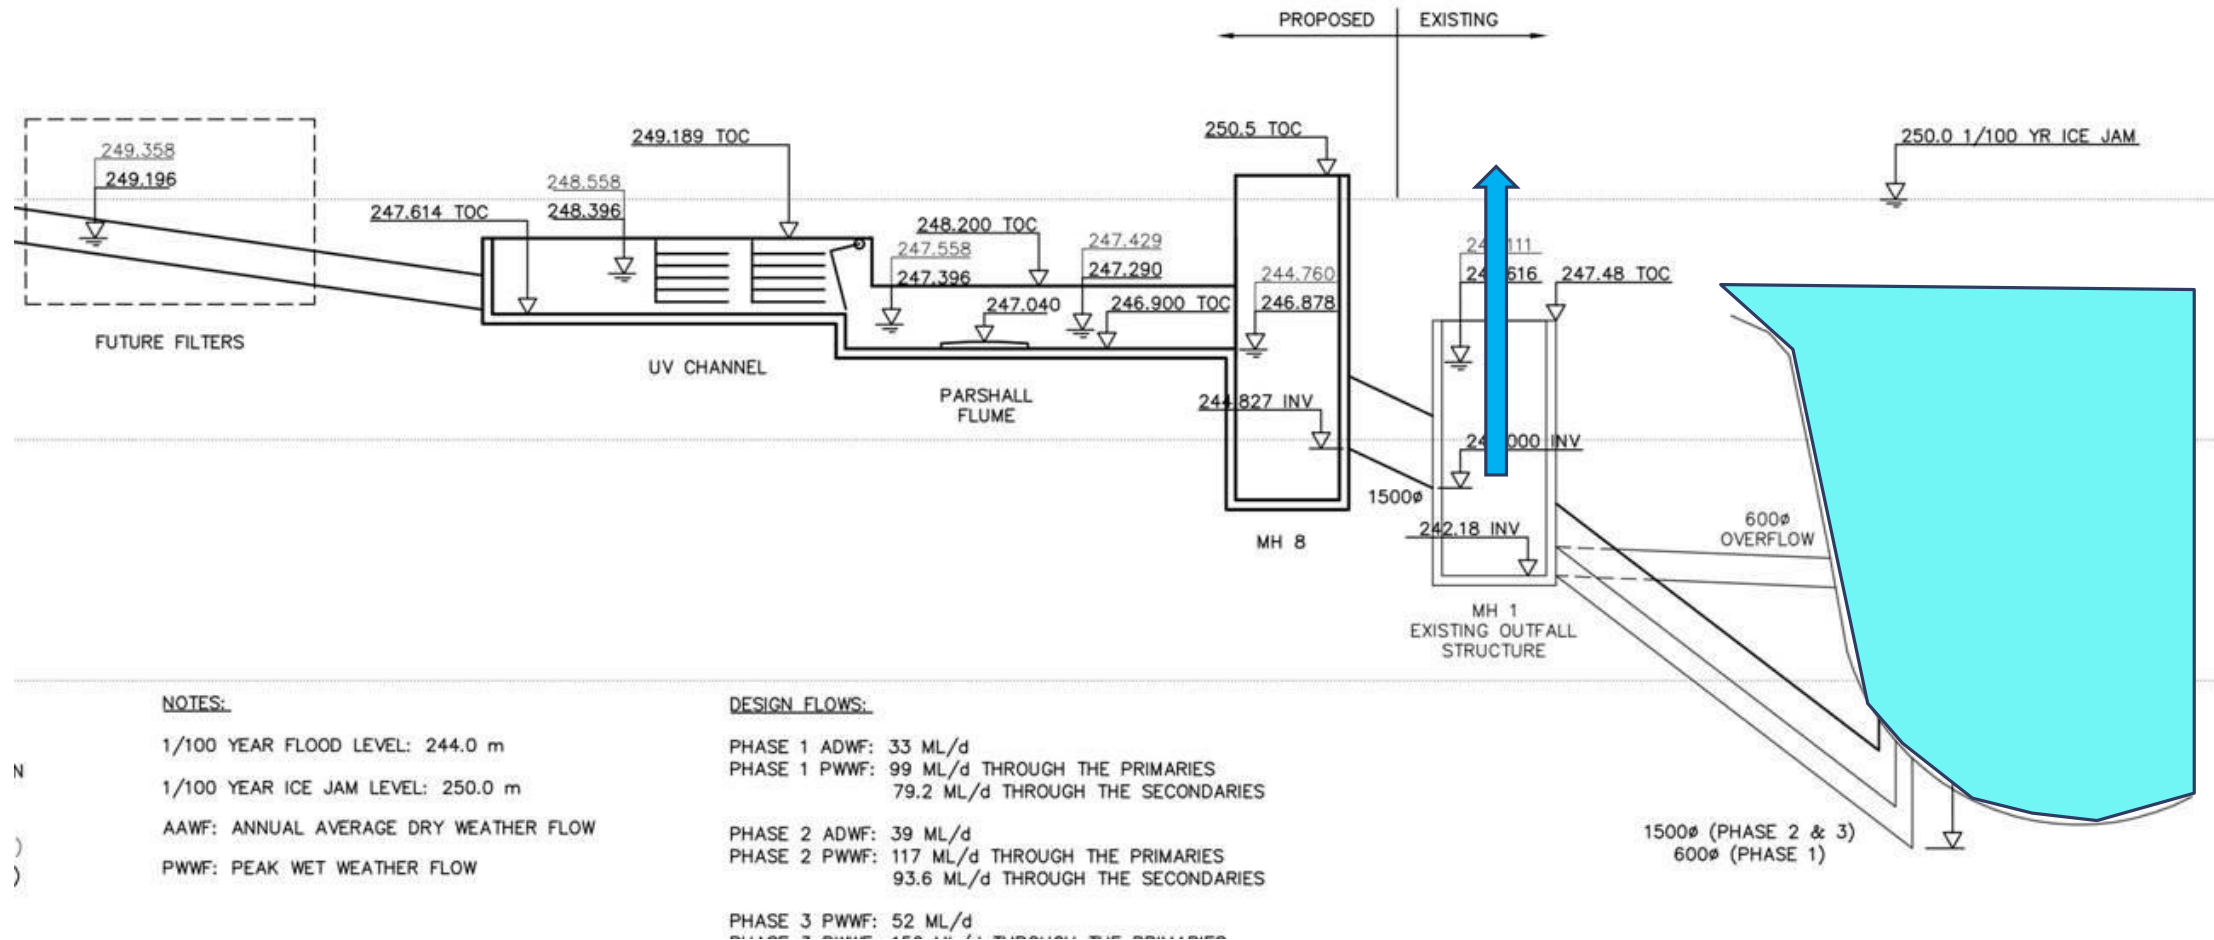
WWTP & Taiga Nova – Underground Flow Path

- After “spike”, Athabasca River levels at Taiga Nova stabilized around 247.5 +/-
- Dykes and flap gate did not fail, as maximum water level inside eco park was 245.7 (2m lower than river)
- High river level contributed to flooding, via WWTP outfall pipe (no flap gate)
- Water was reported flowing from manholes, with enough force to remove MH covers.
