2020 Ice Jam Flood Event

Performance of Municipal Infrastructure

December 15, 2020

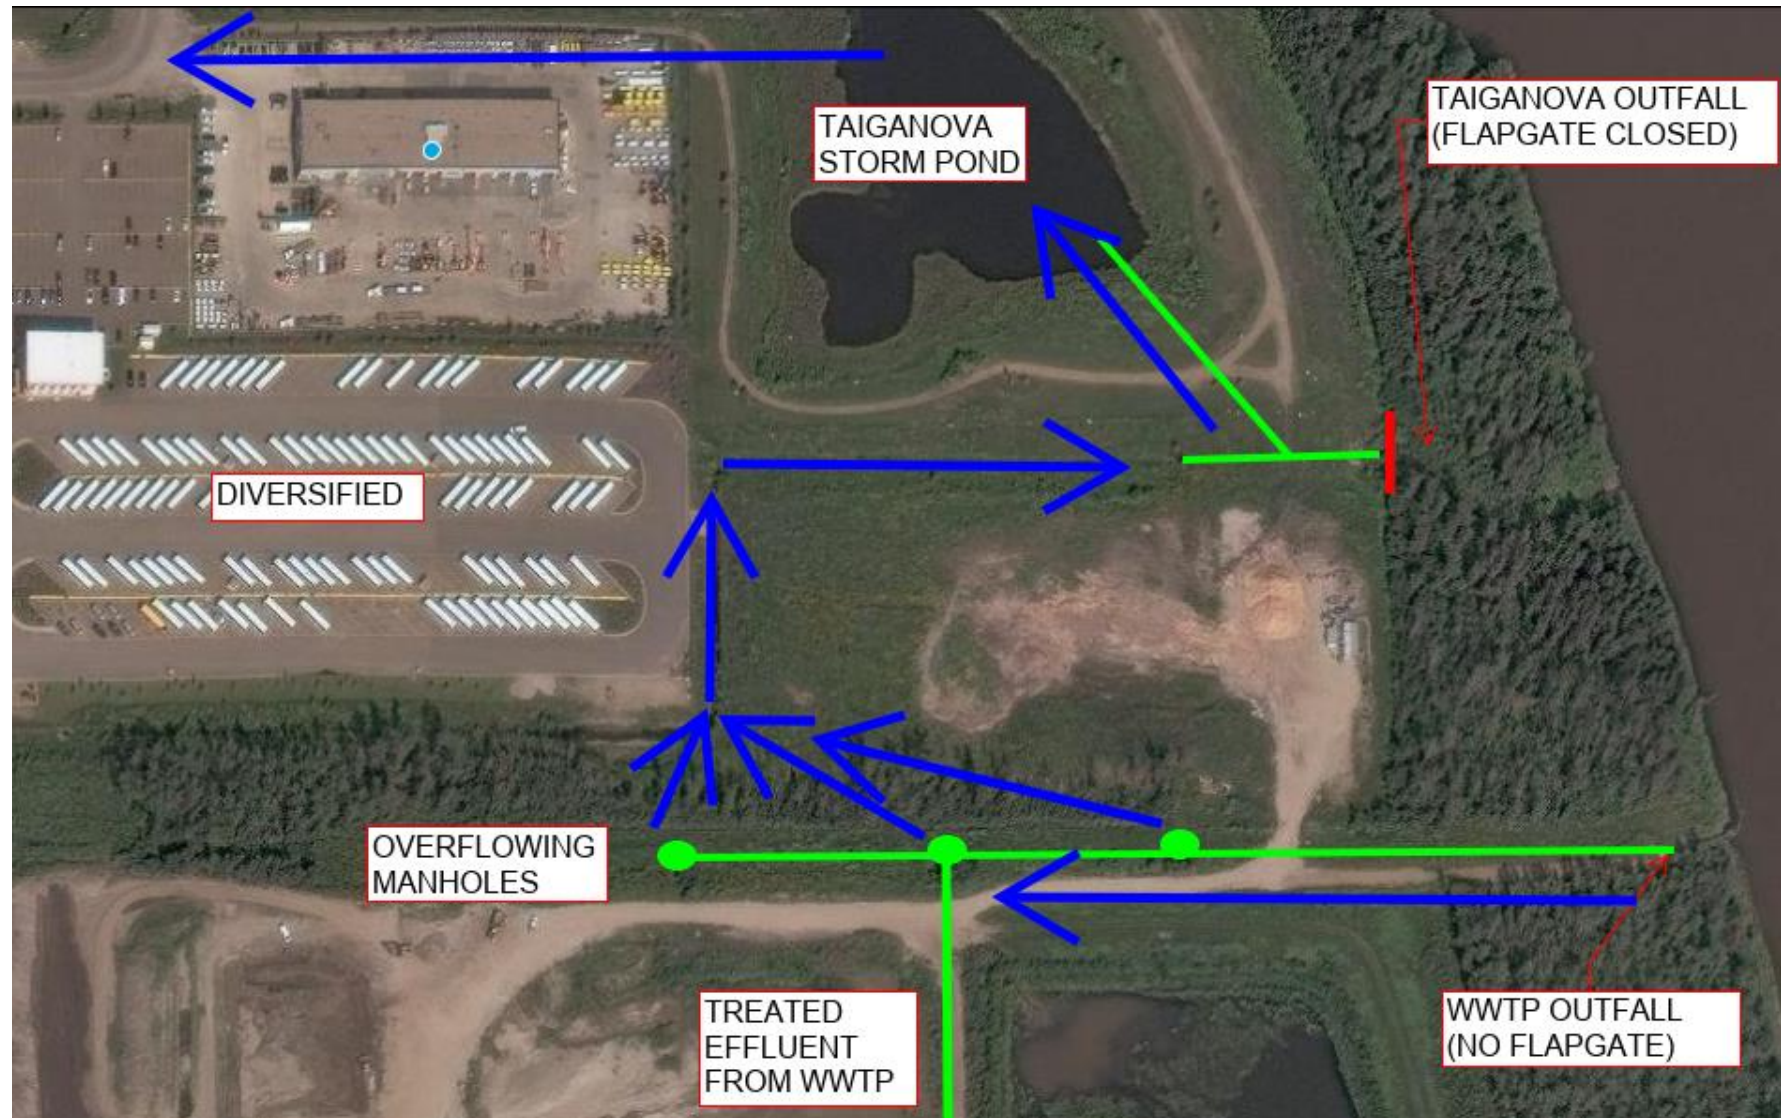
WWTP Outflow Pipe to Taiganova Flow Path

- After “spike”, Athabasca River levels at Taiga Nova stabilized around 247.5 +/-
- Dykes and flap gate did not fail, as maximum water level inside eco park was 245.7 (2m lower than river)
- High river level contributed to flooding, via WWTP outfall pipe (no flap gate)
- Water was reported flowing from manholes, with enough force to remove MH covers.
