## **APPENDIX D - Weather Data Analysis**

- D.1 Letter from Environment Canada (August 8, 2015)
- D.2 July 12, 2015 Storm Event Analysis (Associated Engineering, August 10, 2015)
- D.3 Rainfall Correlation (Associated Engineering, September 25, 2015)

#### Re: JULY 12, 2015 STORM EVENT ANALYSIS

Associated Engineering	GLOBAL PERSPECTIVE. LOCAL FOCUS.	Date:	November 26, 2015 File: 01.00		
		То:	Oscar Gonzalez, PMP, P.Eng.		
		From:	Larry E. Bodnaruk, P.Eng.		
		Project:	20153363.00		
MEMO		Subject:	Rainfall Correlation

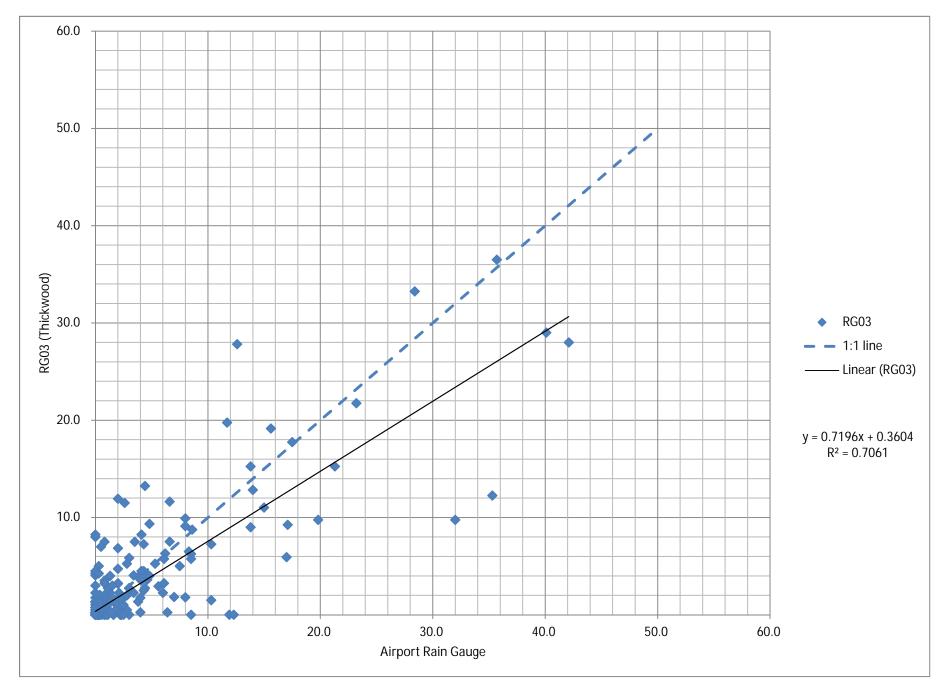
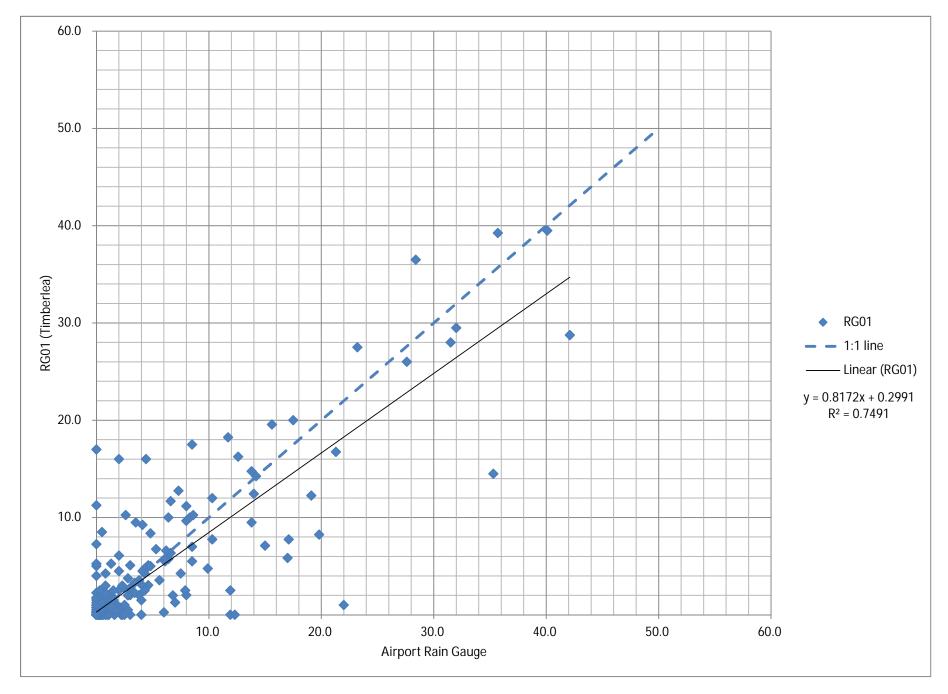
Figure 3 Correlation of Airport Rain Gauge with Lift Station 1A Rain Gauge

Figure 2 to 5 provide the scatter graphs of daily rainfall at the Airport plotted against the daily rainfall recorded at each of the RMWB rain gauges for the same date, for the four-year period of record. Also shown are the least-squares regression line, the best-fit regression equations, and the Index of Determination ( $R^2$ ) which provides a measure of the strength of the correlation. For comparison the 1:1 Line, which represents the condition where Airport and other rain gauge values would be equal (the line of perfect agreement), is also shown.

Table 1 provides an overall summary of the R<sup>2</sup> values, which represent the strength of the correlation, and the slope coefficient "b" from the regression equation which represents the average ratio of rainfall amounts for the respective rain gauges. These values and the graphs indicate a reasonable level of correlation between the various rain gauges, as would be expected, with R<sup>2</sup> values ranging from 0.71 to 0.84. The plots do show a significant amount of scatter, within a range of about 15-20 mm from the best-fit regression line for individual rainfall events. Generally the best correlation occurs with rain gauges closest to the Airport, as would be expected.

Interestingly, the slope coefficient "b" in the regression equations is less than 1.0 for all rain gauges, which indicates that lower rainfall amounts on average were recorded at the RMWB rain gauges than at the Airport rain gauge. This could indicate that more rainfall occurs at the Airport generally than in Fort McMurray, but this is unlikely to be the case. More likely it suggests a sampling difference due to wind effects in that the RMWB rain gauges were mostly located on rooftops and were more exposed to higher winds than the AES rain gauge. Wind effects during rainstorms are known to reduce the catch efficiency of rain gauges and could result in rain gauges indicating less rainfall than actually occurred in some events.
