REGIONAL MUNICIPALITY OF WOOD BUFFALO

Anzac Community Centre
Update to Anzac Recreation and Social Society

Current Building Review

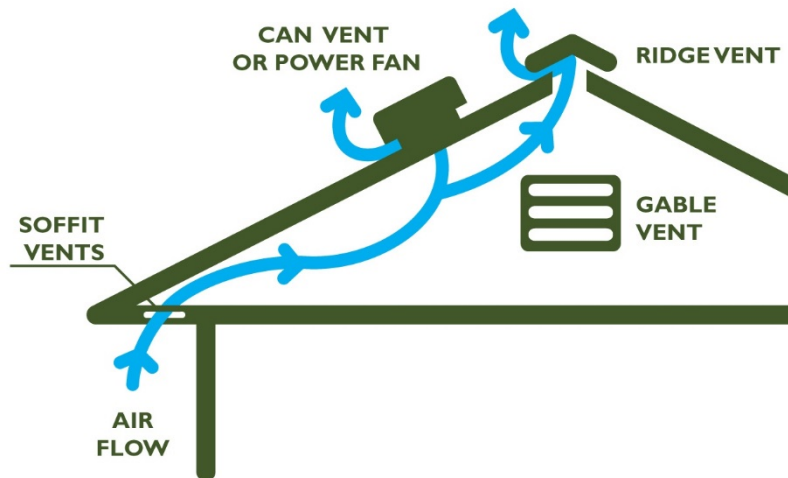
The attic space is separated into compartments and creates concealed spaced without ventilation.

This promotes moisture build-up.

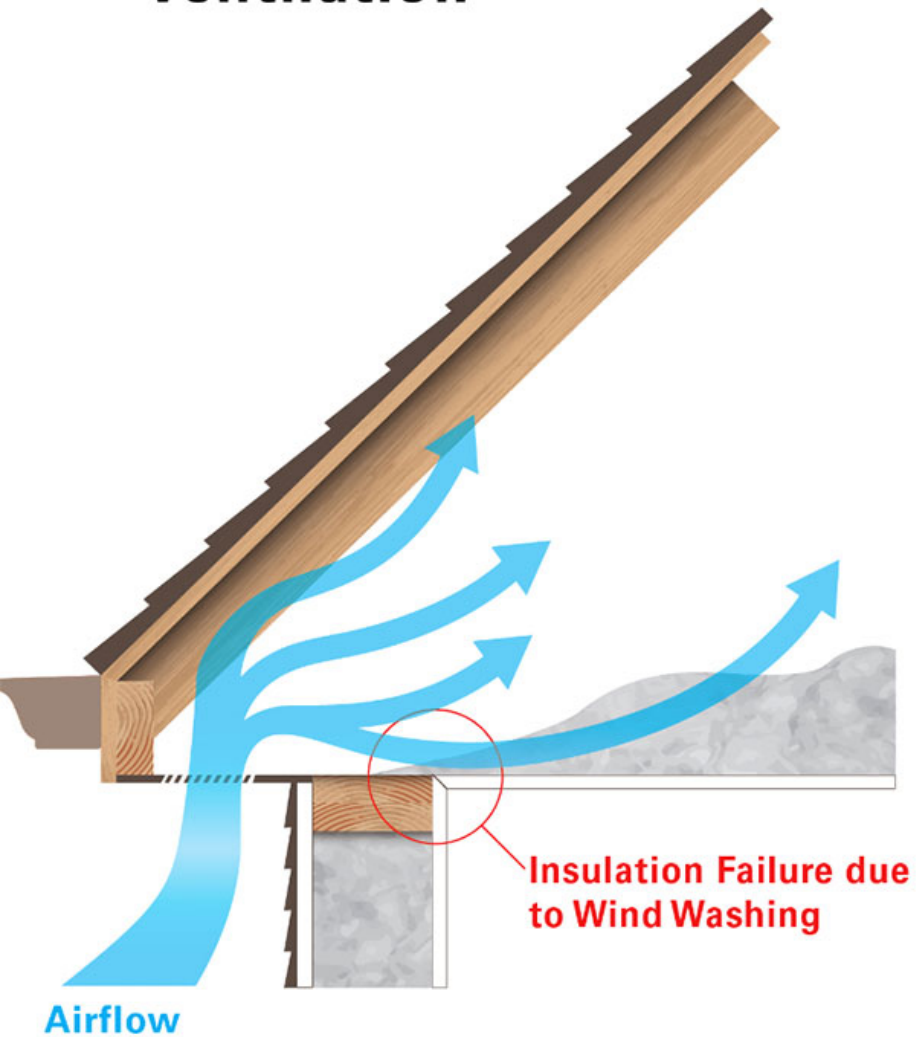
Improper Attic Ventilation

Typical eave is 4.5" deep and does not allow for adequate insulation or venting and the heel of the truss is completely blocked.
