REPORT

Regional Municipality of Wood Buffalo

2020 Ice Jam Flood Event Infrastructure Performance

DECEMBER 2020

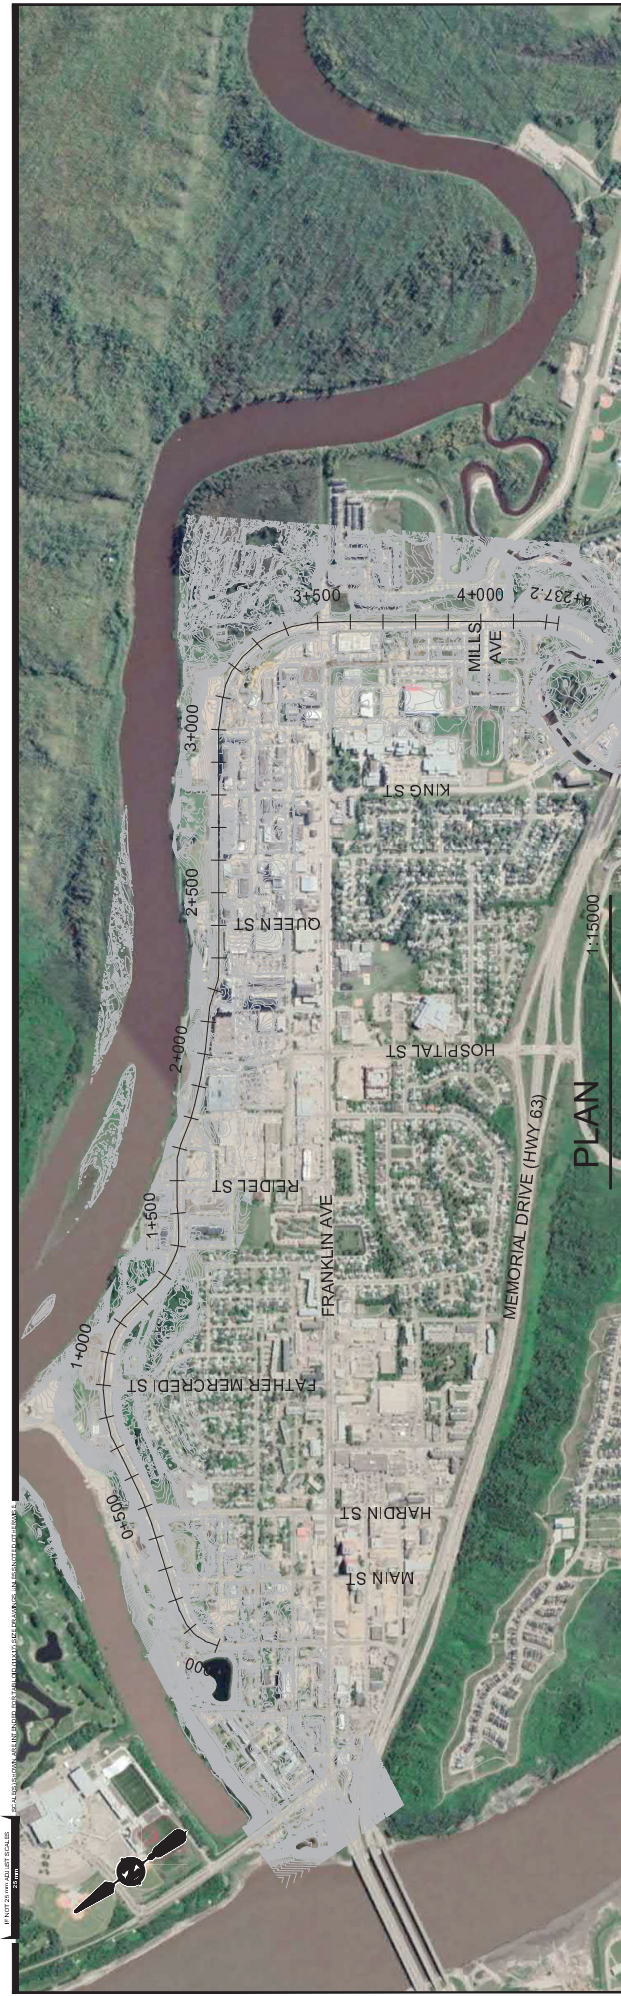
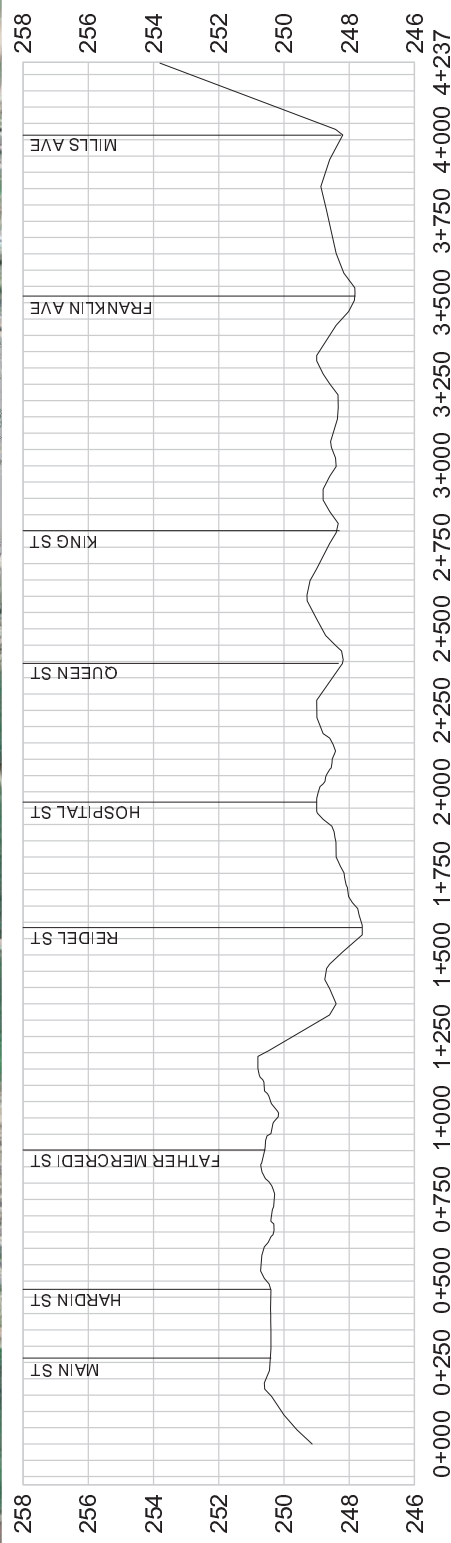
FIGURE 2-1

As a result of the above factors, the status of Clearwater Drive as a flood barrier for the Lower Townsite consisted of two sections constructed to two different design standards. The eastern portion was constructed to a nominal standard of the 1:40-year flood level, and the western portion was constructed to the 1:100-year level including an allowance for freeboard. A profile of the road surface along the entire length of Clearwater Drive as of 2020 is presented in the following **Figure 2-1**.

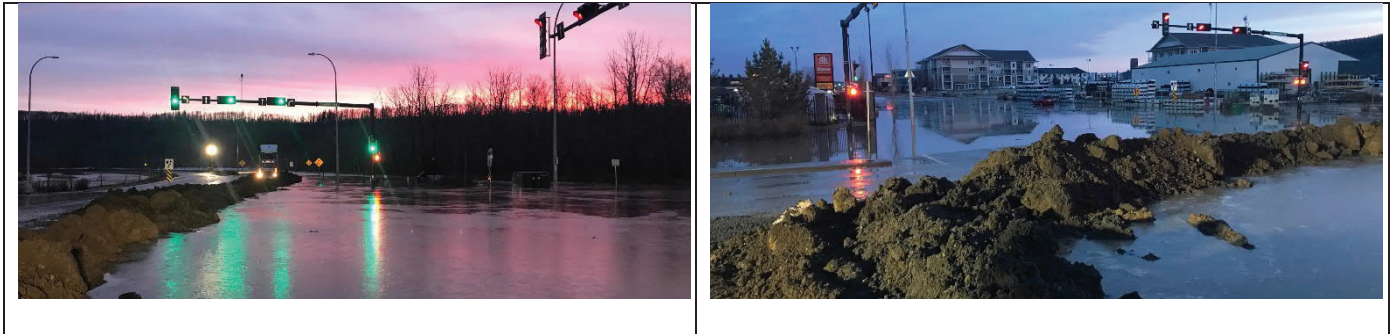
The following photos show the status of the emergency dyke construction at Franklin Avenue and Clearwater Drive at approximately 5:30am on the morning of April 27, 2020. As can be seen, the dykes were holding back approximately 1m of water. However, as can be seen in the second photo, water was continuing to rise on the land side of the dyke.

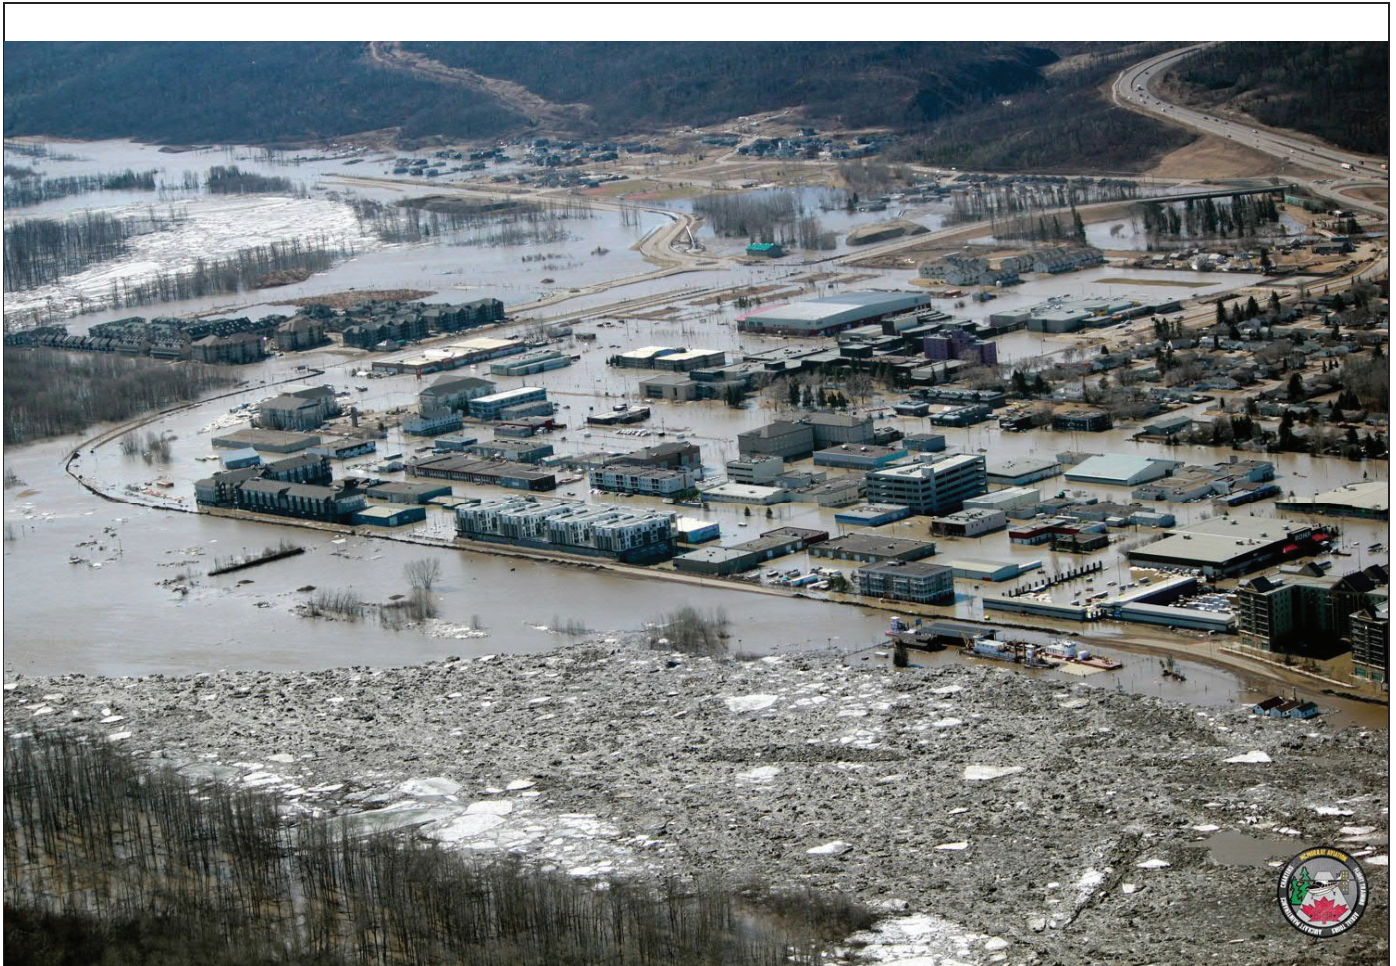
The following photo taken by McMurray Aviation on April 29, 2020 shows the emergency clay dykes constructed on Clearwater Drive. The series of dykes can be seen as the thin dark line running along Clearwater Drive.

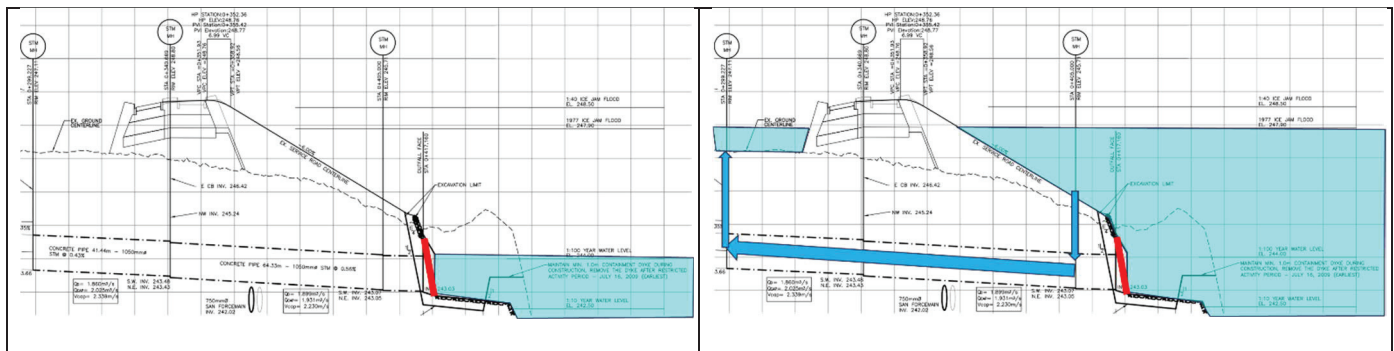
As indicated in the Stantec (2020) report, there is no evidence of failure of the flap gates. However, it is apparent that flood water was able to find underground pathways, where water was able to bypass the flap gates and enter the storm system. Any structure (such as a manhole, catch basin, inlet pipe) between the flap gate at the outfall and the crest of the dyke is a potential pathway for water to get into the storm system. Once a hydraulic connection has been established, water will equalize, flowing until the water levels inside of the dyke match the water levels outside of the dyke.

The following figures display this concept. The figure on the left depicts a high-water event on the river (light blue) with the flap gate (red line) closed, preventing back flow up into the storm system. During an extreme high-water event, the river level rises to a point near, but not overtopping the road that forms the dyke. If the water is able to enter the storm manhole located on the river side of the dyke, whether through vent holes in the manhole cover, or a connected catch basin, or some other opening, then the water will flow into the connected storm pipe, and backflow underneath the dyke, while completely bypassing the flap gate. Due to the hydraulic forces, water will naturally equalize, by flowing from one side to the other until both reach the same elevation. In this case, the water levels on the land side of the dyke will continue to rise until they equalize with the river, resulting in flooding on the land side.

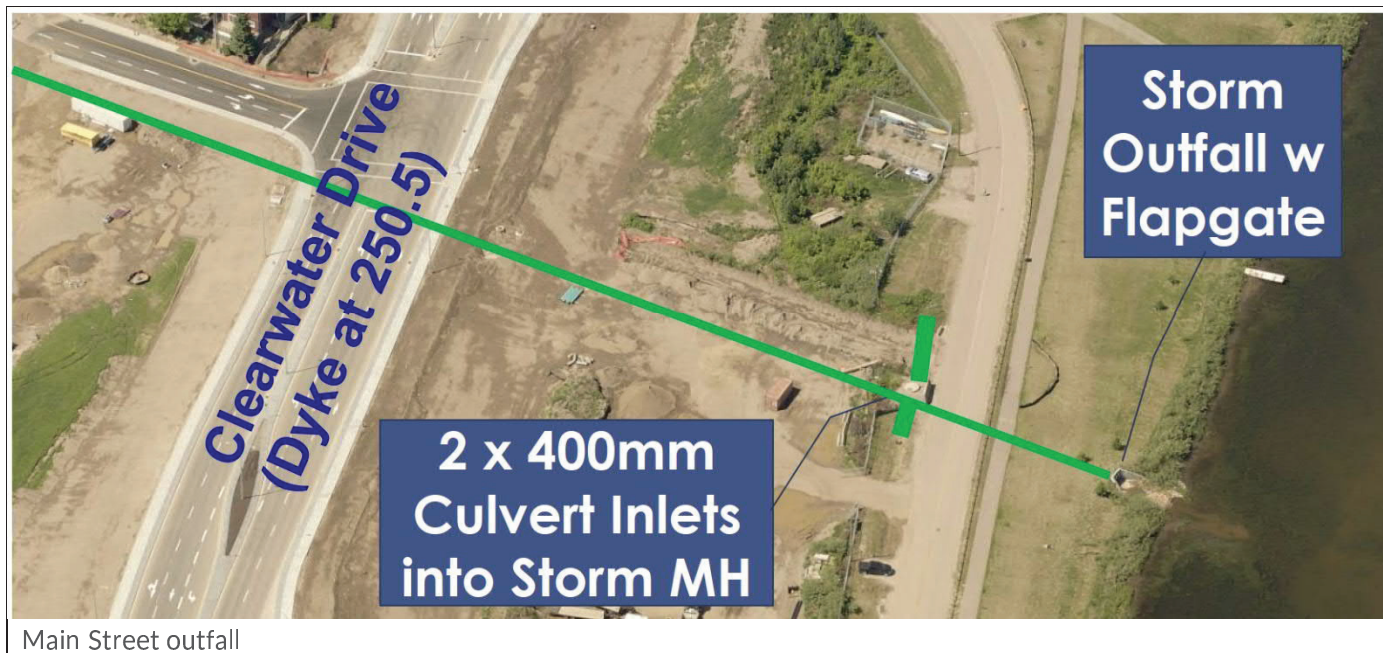
4.3.1 Main Street

At the Main Street Outfall, there is a storm manhole on the south side of Morimoto Drive. This structure acts as a vertical drop chamber to allow the storm sewer to pass overtop of the adjacent watermain, and then underneath the adjacent sanitary sewer mains. The structure also includes two storm pipe inlets, to intercept the ditch drainage that is flowing in from both directions on the south side of Morimoto Drive.

During the 2020 flood, as the river levels began rising, water was able to flow into the two inlet pipes and bypass the flap gate to backflow up the Main Street storm sewer.

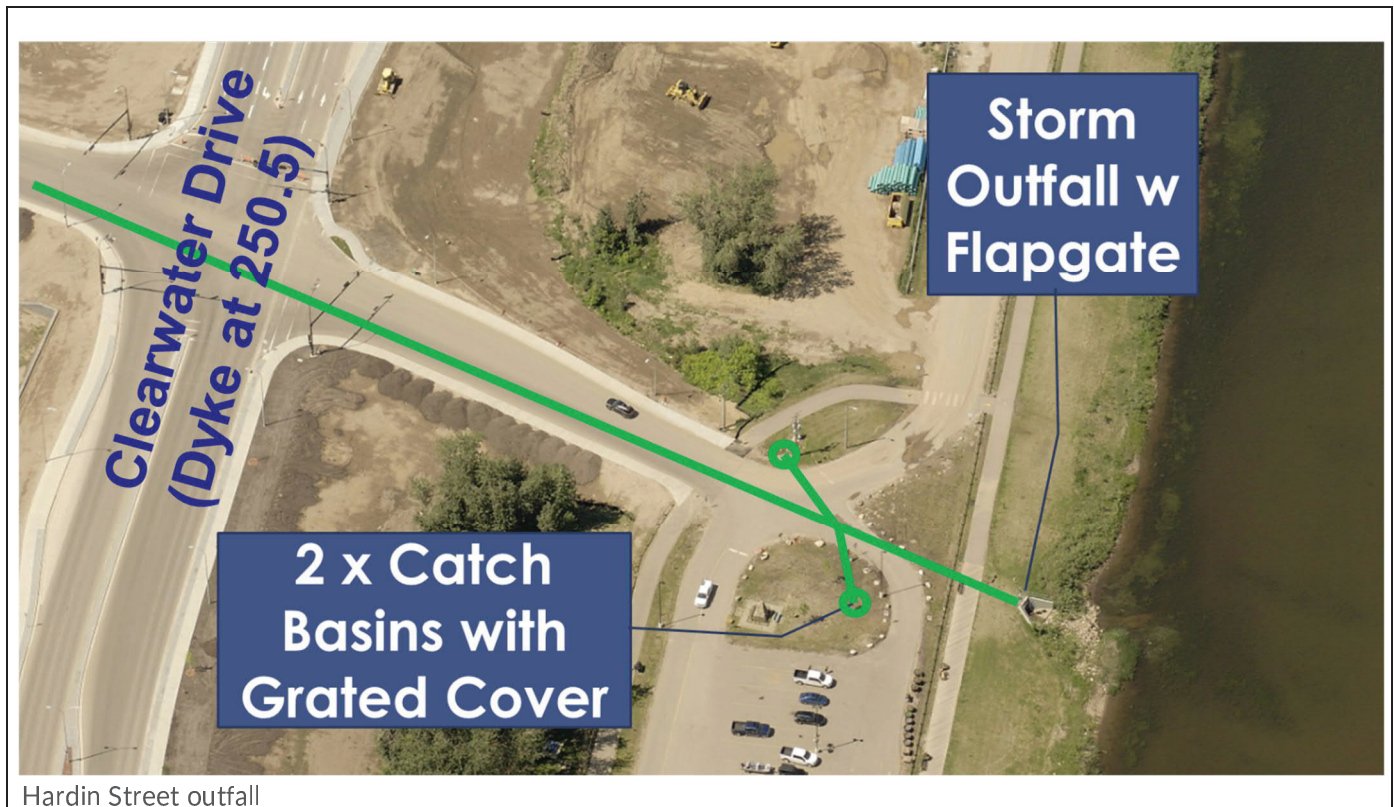
4.3.2 Hardin Street

In the vicinity of the Hardin Street Outfall, there are two catch basins in the green space near the entrance to Snye Point Park. These catch basins are connected to the storm sewer. Similarly to the Main Street outfall, as the river levels began to rise, water was able to flow into these catch basins, and bypass the flap gate to backflow up the Hardin Street storm sewer.

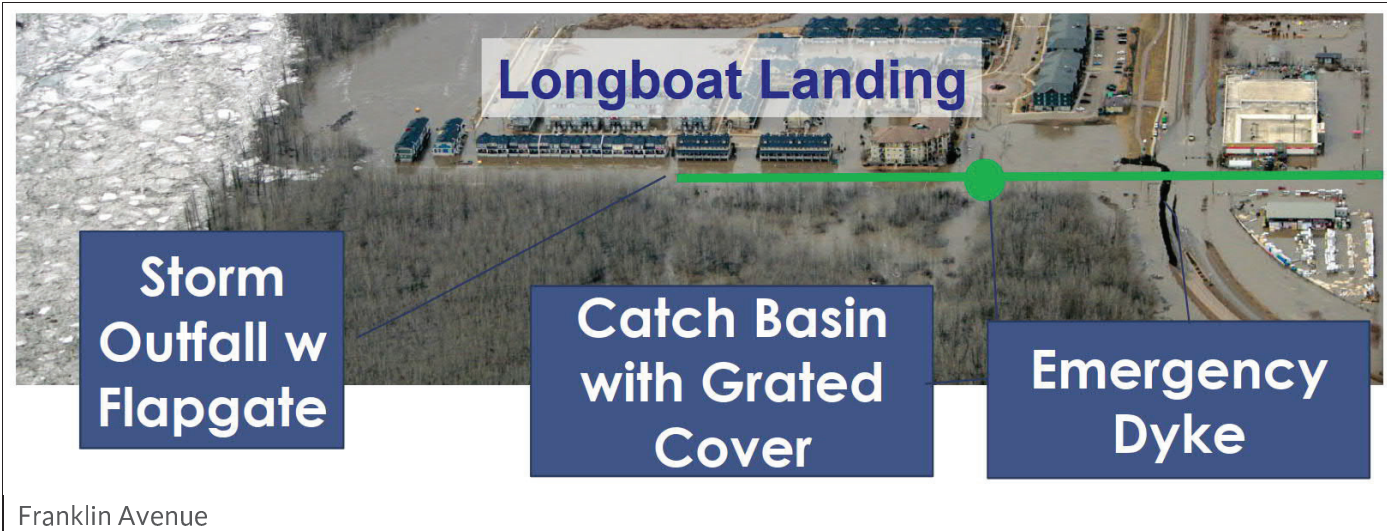
4.3.3 Franklin Avenue

The Franklin Avenue outfall discharges into a ditch that runs along Longboat Landing. There is a flap gate at the end of the pipe. Immediately upstream of the flap gate, at the intersection of Franklin Avenue and Denholm Gate, are three catch basins that are connected to the Franklin Avenue storm sewer.

During the operation for the construction of the emergency clay dykes, a consequence of placing the alignment of the clay dyke on Clearwater Drive at this location was inadvertently stranding these catch basins on the river side of the dyke. As the river waters rose and breached the intersection of Franklin Avenue and Denholm Gate, the water was able to enter the catch basins, bypassing the flap gate, and back flow up the Franklin Avenue storm sewer into the Lower Townsite.

It should be noted that this location was only problematic during the 2020 flood event on account of the alignment of the emergency dyke on Clearwater Drive not protecting the catch basins at Denholm Gate. Depending on the alignment of any future temporary or permanent flood structures, this location may not be problematic or require any particular remedy. This is an example of how easy it is to inadvertently create underground flooding pathways underneath the dyke.

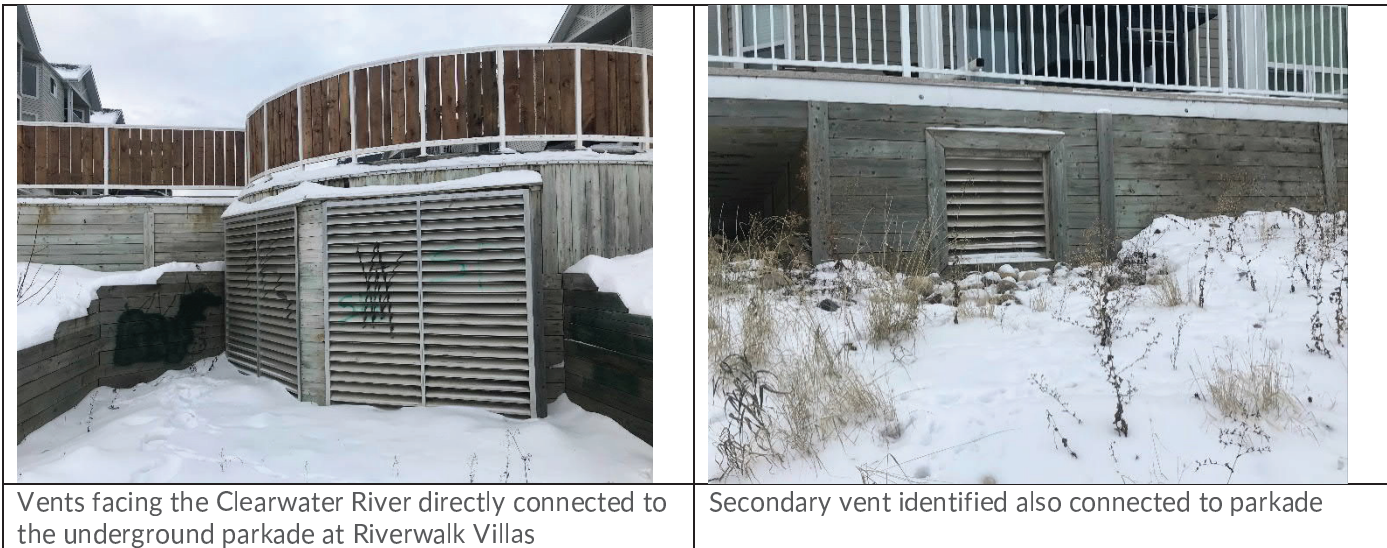
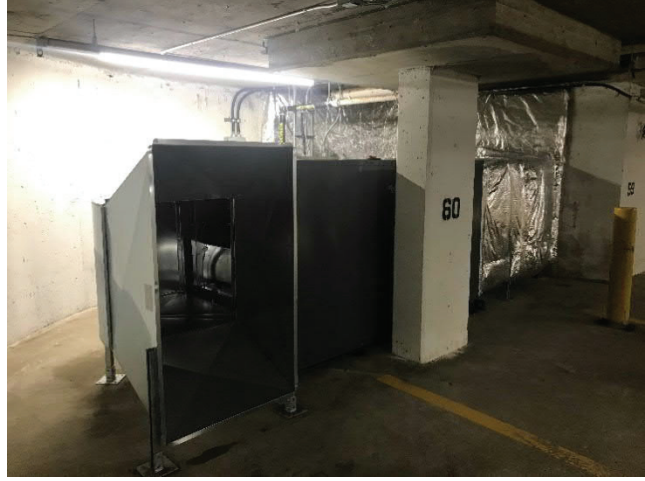
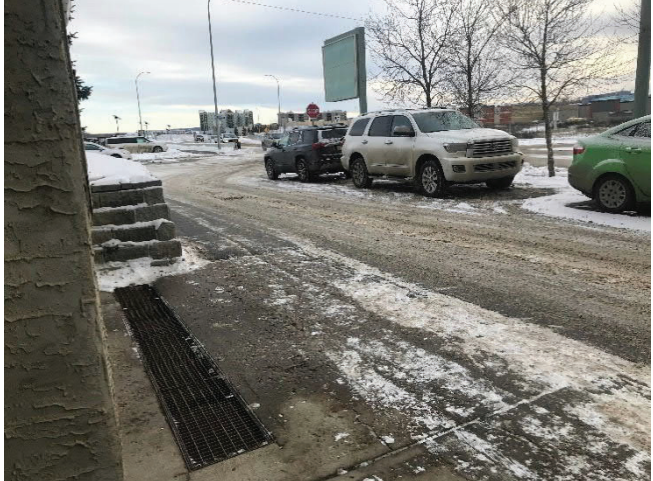
4.3.4 Riverwalk Villas

The Riverwalk Villas condominium complex is located on the river side of Clearwater Drive at Riedel Street. There are two vents that face the Clearwater River, that provide direct connection into the parkade for the Riverwalk Villas development. During a site visit on November 26, 2020, the property manager confirmed that these vents are part of the make-up air system for the parkade. She also reported that during the 2020 flood event, she witnessed flood waters entering the parkade via these vents. The site visit also confirmed that the parkade is a single level, with at-grade access to the street near the intersection of Clearwater Drive and Riedel Street. A trench drain is located immediately outside of the overhead garage door, and this drain is connected directly into the storm sewer.

<p>Make up Air unit inside parkade, connected to vents</p>	<p>Trench drain in front of at-grade overhead door access to parkade</p>

Based on the review of the infrastructure at Riverwalk Villas, it is evident that the rising flood waters flowed freely through the vents into the underground parkade. Once the floor drain sumps were filled, water then flowed out the garage door, where it would have flowed into the trench drain, and directly into the storm sewer. Once the capacity of the 75mm connection pipe to the storm sewer was exceeded, flood waters would have then flowed freely out to the street, contributing to the overland flooding in the Lower Townsite via Riedel Street.

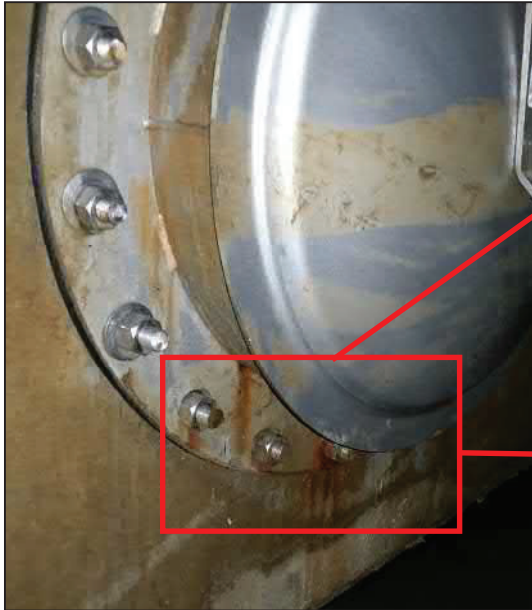
600mm flapgate

Situation : We have found several anchor nuts not properly tighten and without washers. This can create some leakage between the wall and the frame if the wall gasket is not properly compressed. Also, there was a rusted carbon steel washer that is contaminating the stainless steel flap gate. *Refer to pictures below.*

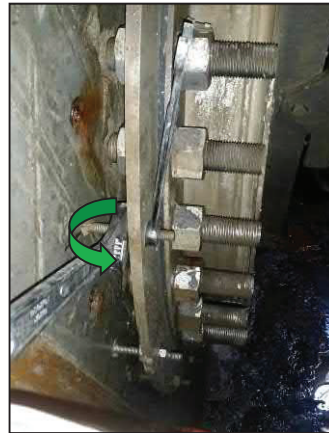
Frame readjustment using anchors back nuts

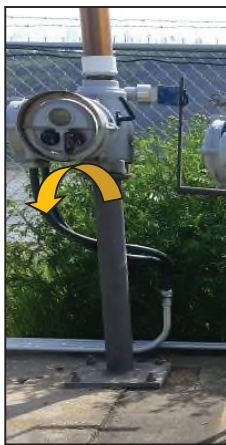
Situation: This gate is a rising stem type. With this operating arrangement, the pedestal (along with the actuator) is the key component and it is taking the entire sluice gate operating thrust. Therefore, it must be strongly secured onto a structural concrete floor slab or proper supports. However, the pedestal of this “Outfall sluice gate” have only two anchors bolted in the concrete slab and two anchors bolted inside a “mobile” concrete cover which is not attached to the structure. When the gate is reaching near the full close position, the concrete cover is moving upward thus bending the operating stem and not closing the gate. This could be the reason why the full close setting of the actuator was originally adjusted before the sluice gate is reaching it full close position. Refer to pictures below.

The pedestal is moving to the left because the cover is moving upward when closing the sluice gate

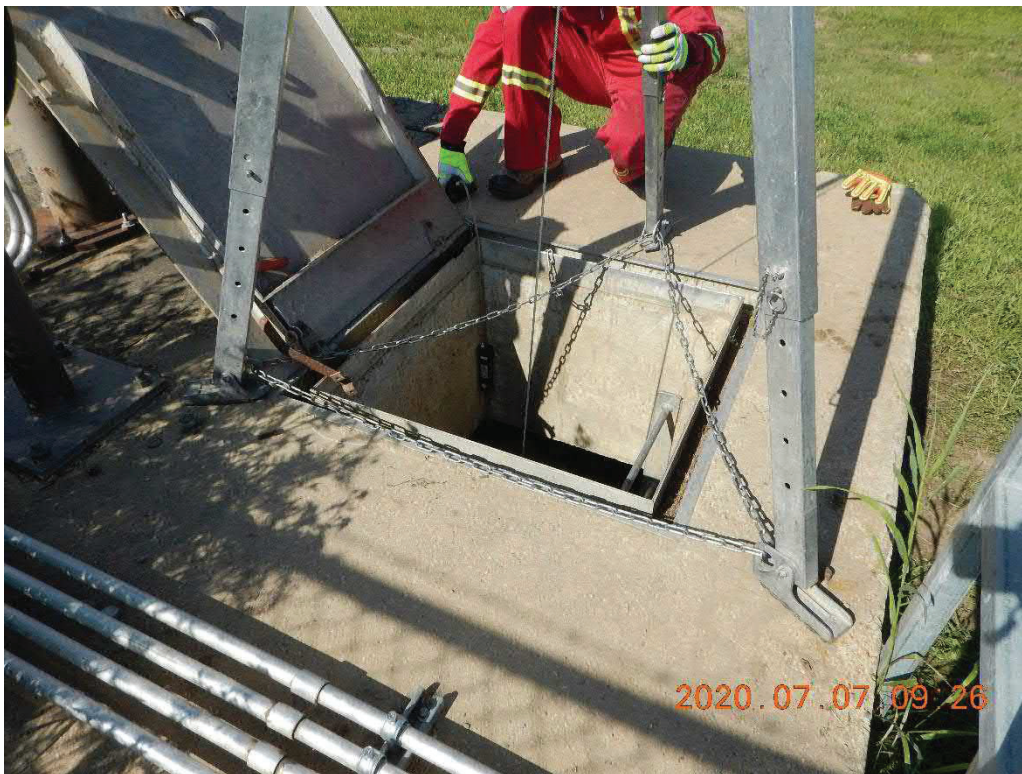
1. Looking at new outfall chamber gate

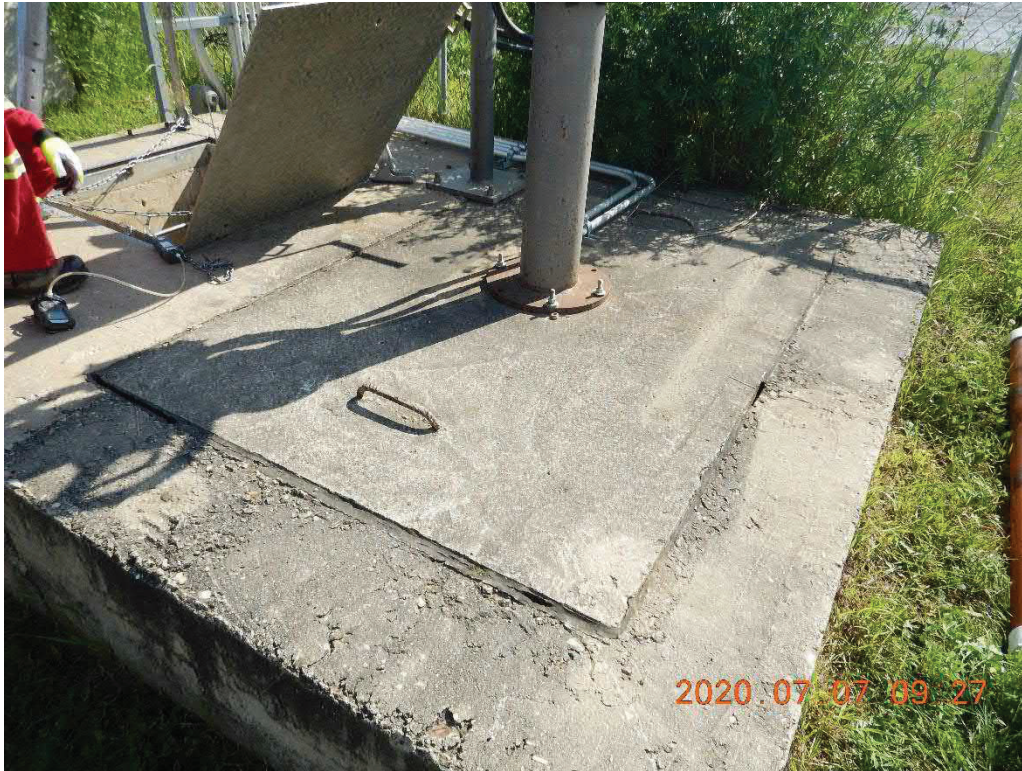
2. Looking at former concrete outfall chamber gate

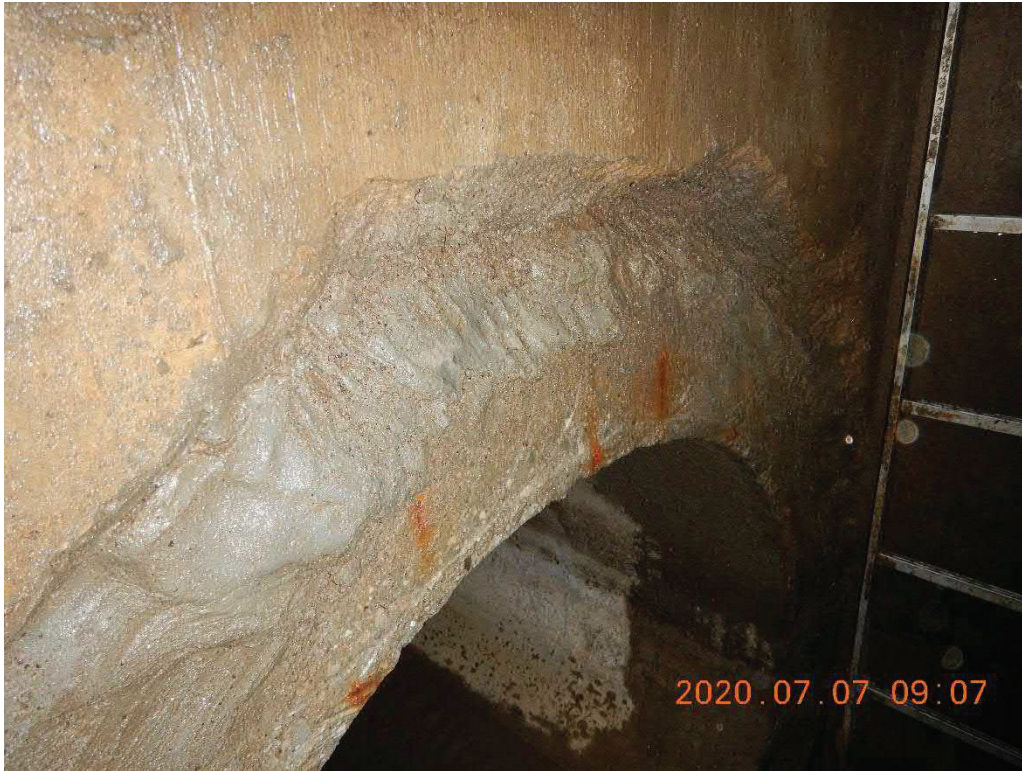
8. Pipe opening of overflow line in Outfall Chamber to WTP. No immediate concern.

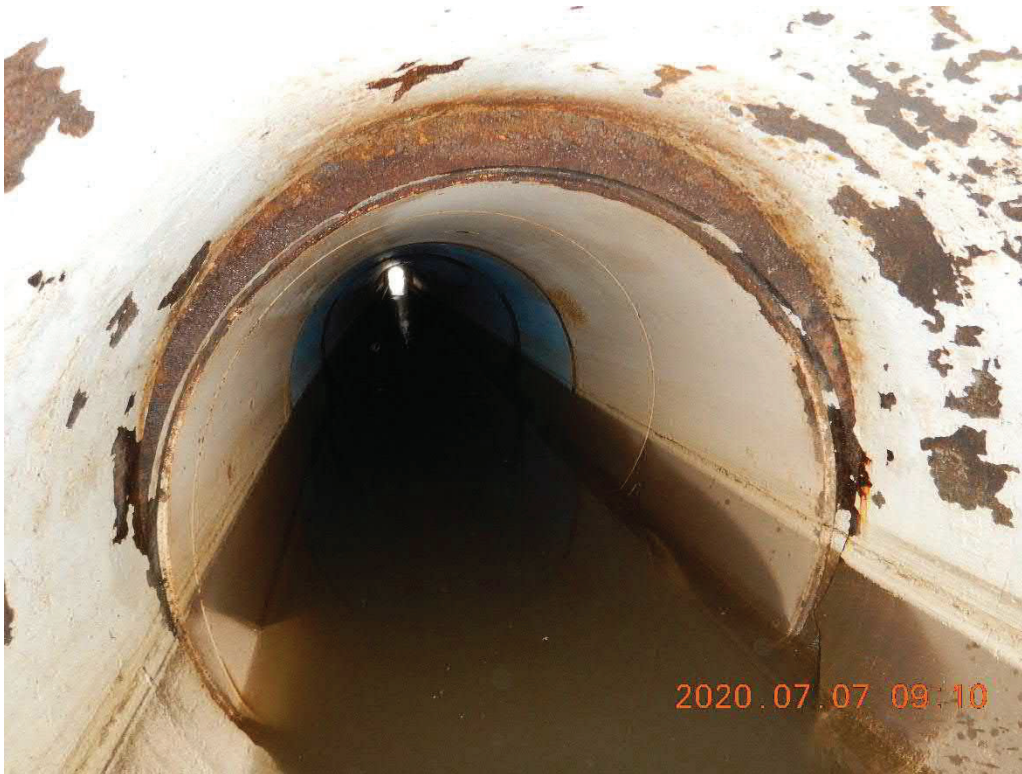
9. Section of outlet pipe to river disconnected, 3 ft from opening.

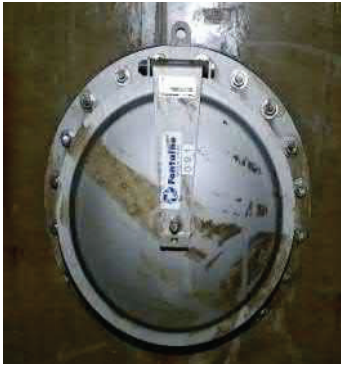
600mm flap gate

Situation: This flap gate is equipped with a neoprene lip seal secured onto the equipment wall frame. However, the upper section of the sealing system is damaged thus creating leakage. Refer to pictures below.

Recommendations: The damaged lip seal will need to be replaced and the flap gate disc readjusted as per the new seal. Refer to picture aside for a new seal view

Seal repaired with Sika 1a By Donald of Vanex Monday
October 5th 2020

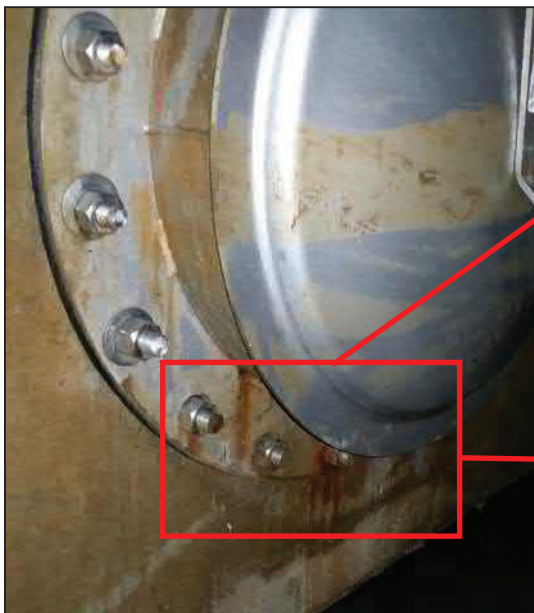
600mm flapgate

Situation : We have found several anchor nuts not properly tighten and without washers. This can create some leakage between the wall and the frame if the wall gasket is not properly compressed. Also, there was a rusted carbon steel washer that is contaminating the stainless steel flap gate. *Refer to pictures below.*

Missing and corroded washers

Recommendations: We have retightened the loose nuts but we had no stainless steel washers available of this size. New stainless steel washers will need to be installed when replacing the flap gate lip seal and the nuts will need to be properly tighten in order to make sure there is no leakage at the EPDM wall gasket.

New stainless steel washers added and nuts tightened Monday October 5 2020 by Donald of Vanex

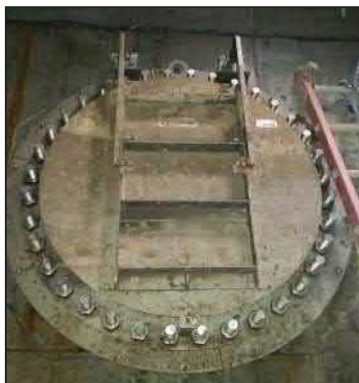
1050mm flap gate

Situation: The original flap gate installation works was not properly completed. The frame was not grouted on the wall as it should be; leaving a couple inches gap all around the frame circumference thus creating heavy leakage. *Refer to pictures below.*

Recommendations: The flap gate frame must be properly grouted using high performance non-shrink grout suitable for this application.

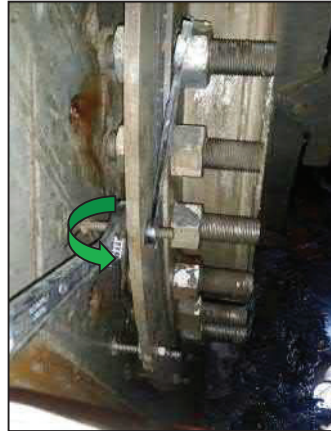
Frame readjustment using anchors back nuts

Recommendations: Since the frame was not grouted yet, we have taken this “opportunity” to perform our self the required frame adjustment during this inspection. We loosen the front nuts and restraighten the frame using the backing nuts of the frame anchors. We were able to closed the gaps between the disc and the seal fairly easily. The frame is now ready to be poured. *Refer to picture below.*

Donald Cote of Vanex inspected proper seal before and after placement of grout by Chandos

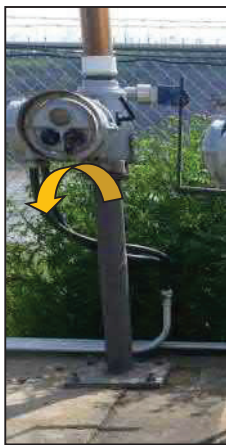
Situation: This gate is a rising stem type. With this operating arrangement, the pedestal (along with the actuator) is the key component and it is taking the entire sluice gate operating thrust. Therefore, it must be strongly secured onto a structural concrete floor slab or proper supports. However, the pedestal of this “Outfall sluice gate” have only two anchors bolted in the concrete slab and two anchors bolted inside a “mobile” concrete cover which is not attached to the structure. When the gate is reaching near the full close position, the concrete cover is moving upward thus bending the operating stem and not closing the gate. This could be the reason why the full close setting of the actuator was originally adjusted before the sluice gate is reaching it full close position. Refer to pictures below.

The pedestal is moving to the left because the cover is moving upward when closing the sluice gate

Recommendations: The pedestal must be anchored onto a fix and structurally sound surface. It could be possible to have a stainless steel bracket bolted on the thickness of the concrete slab in order to bolt on the 2 anchors that are actually on the “mobile” concrete cover. Another possibility is to extend the structural concrete slab underneath the entire pedestal. This will require a structural engineer to determine the best solution to solve this situation. We also recommend to have the operating stem straightness verify to make sure there is no permanent bent since it will affect the sluice gate operation. When all modifications and installation is completed the actuator switches will need to be readjusted as well as the closing wedges to make sure the gate is reaching it full close position and the actuator will stop before forcing/damaging any components.

October 1 2020 Dave Stout of Chandos added 2 steel base plates anchored to the concrete vault top with Hilti anchors and Hilti Hit, October 2 Northweld welded steel brackets to new base plates and existing sluice gate operating pedestal base plate, 2 C channel were then bolted across all there base plates. During sluice gate adjustments on October 6 it was found that this completely fixed the problem of unwanted movement in sluice gate operating shaft.

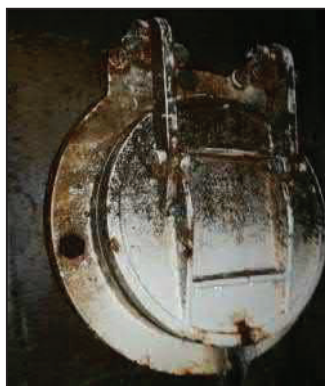
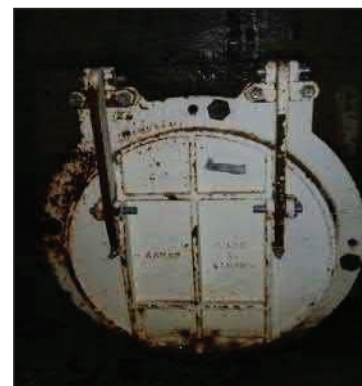
Situation: Since we were inside the outfall chamber, we took a quick look at the 3 ARMCO flap gates installed inside it. Those are all in good working condition without damages on the disc, hinges nor the frames. However, the anchor bolts are in steel and slightly corroded. Also, one anchor is loose on the middle flap gate that will need to be repaired or replaced. Refer to pictures below.
