2020 Ice Jam Flood Event

Performance of Municipal Infrastructure

December 15, 2020

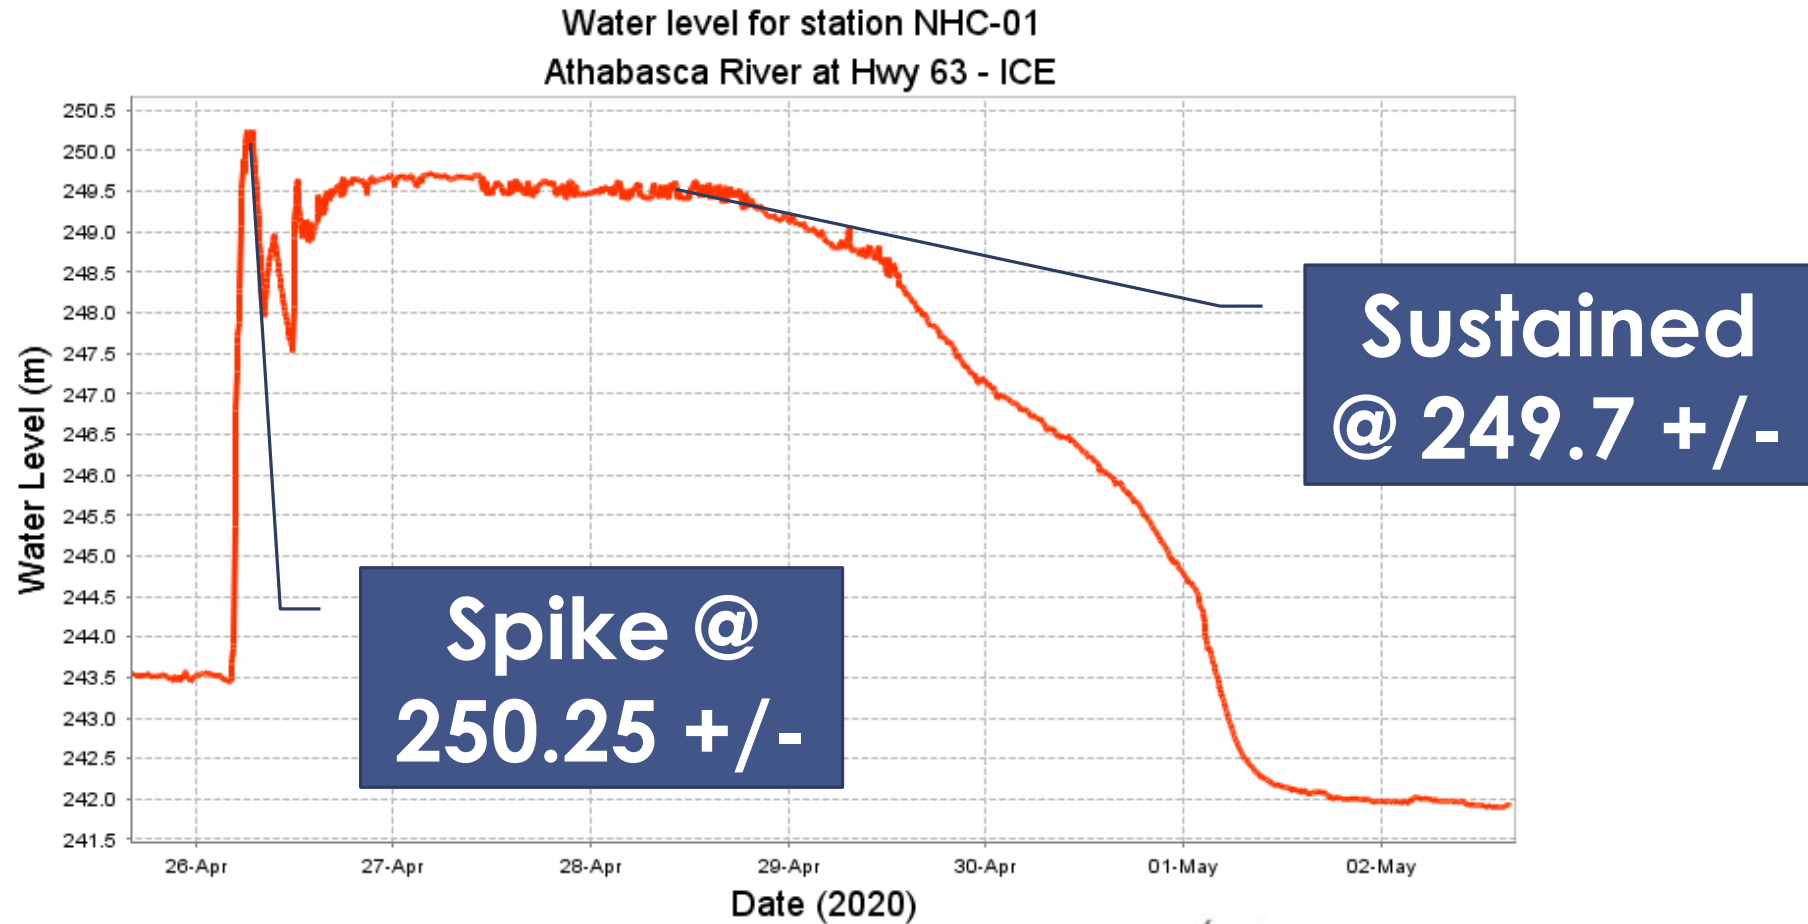
Flood Stage at Athabasca River Bridge

- Athabasca River started to break on April 26, 2020
- Ice Jam formed downstream of confluence of Athabasca and Clearwater Rivers, causing water levels to rise
- Water levels spiked to 250.25 at Athabasca Bridge / WTP
- Water levels peaked at 248.9 +/- on Clearwater
- Approximately 5 days for water levels to recede

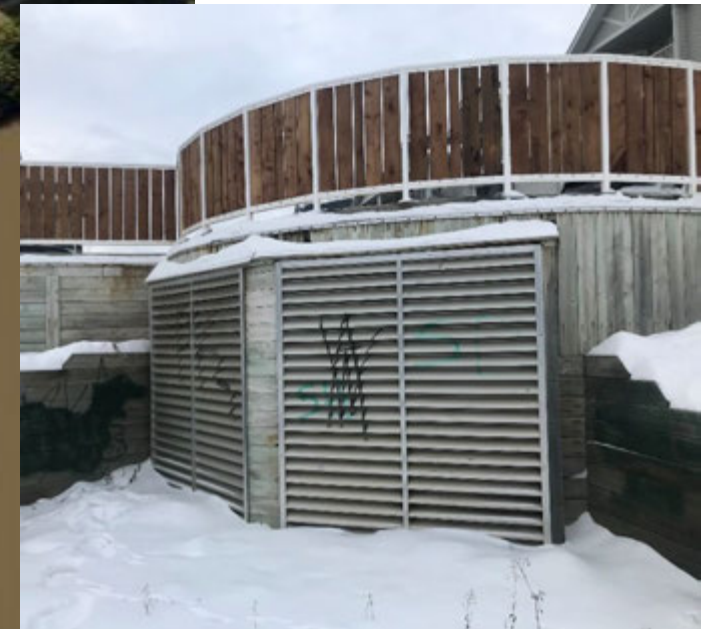
Underground
Parkade Air
Vents

- Flood water was observed inside of the dykes before overland breaches occurred.
- Water continued to rise inside of dykes, despite emergency dyke construction.
- Underground pathways allowed water to bypass the flap gates flooding both the storm and sanitary sewers.
- Once inside the dyke system, water will keep flowing until equalization

2. Implement a comprehensive Flood Protection System (continued)
 - b) Identify and plug all underground flooding pathways
 - c) Apply a multi-barrier approach, including redundancy for critical infrastructure (e.g. Hospital), and means of isolation to limit damage in the event of a breach
 - d) Implement pumping measures to manage drainage inside of the dykes

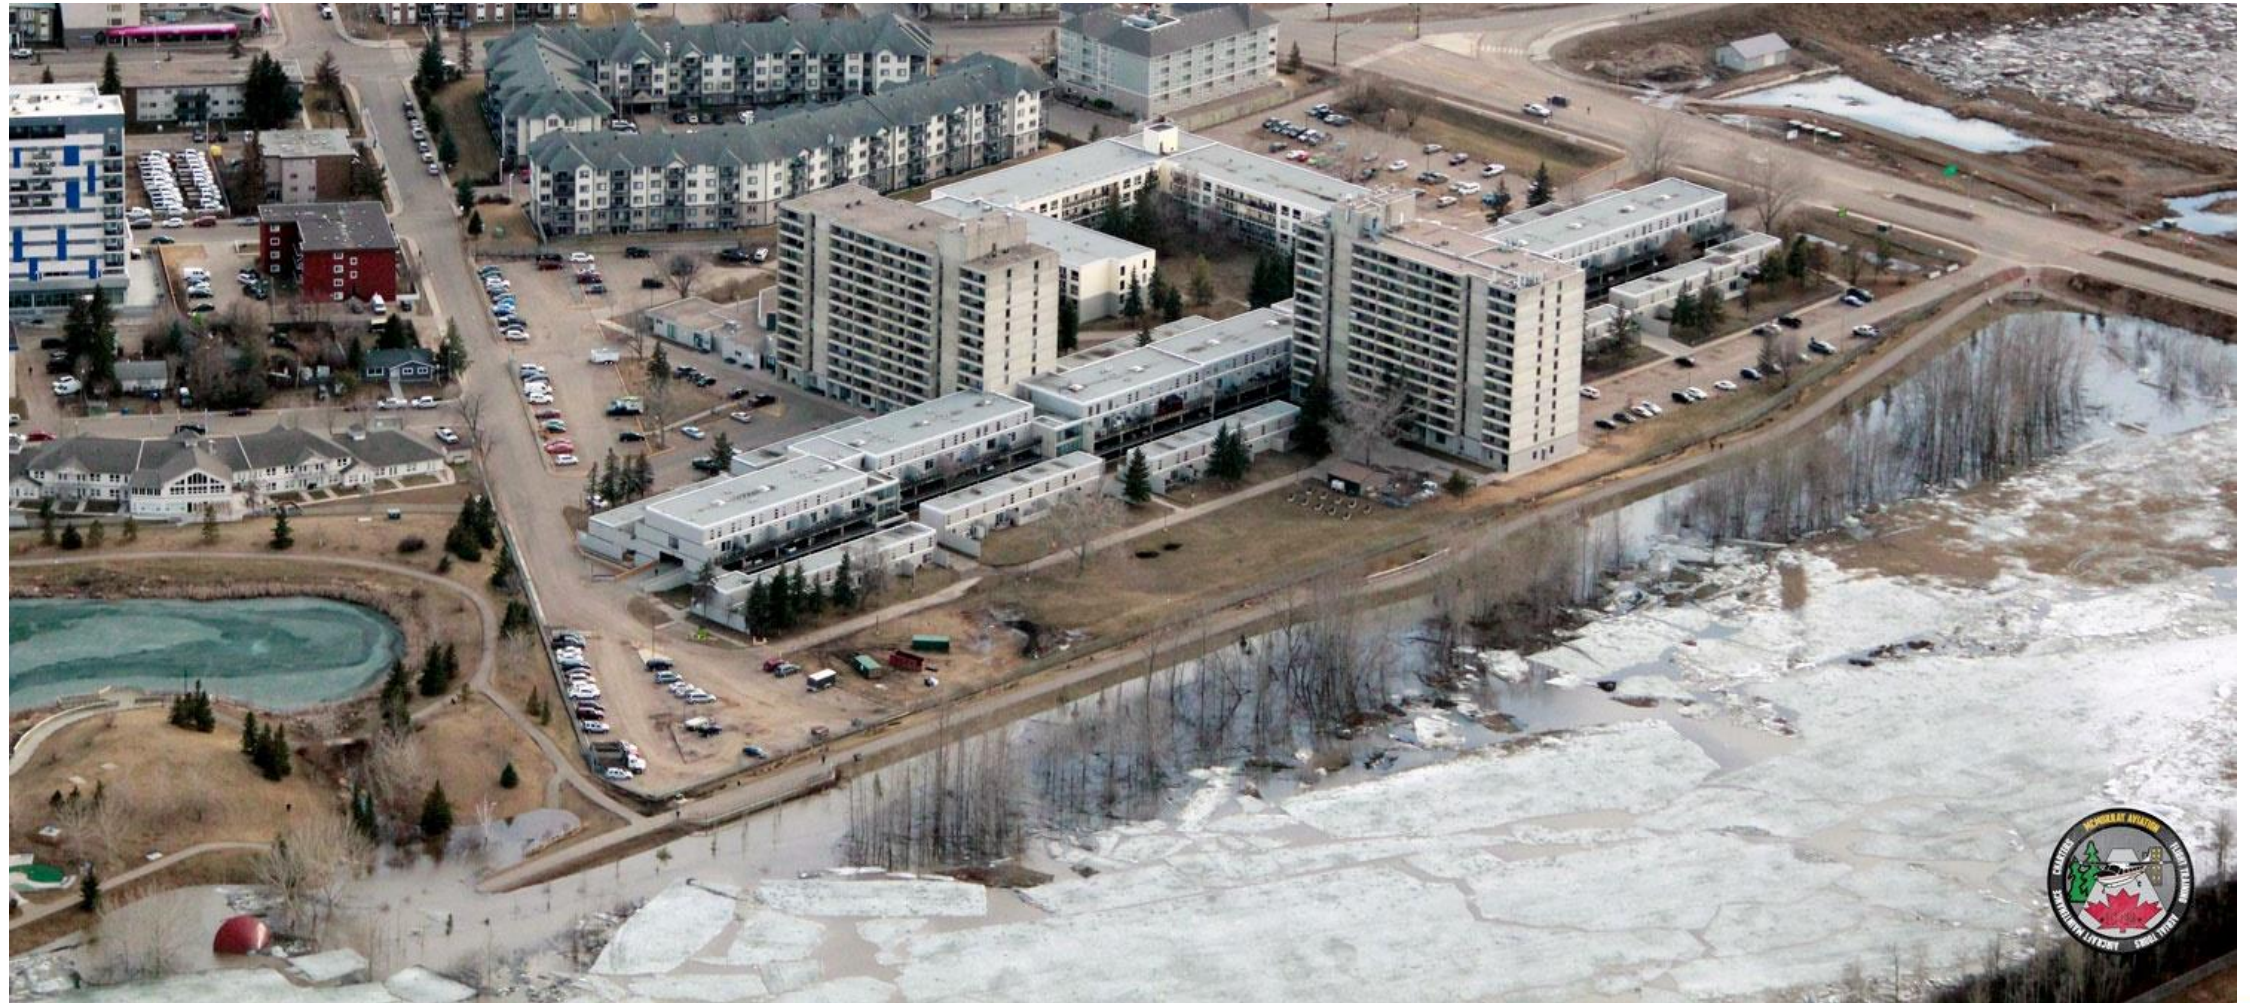
Reach 1 / River Park Glen

- No bridges damaged
- No flooding from Athabasca River / MacDonald Drive Causeway (i.e. 250.25 “spike” didn’t inundate downtown)
- No Flooding at River Park Glen (Reach 1)
- Lift Station 1A protected by 2013 dykes
- Hospital did not flood

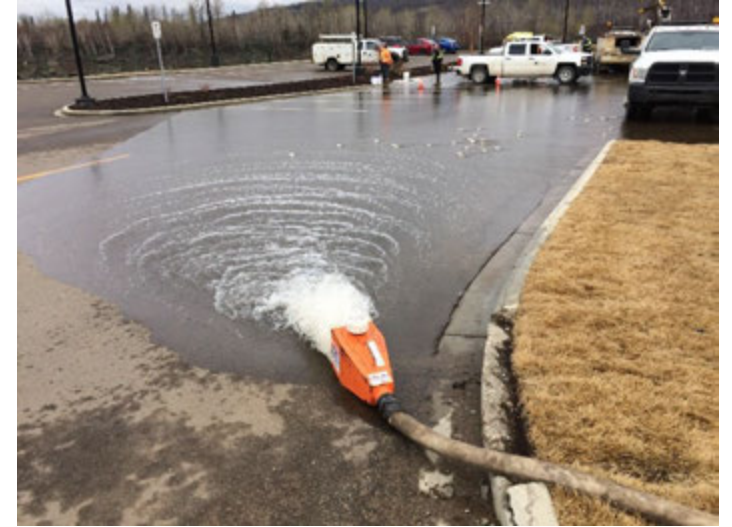
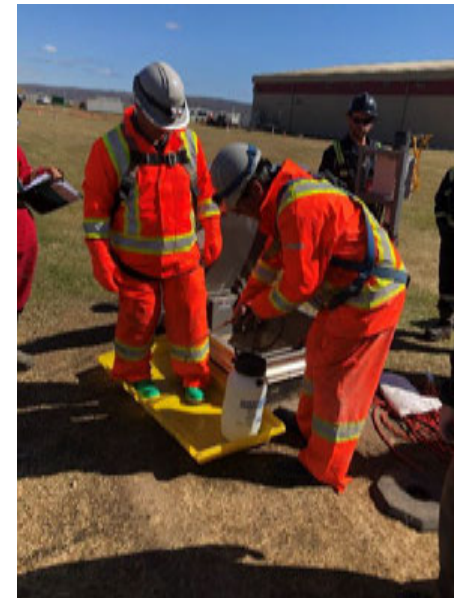
Water Treatment Plant – Repairs and O&M

- Outfalls damaged by river ice
- Sluice gate at outfall not sealed
- Flap gates bypassed at clearwell overflow piping

- Sluice gate and flap gates repaired
- Dive team removed precipitate from valves
