## **Anzac Community Centre**

Building Envelope & Mould Remediation  
Report; Addendum 1

May 17, 2018

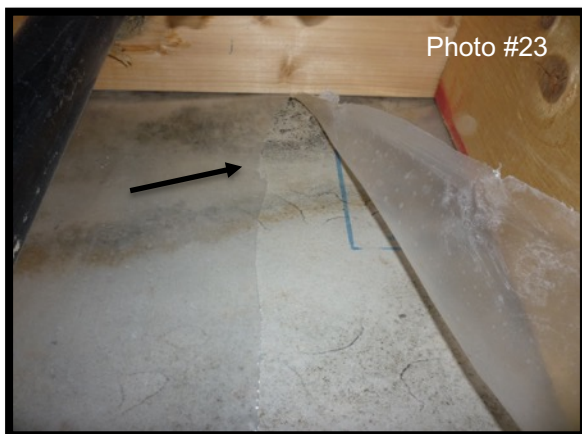
Photo #23

Mould growth on the backside of the drywall within the Men's washroom in the Hall Area

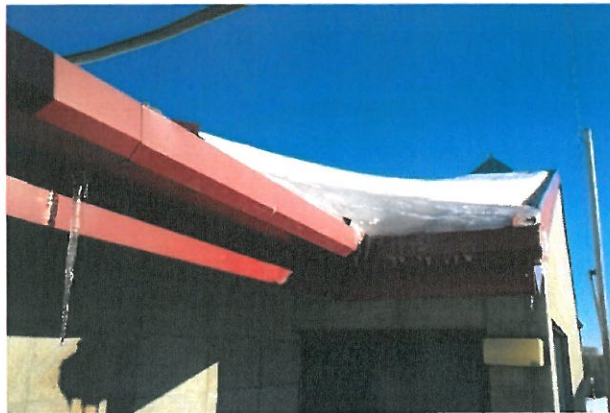
- Significant ice damming was observed on roof areas above the main washrooms (Photo 3), the rink hall entrance (Photo 4), and the nurse's office (Photo 5). Ice damming occurs when the underside of the snow cover melts as a result of exposure to a heat source. Heat sources can be from heat loss in the attic space or the surface of the metal roof due solar heat gain. When the melted water flows over colder sections of the roof and eavestrough, ice formations occur. Ice damming can be minimized by keeping the attic space cold, but this can be impeded by leakage of warm air into the attic, heat loss from uninsulated ducts and pipes, heat loss through the attic insulation and insufficient ventilation in the attic. Comments and observations from our review of the attic are included in Section 3.3 of this report. Attic ventilation is achieved through vented soffits and roof vents; however, no roof vents were visible on the roof at the time of our review. We also could not confirm if there were any ridge vents at the peaks of the metal roof. We recommend further review to assess how the roof is vented.

**Photo 4: Ice damming above rink hall entrance**

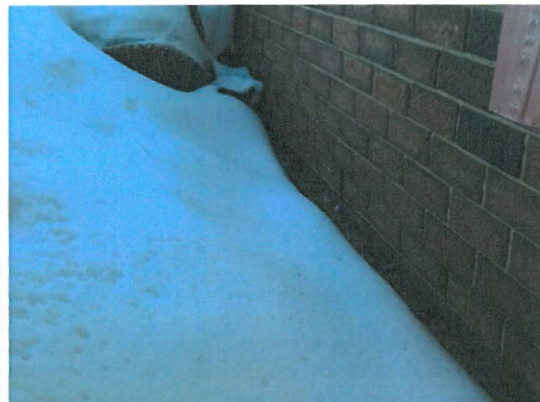
**Photo 11: Location of thermal image**

Thermal scans of the exterior grade beam show a noticeable amount of heat loss through the exposed concrete foundation (See Image 3, Photo 11 on RJC's Building Envelope and Structure Review). Installation of an exterior foundation protection, consisting of cementitious finished board over rigid insulation and membrane around the entire exterior of the building is recommended to prevent heat loss from the building.

- Thermal scans of the exterior walls found noticeable heat loss through the exposed concrete foundation (Image 3, Photo 11). This appears to be due to thermal bridging through the uninsulated concrete. We recommend adding exterior insulation to reduce the thermal bridging at these locations.

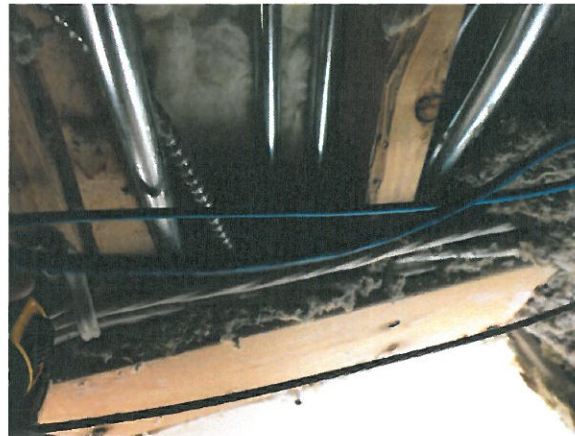
Photo 22: Top of cold wall cavity in Image 8

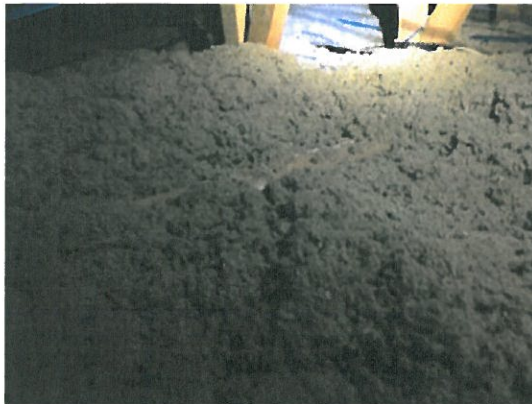
- The attic space above the lower ceiling levels is accessed by two access hatches located in the janitor's room and bar area (Figure 2). The attic hatches consist of an opening framed between the bottom chords of the roof trusses with an insulated wood box serving as the hatch cover. No access hatches are provided to access the ceiling spaces above the main hall and mezzanine (Area 2 in Figure 2); however, a previously made opening the hall ceiling (circled in Figure 2) indicated that this attic space was filled with approximately 6" of loose cellulose insulation with a large air space between the top of the insulate the roof. With the exception of the rink hall and the foyer ceiling/walls in Area 1, which are insulated with batt, all ceiling spaces appeared to be insulated with loose blown-in cellulose insulation. The thickness of this insulation was found to be between 6" and 8". It is difficult to determine what the original thickness would have been since it has been disturbed and has compressed over time from moisture accumulation in the attic (Photos 26 and 27).

**Photo 26: Typical attic insulation cover where insulation appears to have been disturbed**

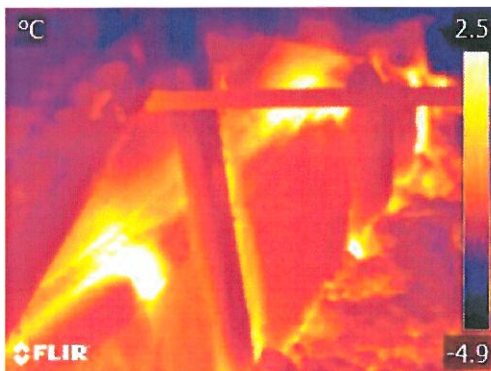
- Thermal scans also found numerous hot spots in the attic at low spots in the insulation, at transitions between interior walls and ceilings, and at electrical penetrations (Images 15 to 17). Most of the heat loss at these locations is due to insufficient insulation or thermal bridging; however, there may also be discontinuities in the vapour barrier, such as between the kitchen and rink hall. Further review would be required to confirm.

Image 16: Heat loss at top of boardroom wall
