Anzac Community Centre

Building Envelope & Mould Remediation
Report; Addendum 1

May 17, 2018

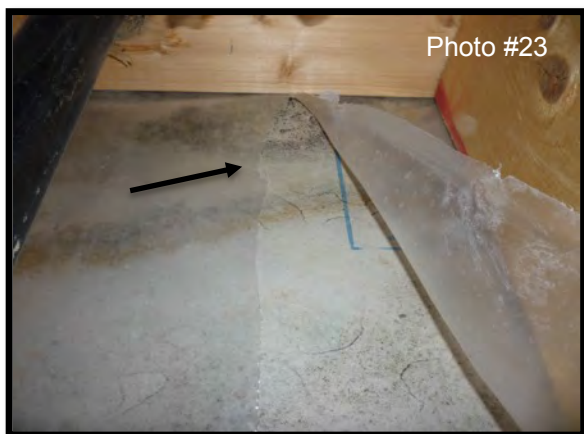
Mould growth on the backside of the drywall within the Men's washroom in the Hall Area

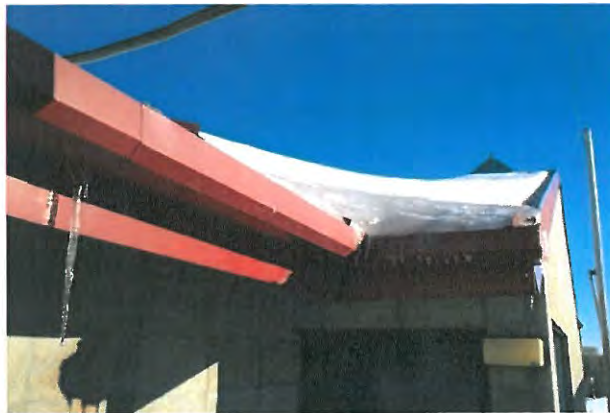
- Significant ice damming was observed on roof areas above the main washrooms (Photo 3), the rink hall entrance (Photo 4), and the nurse's office (Photo 5). Ice damming occurs when the underside of the snow cover melts as a result of exposure to a heat source. Heat sources can be from heat loss in the attic space or the surface of the metal roof due solar heat gain. When the melted water flows over colder sections of the roof and eavestrough, ice formations occur. Ice damming can be minimized by keeping the attic space cold, but this can be impeded by leakage of warm air into the attic, heat loss from uninsulated ducts and pipes, heat loss through the attic insulation and insufficient ventilation in the attic. Comments and observations from our review of the attic are included in Section 3.3 of this report. Attic ventilation is achieved through vented soffits and roof vents; however, no roof vents were visible on the roof at the time of our review. We also could not confirm if there were any ridge vents at the peaks of the metal roof. We recommend further review to assess how the roof is vented.

Photo 4: Ice damming above rink hall entrance

- As a result of ice damming, visible damage has occurred to the eavestroughs (Photos 3 to 5). Snow guards can help reduce the risk of this damage by preventing snow and ice from sliding off the roof. The roof also appears to have been patched above the nurse's office (Photo 5). Roof repairs including new snow guards and eavestroughs are recommended. Heat tracing eavestroughs and downspouts could also be considered.

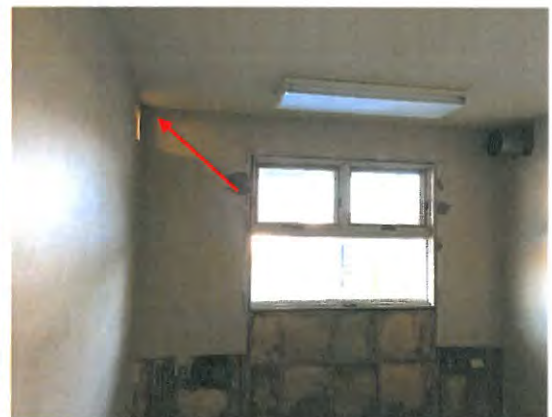
- Roof canopies above the main building entrances are supported by exposed glulam beams, which are supported by exterior columns and the exterior wall (Photo 6). Thermal scans of the exterior walls at the beam connections found noticeable heat loss due to thermal bridging through the wood framing (Image 1, Photo 7). Air leakage was also detected at some of these locations (Image 2, Photo 8). In addition to air vapour barrier repairs, we recommend adding insulation to either the beams or exterior walls to reduce the amount of heat loss at the beam connections.

Photo 7: Location of thermal image and cold spot

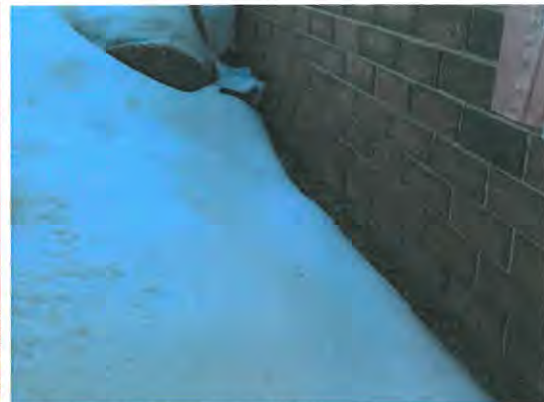
Photo 11: Location of thermal image

- Thermal scans of the exterior walls found noticeable heat loss through the exposed concrete foundation (Image 3, Photo 11). This appears to be due to thermal bridging through the uninsulated concrete. We recommend adding exterior insulation to reduce the thermal bridging at these locations.

Thermal scans of the exterior grade beam show a noticeable amount of heat loss through the exposed concrete foundation (See Image 3, Photo 11 on RJC's Building Envelope and Structure Review). Installation of an exterior foundation protection, consisting of cementitious finished board over rigid insulation and membrane around the entire exterior of the building is recommended to prevent heat loss from the building.

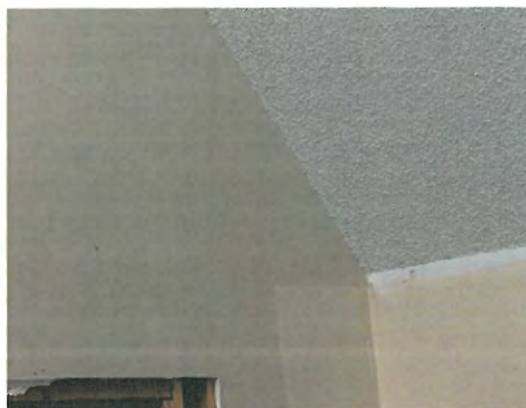
Photo 16: Location of thermal image

- Thermal scans of the interior found numerous cold spots in wall areas adjacent to unconditioned attic spaces (Images 4 to 9). At most locations, the cold spots were found to be locations of missing or fallen batt insulation. At one location between the kitchen and rink hall, a draft was also detected (Image 9, Photo 20). This was found to be due to a discontinuity in the vapour barrier between the kitchen ceiling and rink hall ceiling, which are located at different elevations (Photo 22). This air leakage may have also contributed to the previously noted moisture damage, which had occurred near Grid D11 (Photo 23).

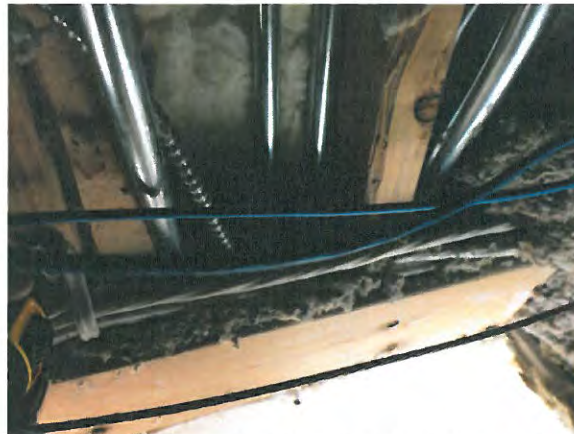
Photo 22: Top of cold wall cavity in Image 8

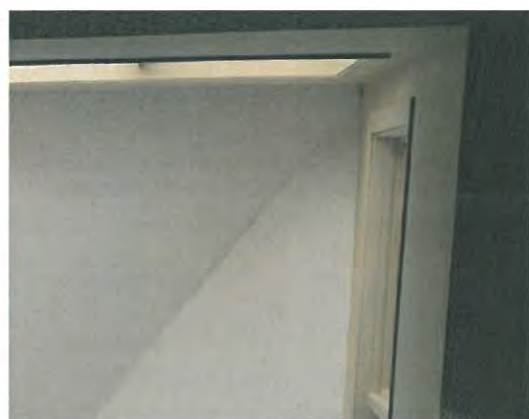
Photo 24: Location of thermal image

- Thermal scans of the upper walls and ceiling in the foyer identified several locations of increased heat loss (Images 10 and 11). There was no access to this ceiling space to confirm the cause of these thermal anomalies; however, we suspect it is similar to the thermal anomalies observed near the lower ceilings.

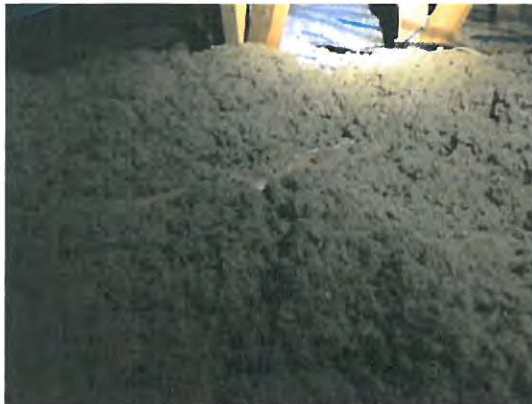
- The attic space above the lower ceiling levels is accessed by two access hatches located in the janitor's room and bar area (Figure 2). The attic hatches consist of an opening framed between the bottom chords of the roof trusses with an insulated wood box serving as the hatch cover. No access hatches are provided to access the ceiling spaces above the main hall and mezzanine (Area 2 in Figure 2); however, a previously made opening the hall ceiling (circled in Figure 2) indicated that this attic space was filled with approximately 6" of loose cellulose insulation with a large air space between the top of the insulate the roof. With the exception of the rink hall and the foyer ceiling/walls in Area 1, which are insulated with batt, all ceiling spaces appeared to be insulated with loose blown-in cellulose insulation. The thickness of this insulation was found to be between 6" and 8". It is difficult to determine what the original thickness would have been since it has been disturbed and has compressed over time from moisture accumulation in the attic (Photos 26 and 27).

Photo 26: Typical attic insulation cover where insulation appears to have been disturbed

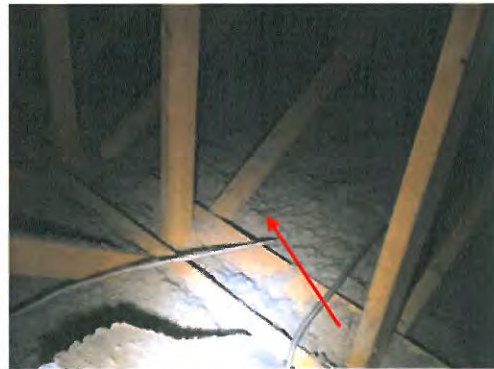
Photo 33: Location of thermal image

- Thermal scans also found numerous hot spots in the attic at low spots in the insulation, at transitions between interior walls and ceilings, and at electrical penetrations (Images 15 to 17). Most of the heat loss at these locations is due to insufficient insulation or thermal bridging; however, there may also be discontinuities in the vapour barrier, such as between the kitchen and rink hall. Further review would be required to confirm.

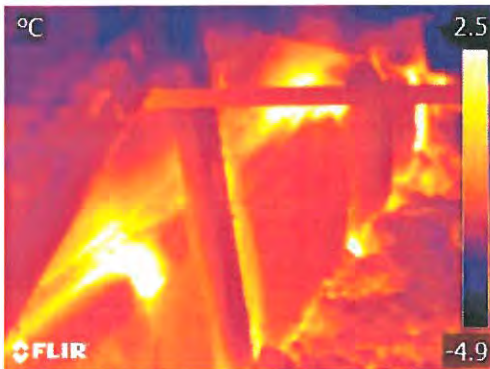
Image 16: Heat loss at top of boardroom wall

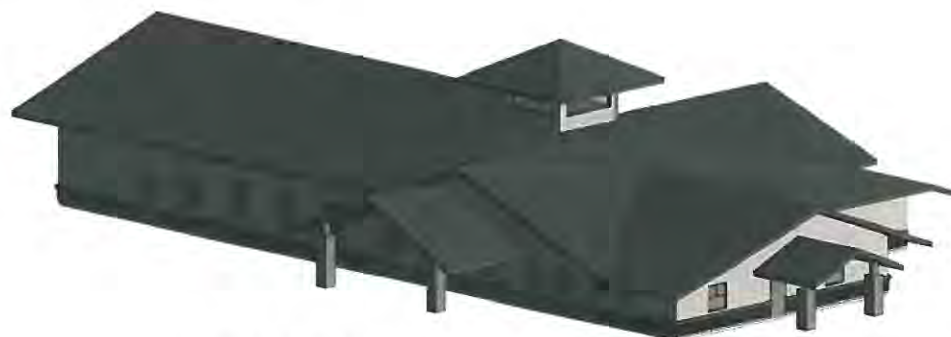
Figure 4: Roof Shape (rendering provided by Stantec)

The roof is a cross-gabled shape with a higher clerestory above the foyer area, as shown in the rendering below provided by Stantec. Since drawings from the original design and construction are not available, the exact framing of the roof structure is not known. The roof trusses are therefore assumed to span between the identified load-bearing walls.
